MOUNT LEMMON CULVERT STUDY

PIMA COUNTY DEPARTMENT OF TRANSPORTATION
AND FLOOD CONTROL DISTRICT
201 N. STONE AVE., 4TH FLOOR
TUCSON, AZ 85701

CMG DRAINAGE ENGINEERING, INC.
85 W. FRANKLIN ST.
TUCSON, AZ 85701

NOVEMBER 19, 1993

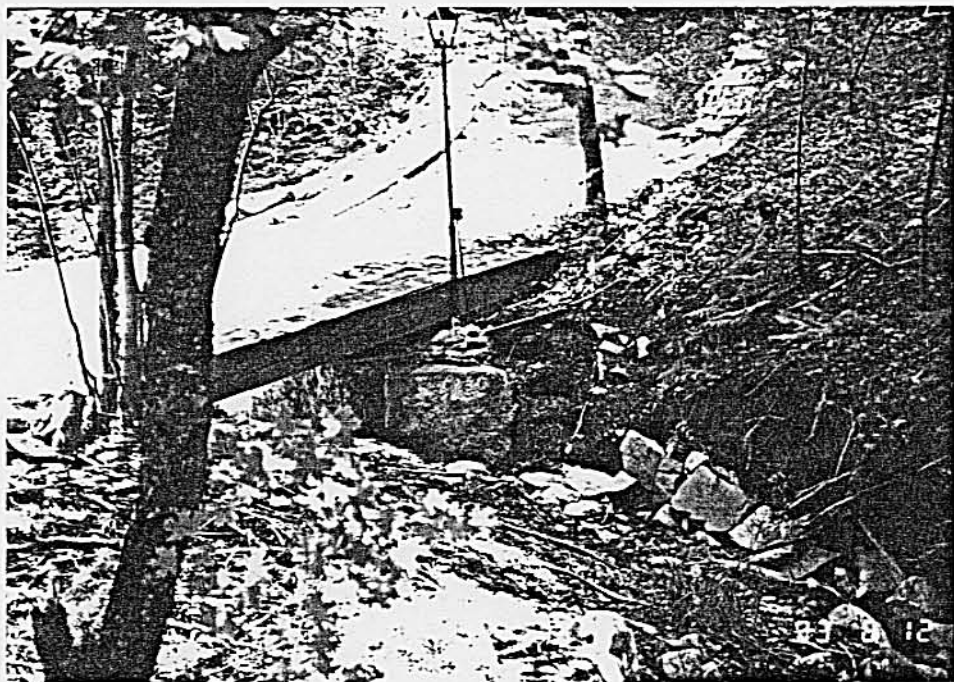
Upstream side of crossing at 11000 Carter Canyon Road. .

NO PERMIT FOUND

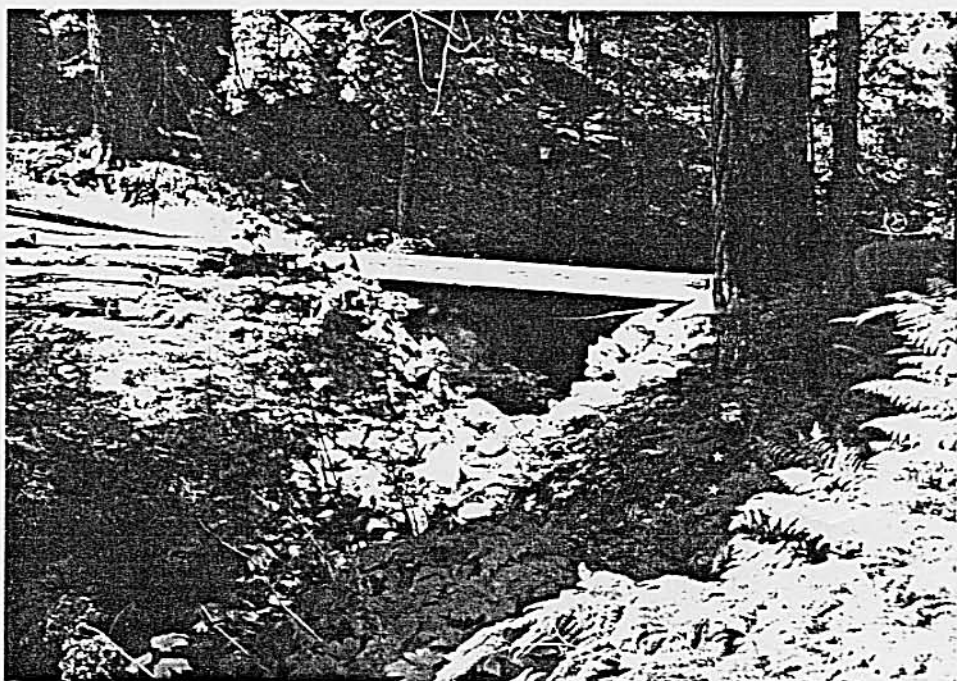
Downstream side of crossing at 11000 Carter Canyon Road.

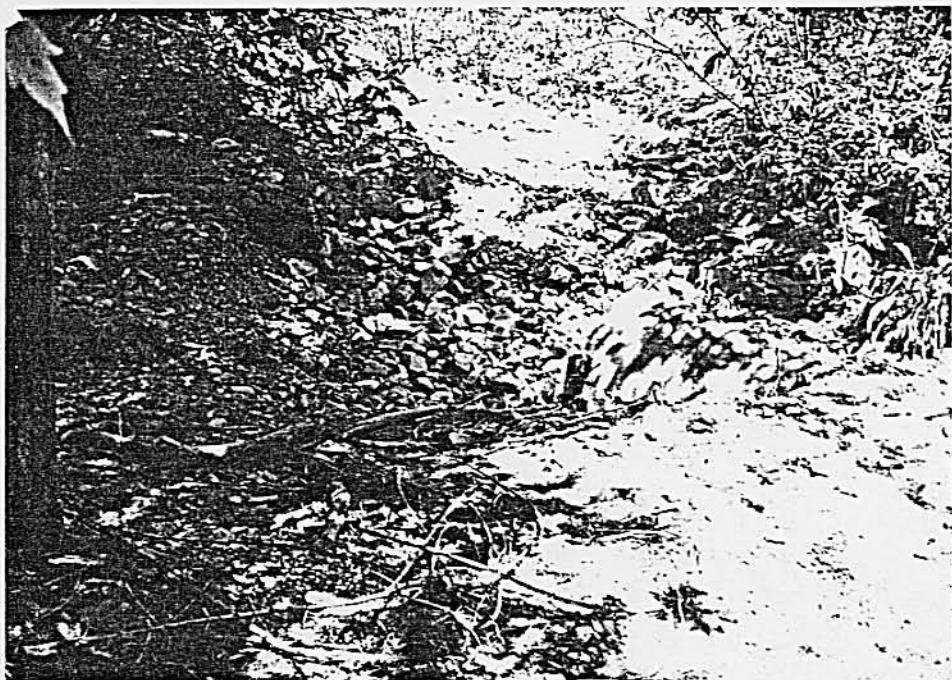
#2: 1-36" CMP

Upstream side of crossing at 11113 Carter Canyon Road.

NO PERMIT FOUND

$Q_{CAP} = 35 \text{ cfs}$

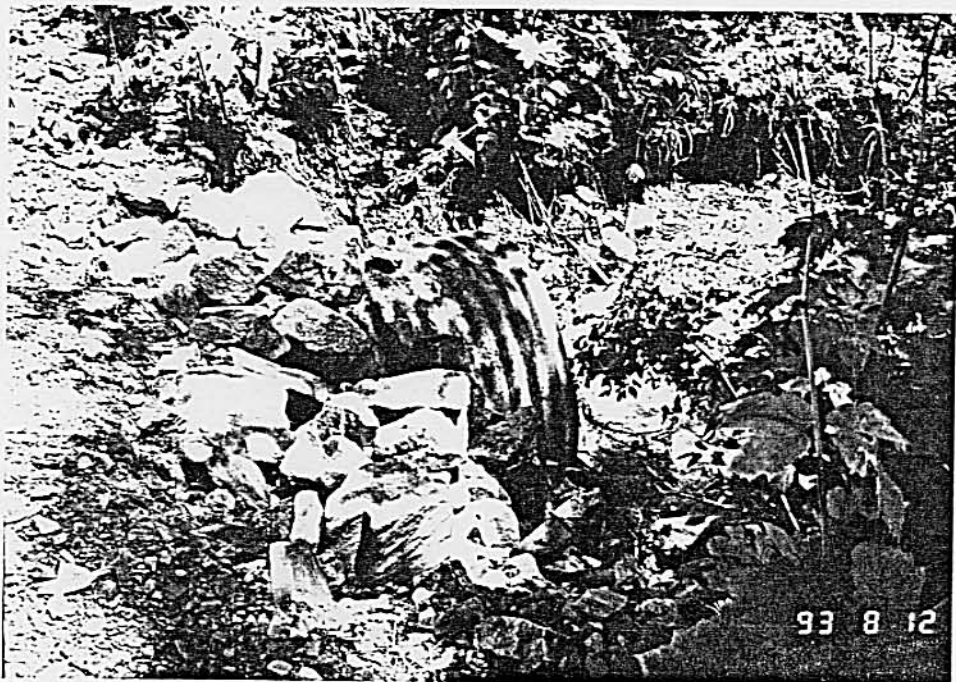
Downstream side of crossing at 11113 Carter Canyon Road.

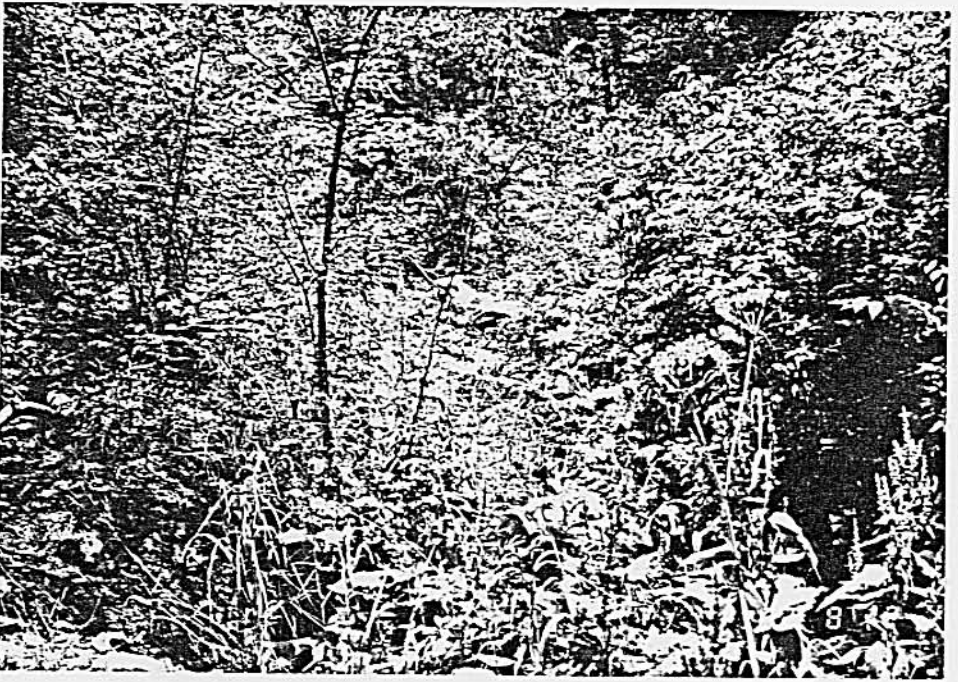
Downstream of crossing at 11113 Carter Canyon Road.
NO PERMIT FOUND

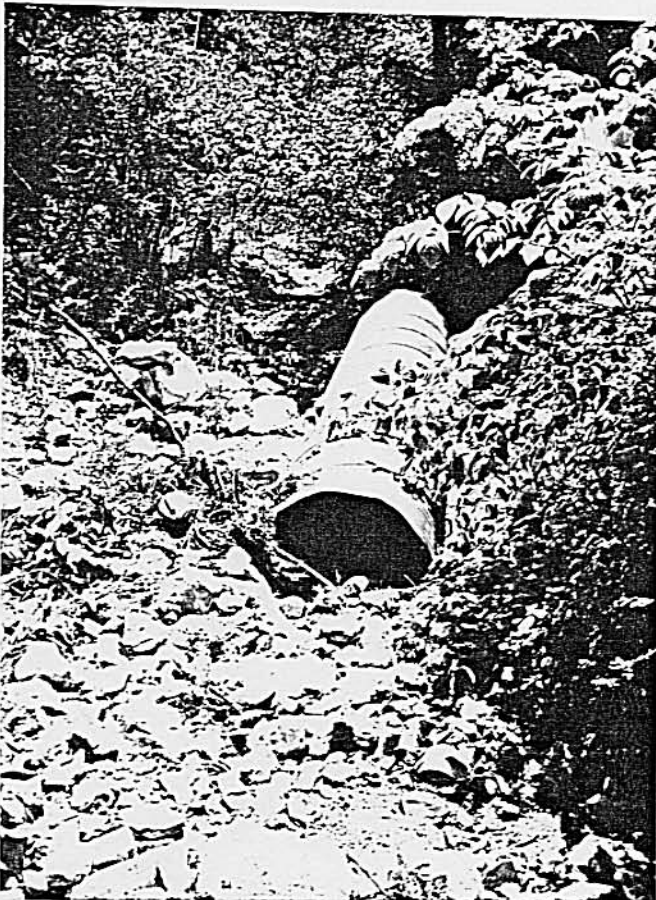
#3: 1-36" CMP

Upstream of washed out driveway at 11119 Carter Canyon Rd.
PERMIT ON FILE WITH PIMA COUNTY

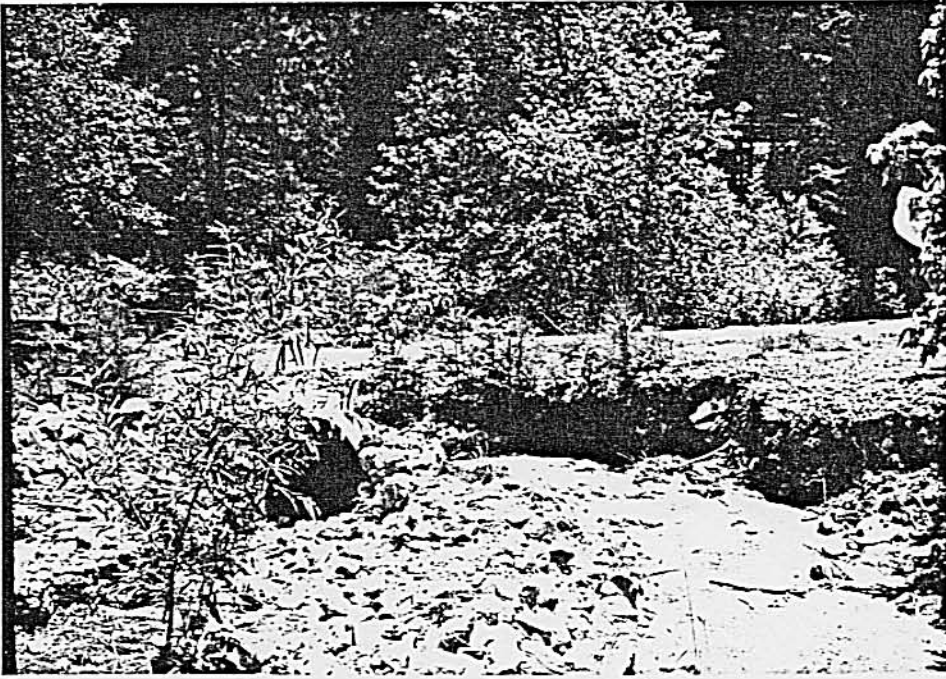
#4: 1-36" CMP

Upstream side of crossing at lots 25 and 26,
Block 30, along Carter Canyon Road

NO PERMIT FOUND

$Q_{cap} = 35$ cfs

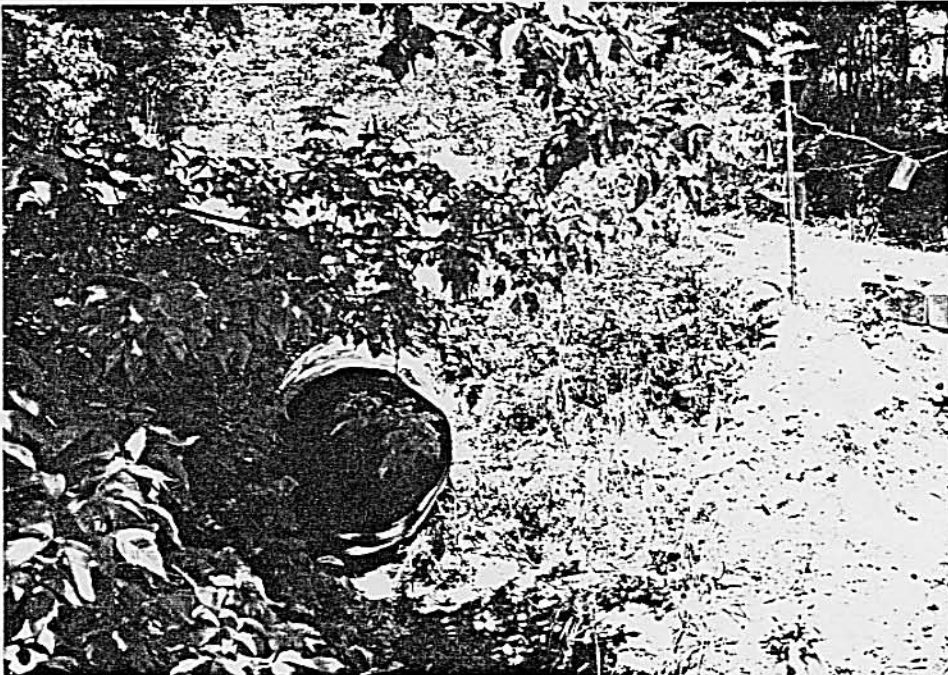
Downstream side of crossing at lots 25 and 26,
Block 30, along Carter Canyon Road

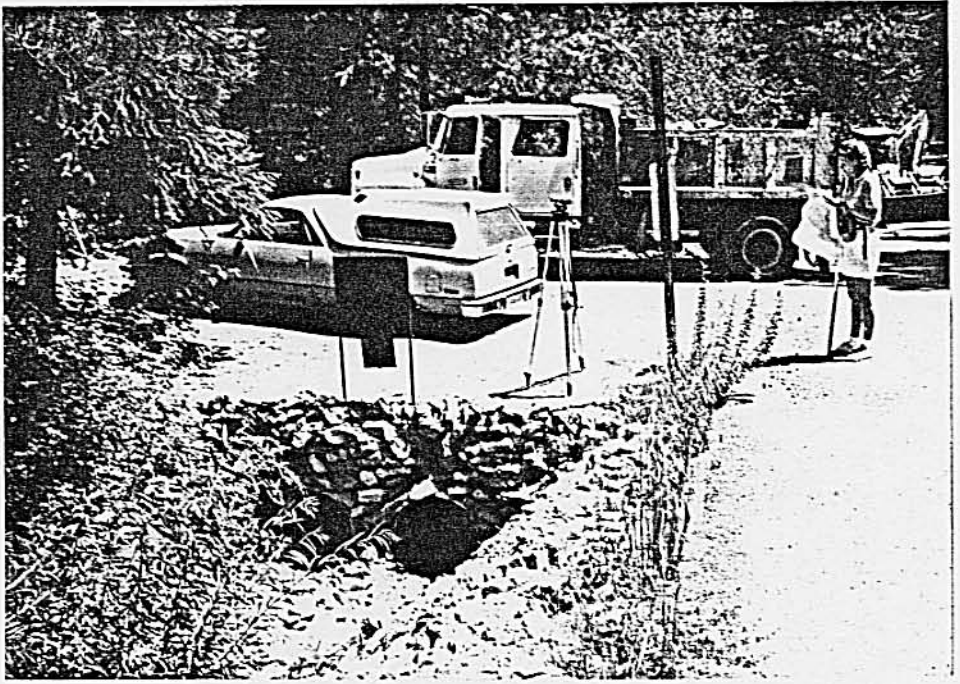
#5: 2-30" CMPs

Upstream side of crossing at 11149 Carter Canyon Road.

NO PERMIT FOUND

$Q_{CAP} = 90 \text{ cfs}$

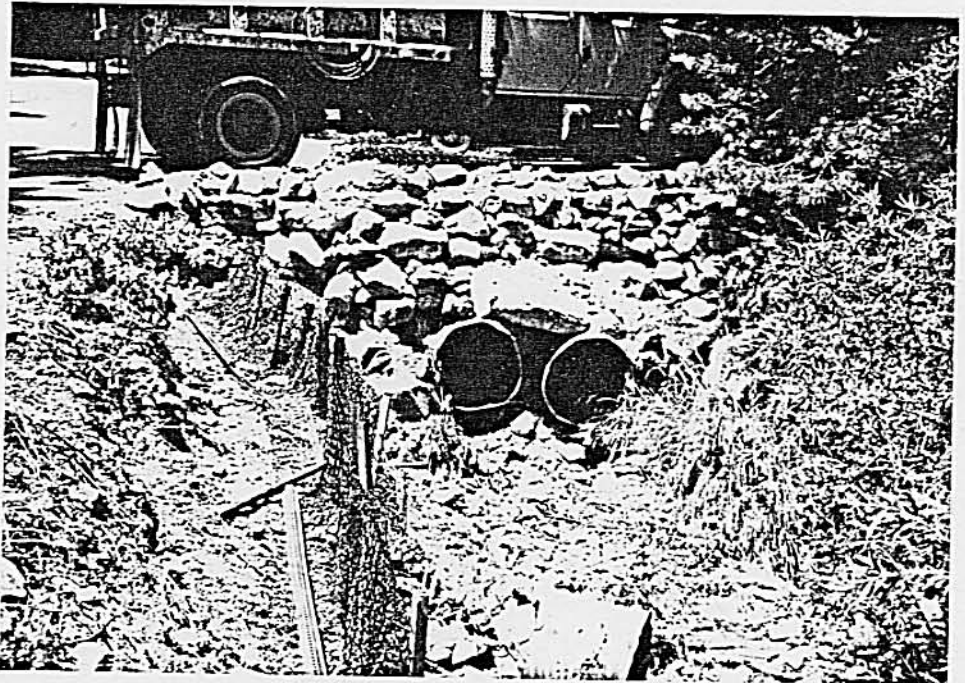
Downstream side of crossing at 11149 Carter Canyon Road.

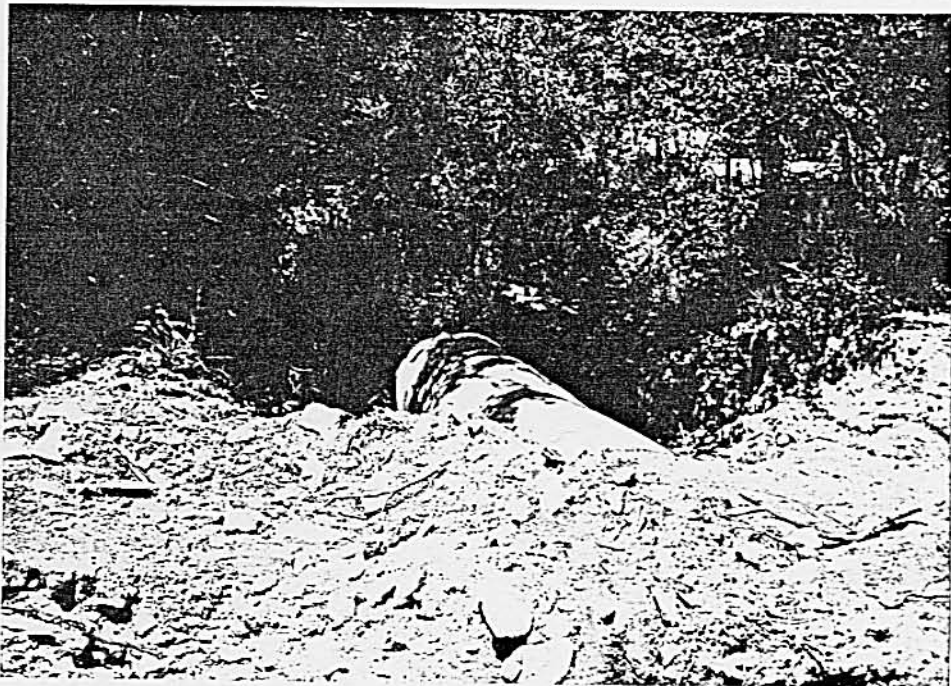
Downstream side of crossing at 11179 Carter Canyon Road.
(driveway partially washed out)

NO PERMIT FOUND

#6: 1-36" CMP $Q_{CAP} = 35$ cfs

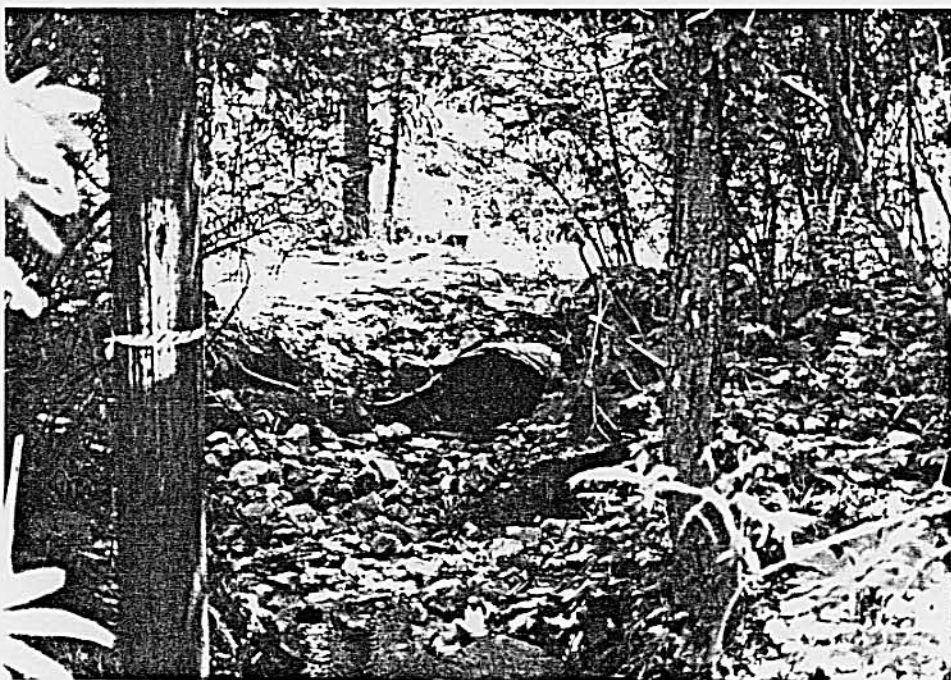
Upstream side of crossing just east of 11179 Carter Canyon Road.

#7: 1-36" CMP $Q_{CAP} = 35$ cfs

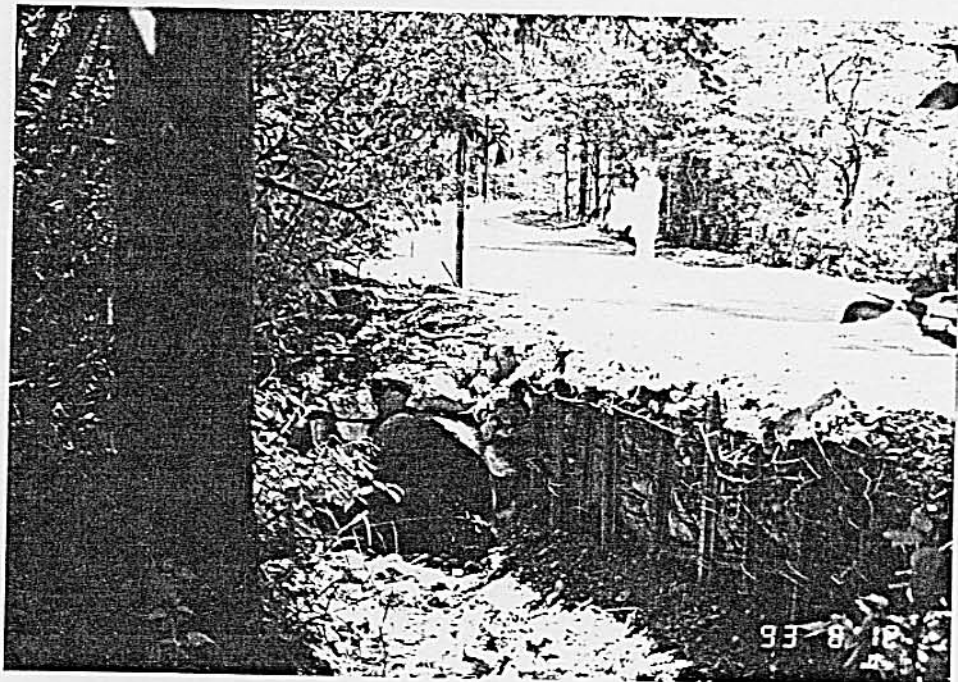
Upstream of crossing from the north to the south side of
Carter Canyon Road (located at 11229 Carter Canyon Road).

#8: 1-42" CMP $Q_{CAP} = 86 \text{ cfs}$

NO PERMIT FOUND

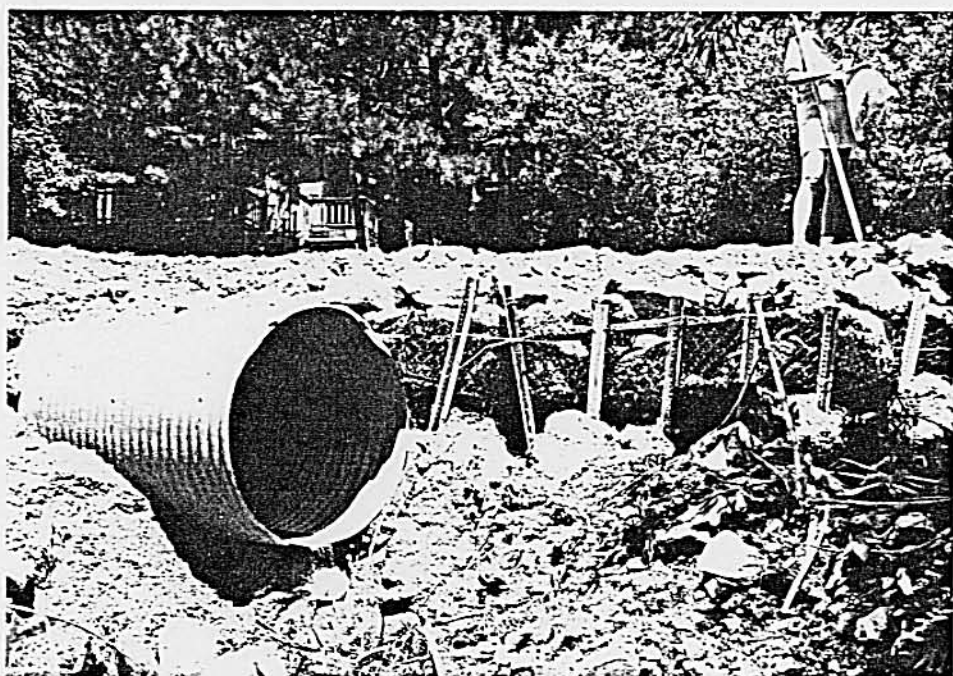
Downstream of crossing from the north to the south side of
Carter Canyon Road (located at 11229 Carter Canyon Road).

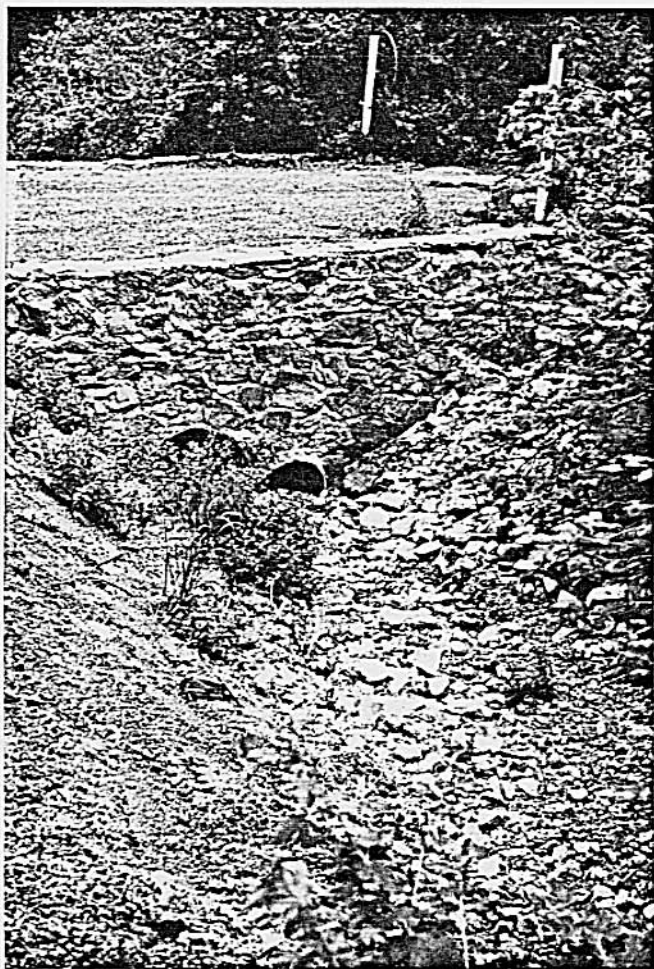
#9: 1-36" CMP, 1-24" CMP

Upstream side of crossing at 10950 Turkey Run Road.

NO PERMIT FOUND

$Q_{CAP} = 119$ cfs

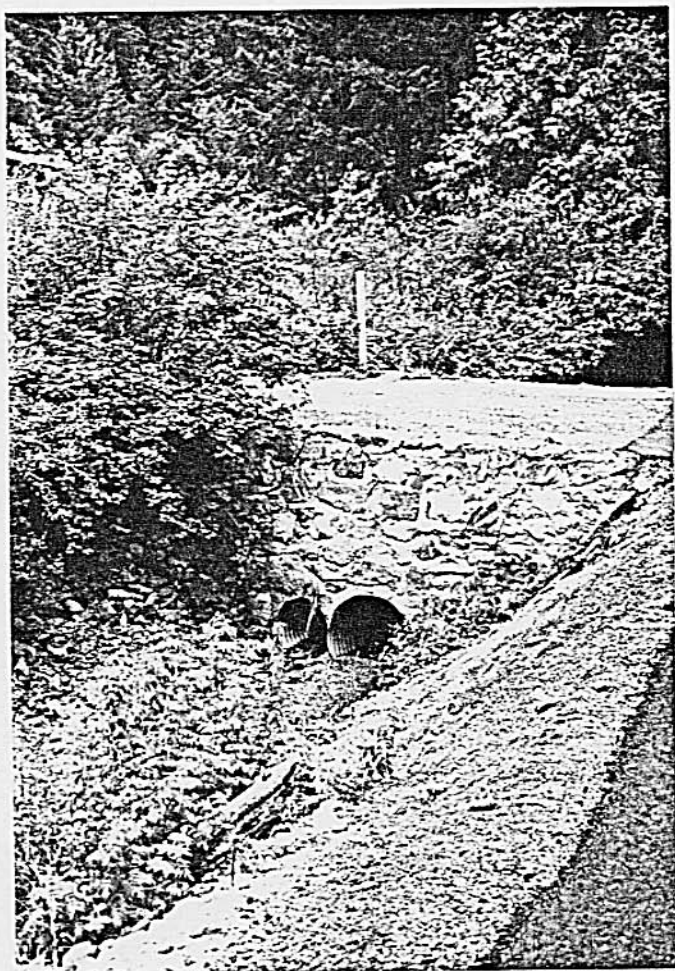
Downstream side of crossing at 10950 Turkey Run Road.

NO PERMIT FOUND

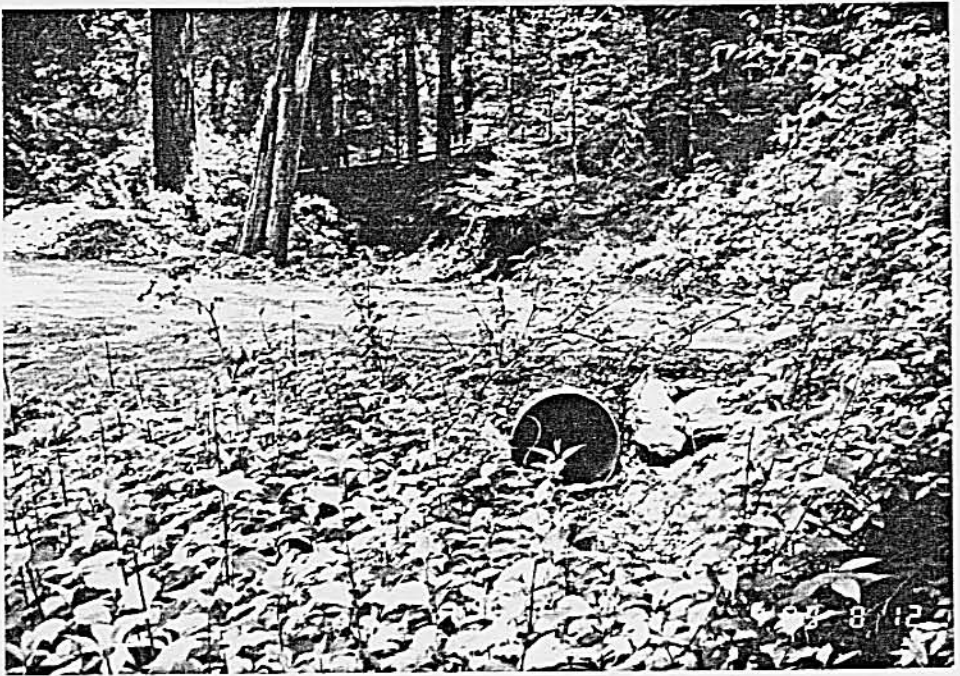
Upstream side of crossing at Guthrie Road and Turkey Run Road.

NO PERMIT FOUND

#10: 1-36" CMP $Q_{CAP} = 35 \text{ cfs}$

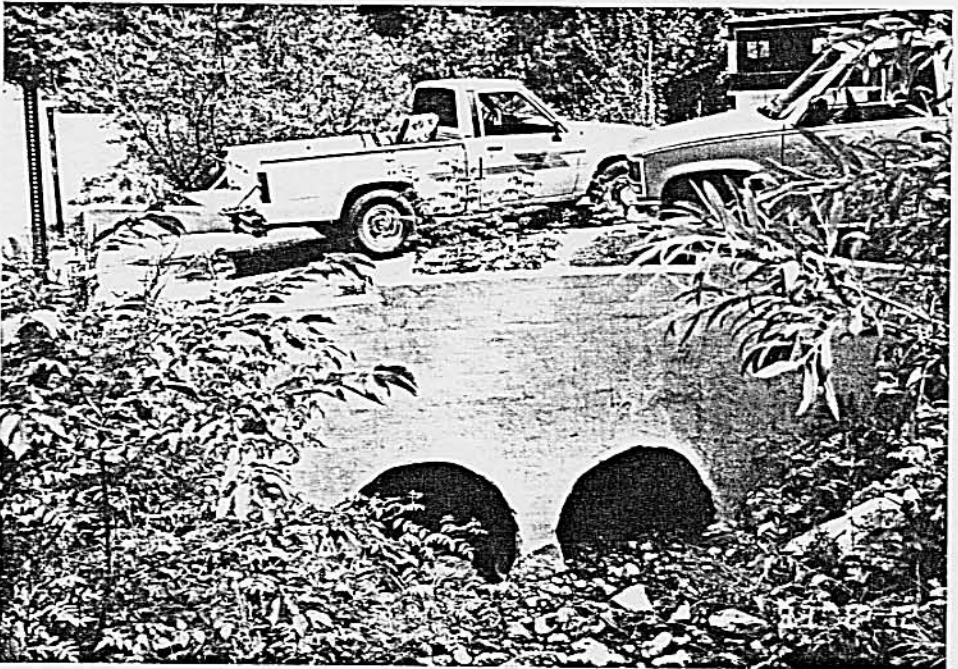
Upstream side of crossing at 11090 Turkey Run Road.

PERMIT ON FILE WITH PIMA COUNTY

#11: 2-42" CMPs $Q_{CAP} = 212 \text{ cfs}$

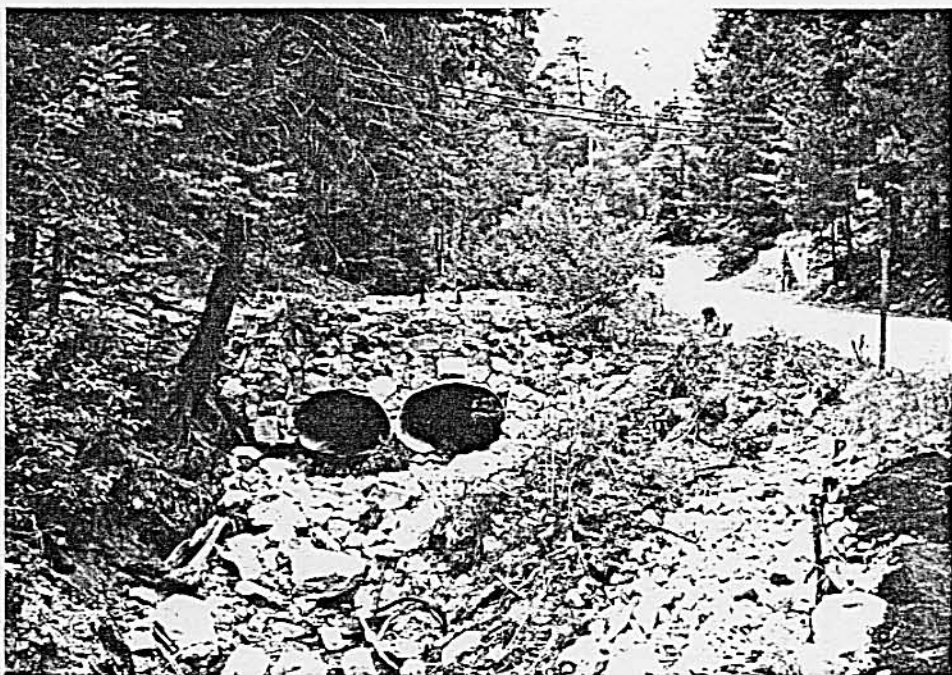
Downstream of crossing at 11122 Turkey Run Road.

NO PERMIT FOUND

#12: 2-42"H x 60"W CMPs $Q_{CAP} = 224$ cfs

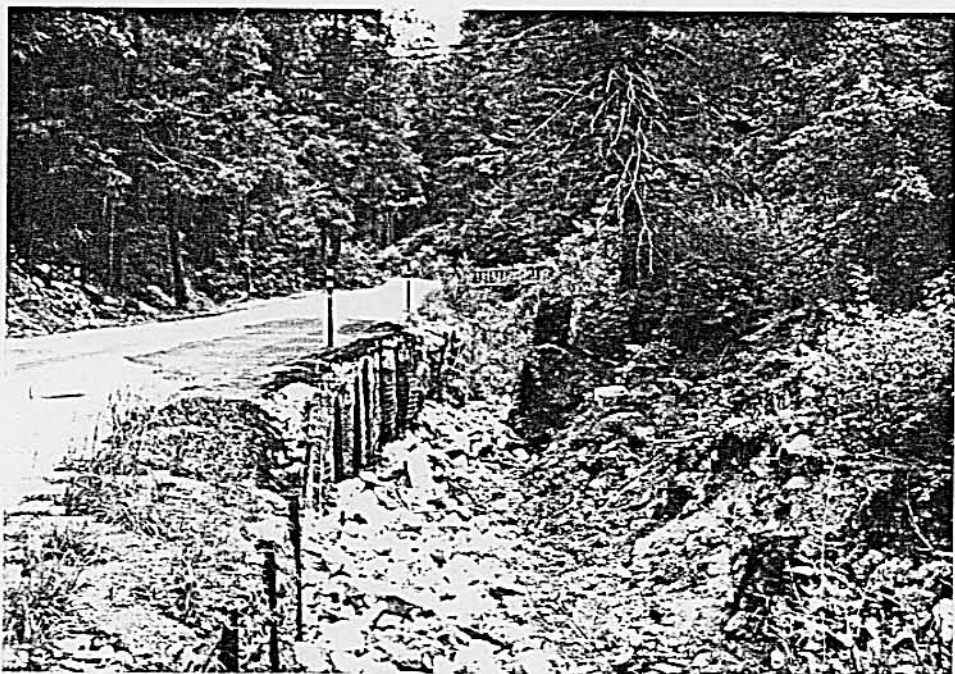
Looking downstream from crossing at 11122 Turkey Run Road.

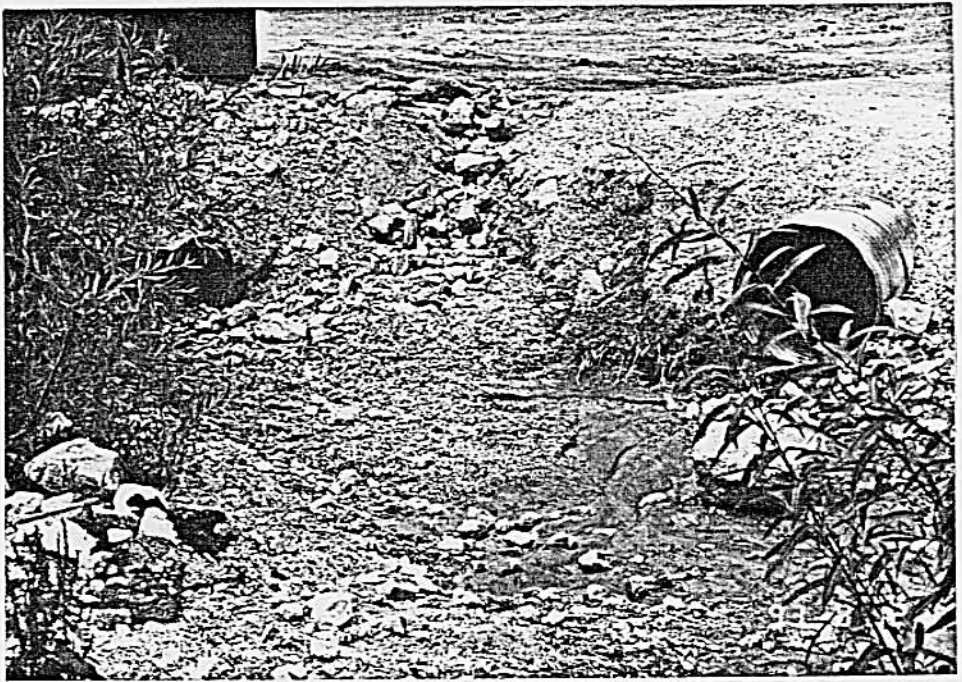
The existing 36-inch CMP beneath Sabino Canyon Parkway at Turkey Run Road is almost completely blocked with sediment. Pima County road maintenance crews have been unable to remove these sediments, so the culvert remains completely unable to pass flow beneath the road. The deposition within the culvert occurs because it is hydraulically inadequate to convey the volume of runoff (and sediments) that are periodically delivered to it by Turkey Run Road Wash. Field observation of the existing culvert crossing led to the conclusion that this problem may not be resolved by installation of more or larger culverts. The available slope for the culvert is not steep enough to transport the sediments, and the hydraulic capacity of even a larger culvert such as a 60-inch diameter would not convey more than about the 2-year discharge.

Pipes coming from Turkey Run Road and ? into Sabino Canyon Park

NO PERMIT FOUND

1-36" CMP

$Q_{cap} = 35$ cfs

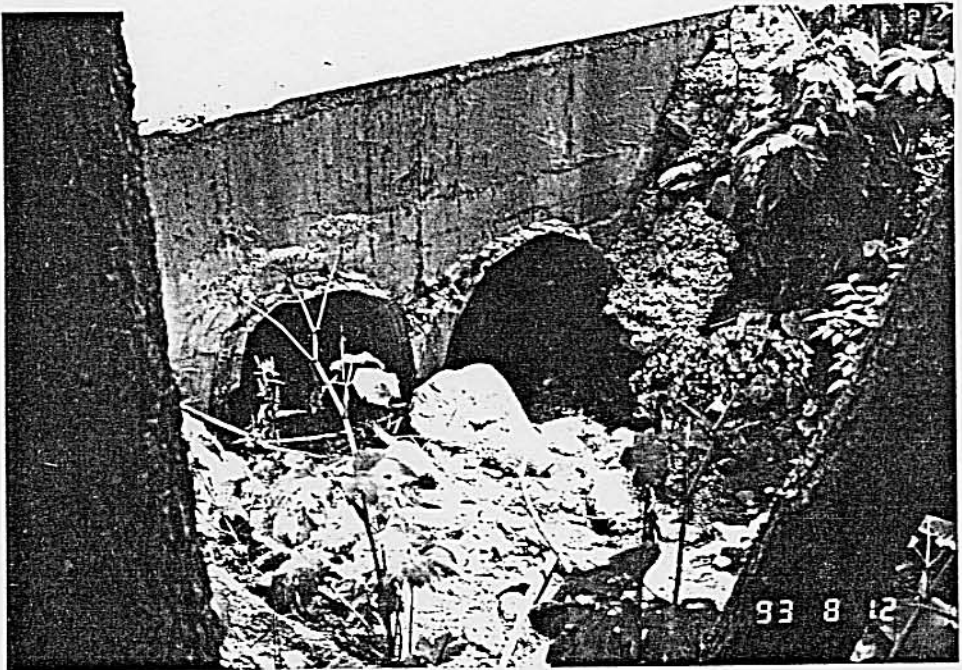
Upstream of 1st crossing at Kimball Springs along Sabino Canyon Park

NO PERMIT FOUND

2-48" CMPs

$Q_{cap} = 276$ cfs

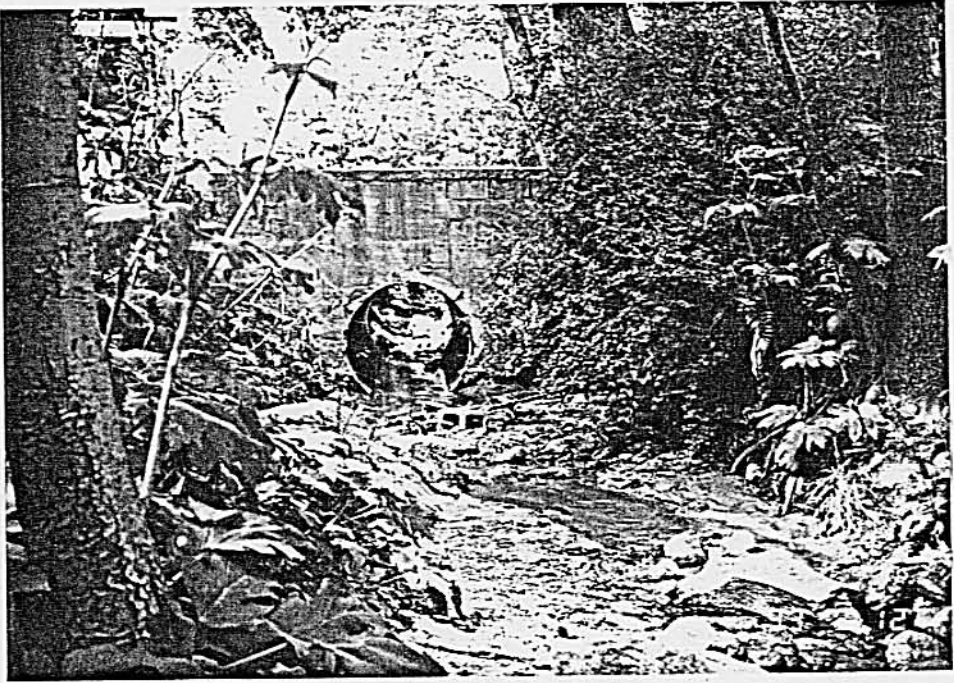
Downstream of 1st crossing at Kimball Springs along Sabino Canyon Park
PERMIT ON FILE WITH PIMA COUNTY

#14: 2-48" CMPs $Q_{cap} = 276$ cfs

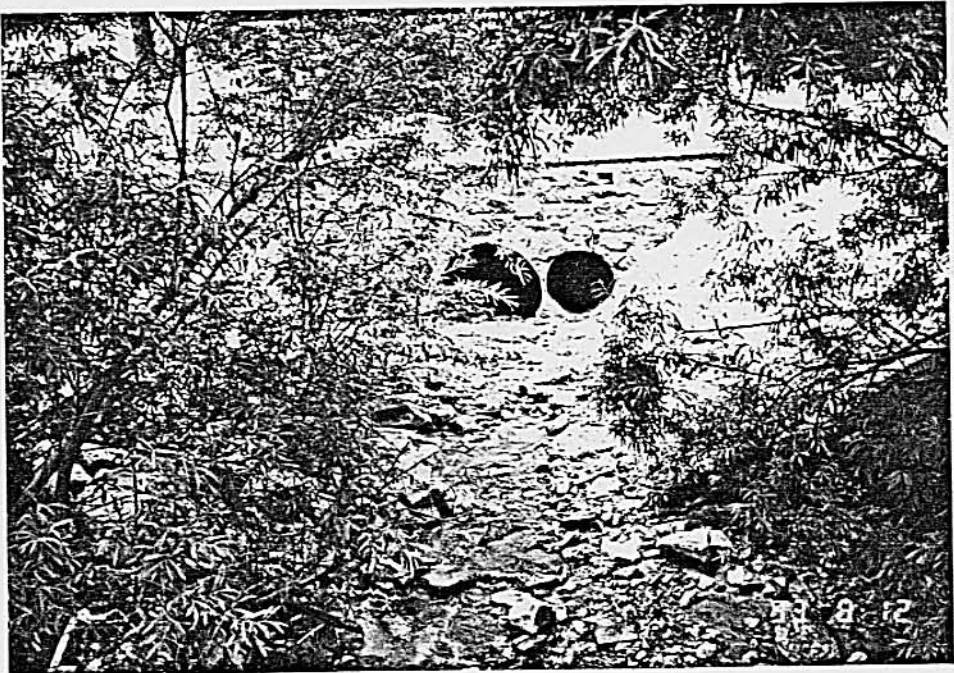
Downstream side of 2nd crossing at Kimball Springs along Sabino Canyon Park
NO PERMIT FOUND

#15: 1-32" CMP, 2-24" CMPs $Q_{cap} = 110$ cfs

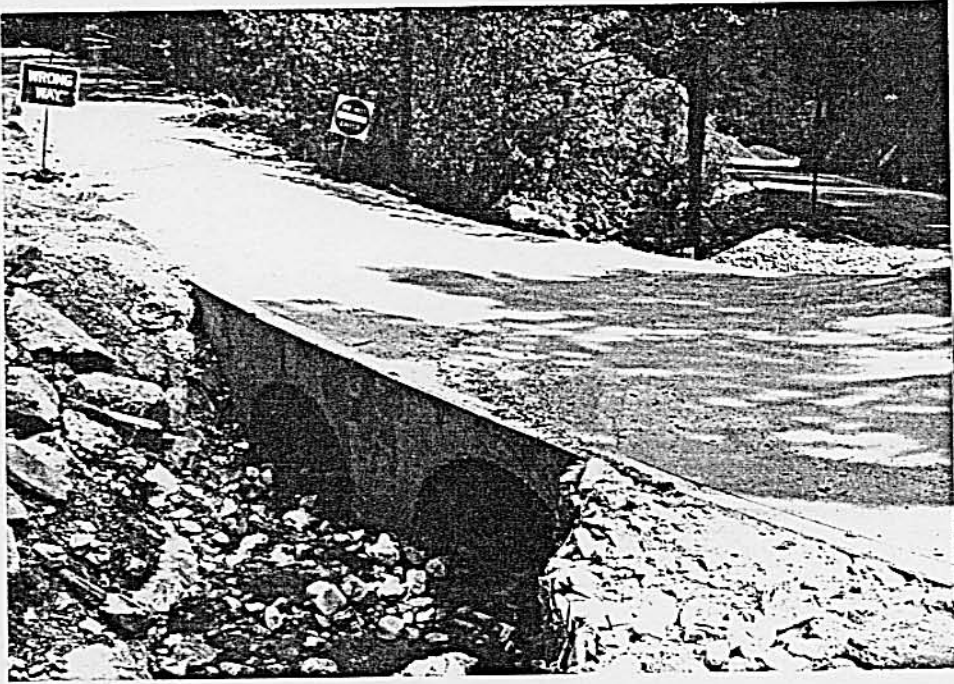
Upstream side of crossing at N. Middle Sabino and Sabino Canyon Park

NO PERMIT FOUND

2-54"W x 36"H CMPs

$Q_{cap} = 100$ cfs

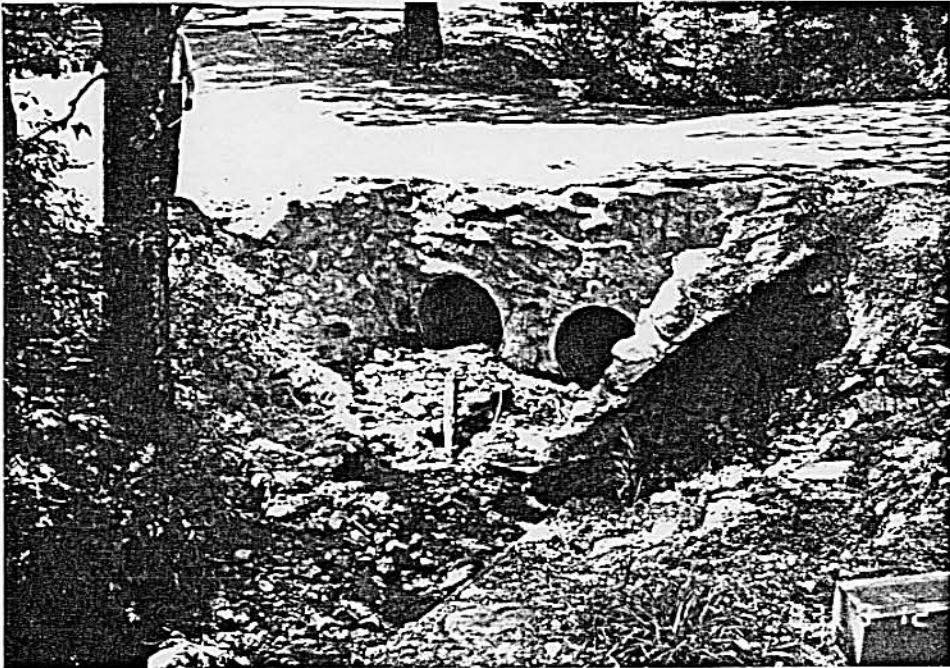
Downstream of 3rd crossing at Kimball Springs along Sabino Canyon Park

PERMIT ON FILE WITH PIMA COUNTY

#16: 2-36" CMPs

$Q_{cap} = 140$ cfs

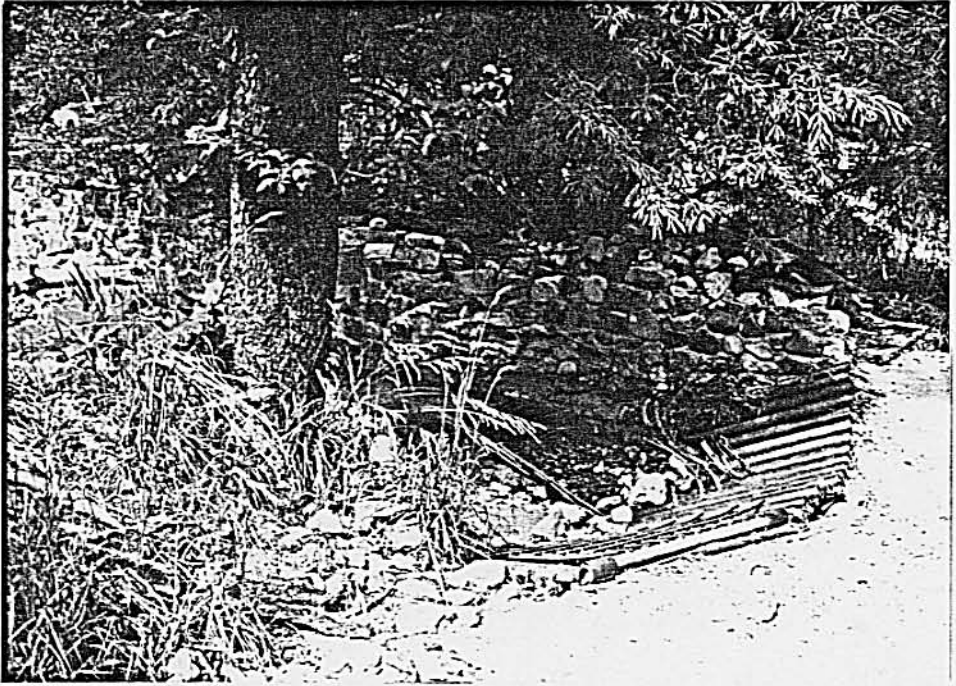
Upstream side of crossing at 12824 Sabino Canyon Park
NO PERMIT FOUND

2-18" pipes $Q_{cap} = ?$

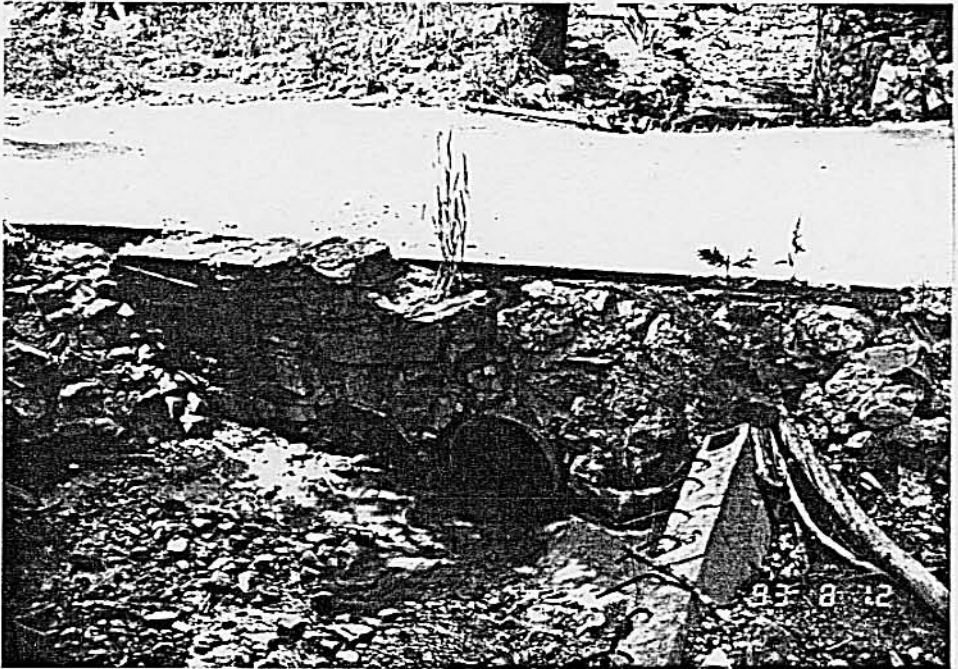
Downstream side of crossing at 12824 Sabino Canyon Park

#17: 2-18" pipes $Q_{cap} = ?$

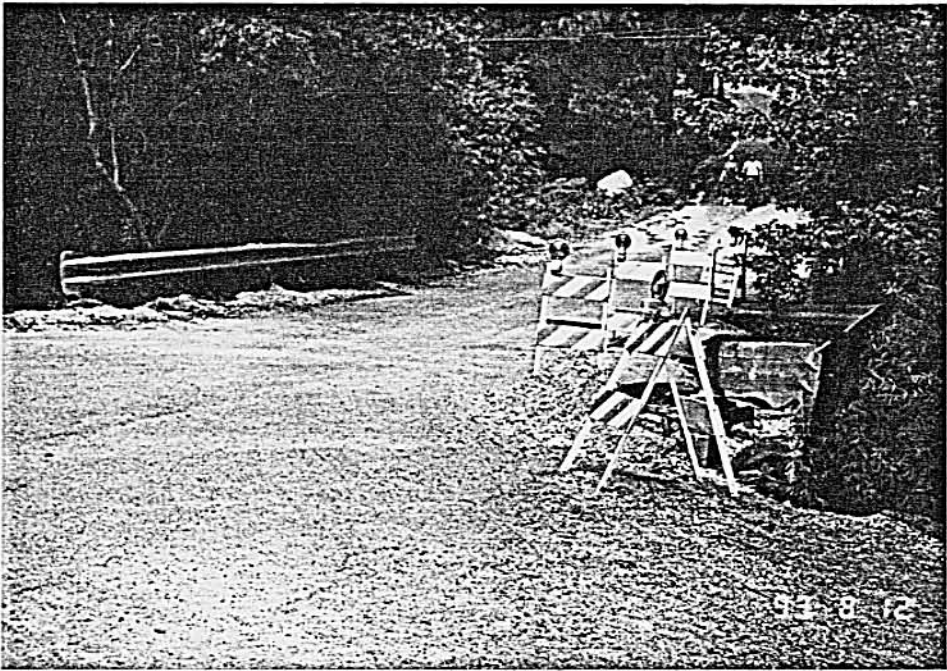
Dip crossing at Goat Hill Road along Sabino Canyon Park

NO PERMIT FOUND

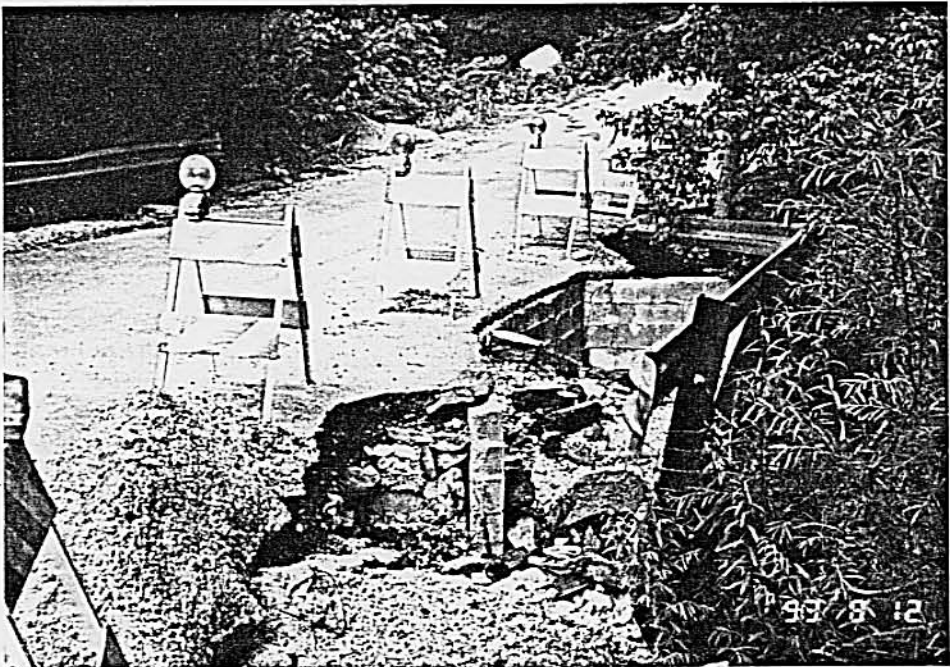
Downstream side of dip crossing at Goat Hill Road along Sabino Canyon Park

NO PERMIT FOUND

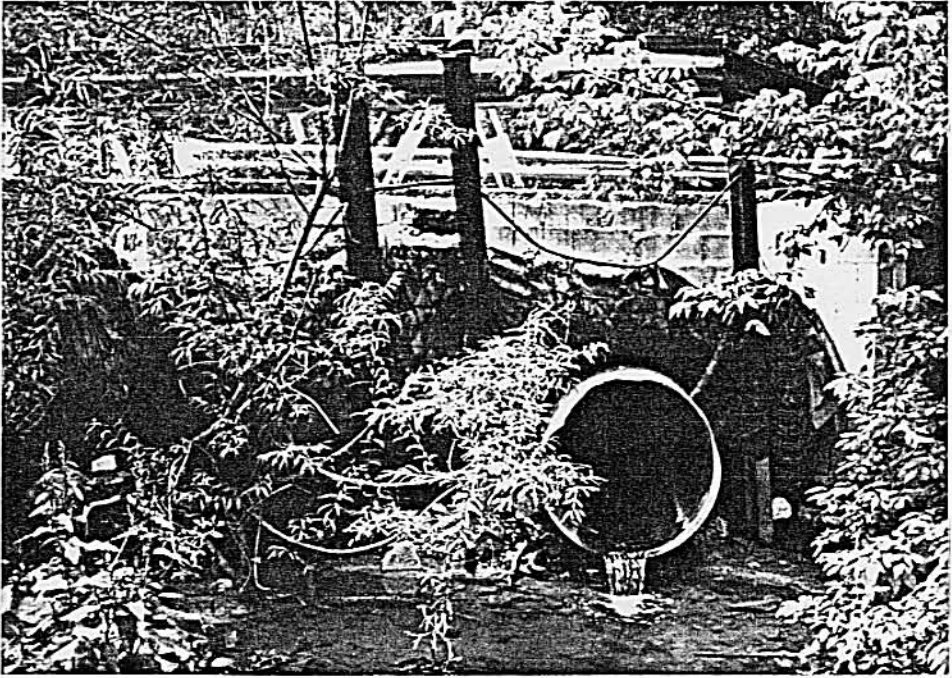
Downstream side of crossing at Goat Hill Road along Sabino Canyon Park

NO PERMIT FOUND

#18: 1-36" CMP

$Q_{cap} = 70$ cfs

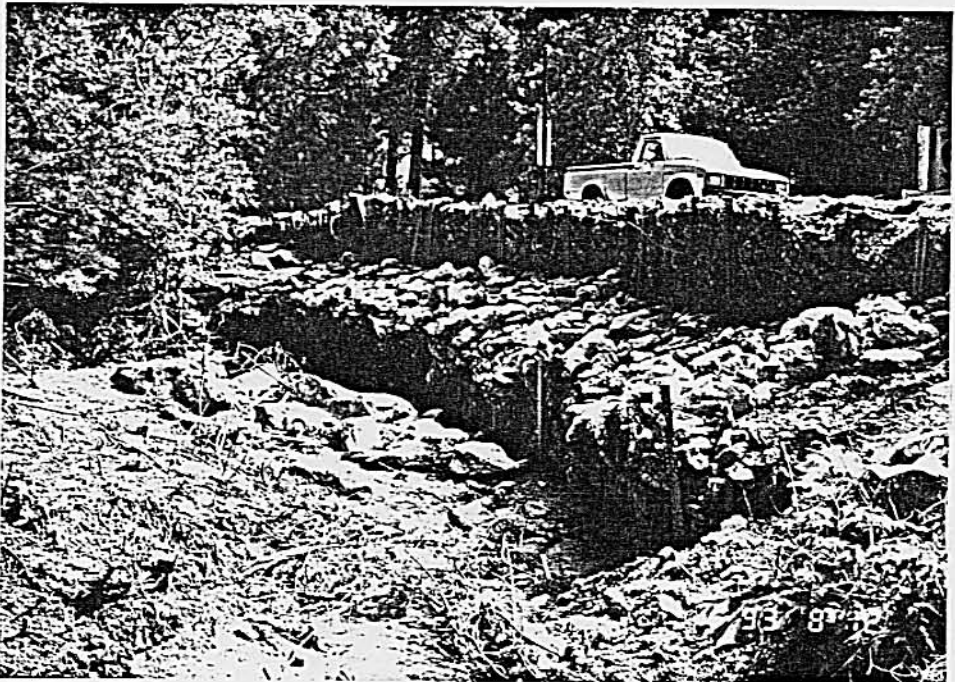
Downstream of crossing at Goat Hill Road along Sabino Canyon Park

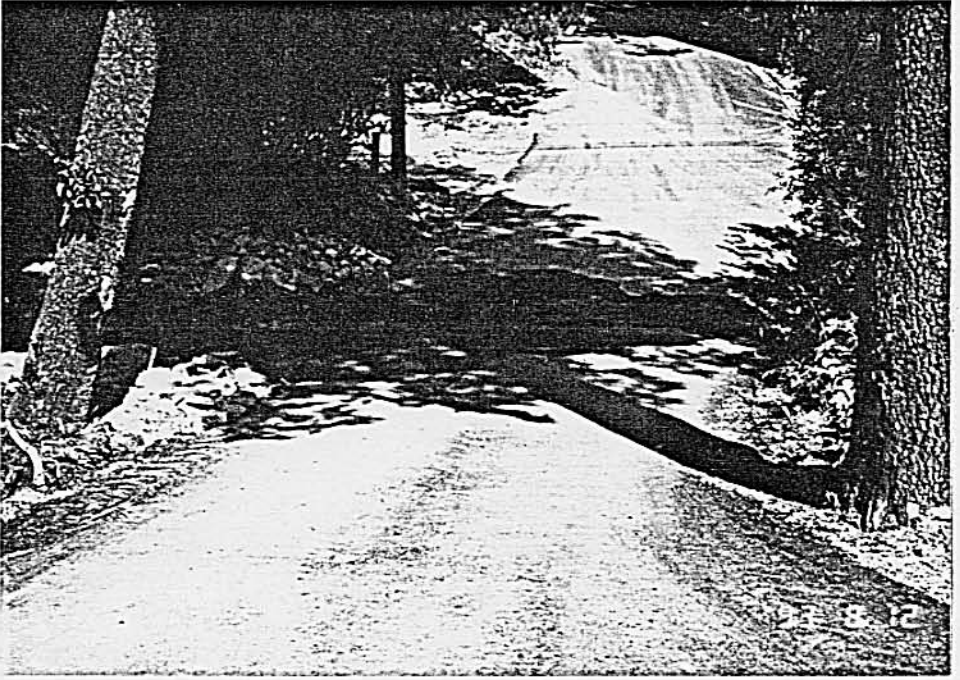
Dip crossing at Retreat Road along Sabino Canyon Park

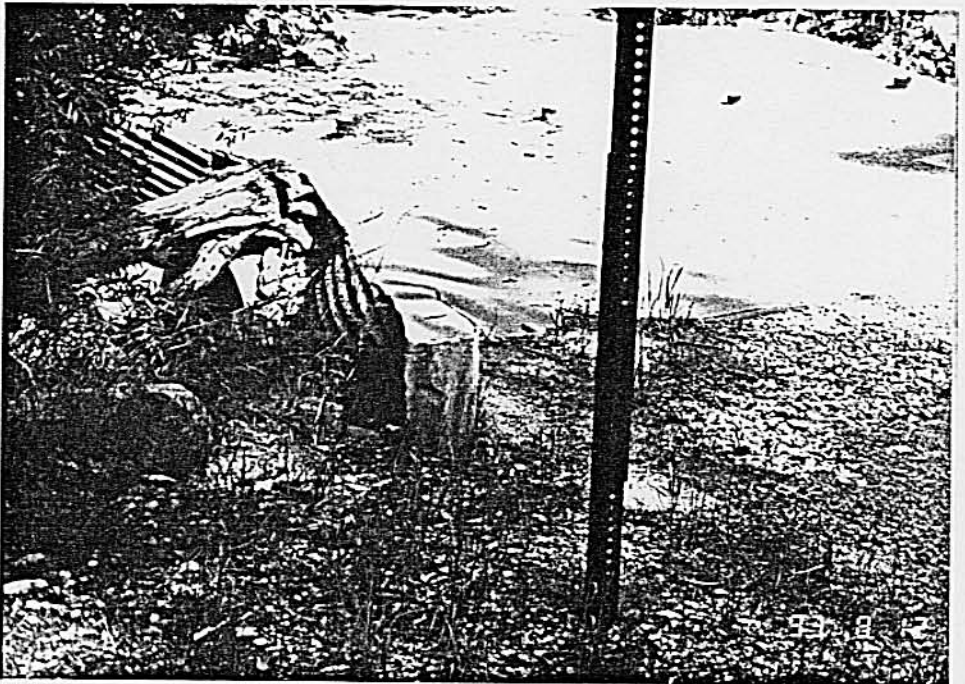
Dip crossing at Nogales Street along Sabino Canyon Park
