MOUNT LEMMON CULVERT STUDY

PIMA COUNTY DEPARTMENT OF TRANSPORTATION
AND FLOOD CONTROL DISTRICT
201 N. STONE AVE., 4TH FLOOR
TUCSON, AZ 85701

CMG DRAINAGE ENGINEERING, INC.
85 W. FRANKLIN ST.
TUCSON, AZ 85701

NOVEMBER 19, 1993

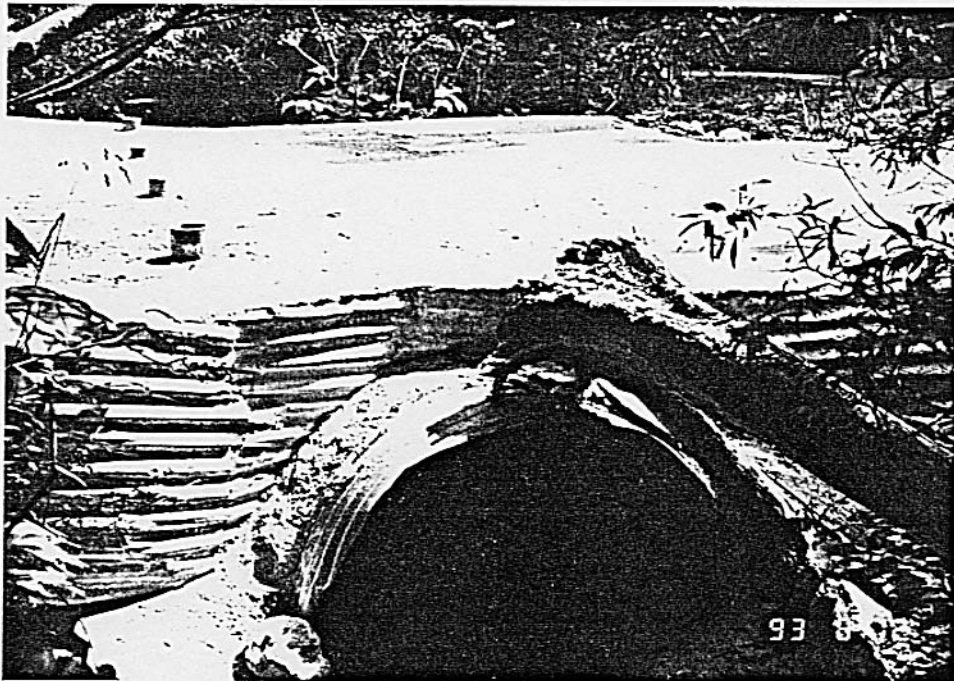
Upstream side of crossing at Nogales Street along Sabino Canyon Park
PERMIT ON FILE WITH PIMA COUNTY

#19: 1-44"W x 36"H CMP
