## GEOLOGIC REPORT OF THE DEVILS KITCHEN SINKHOLE

Paul A. Lindberg

February 2010

Section 1, Township 17 N, Range 5 E  
Sedona, Yavapai County, Arizona

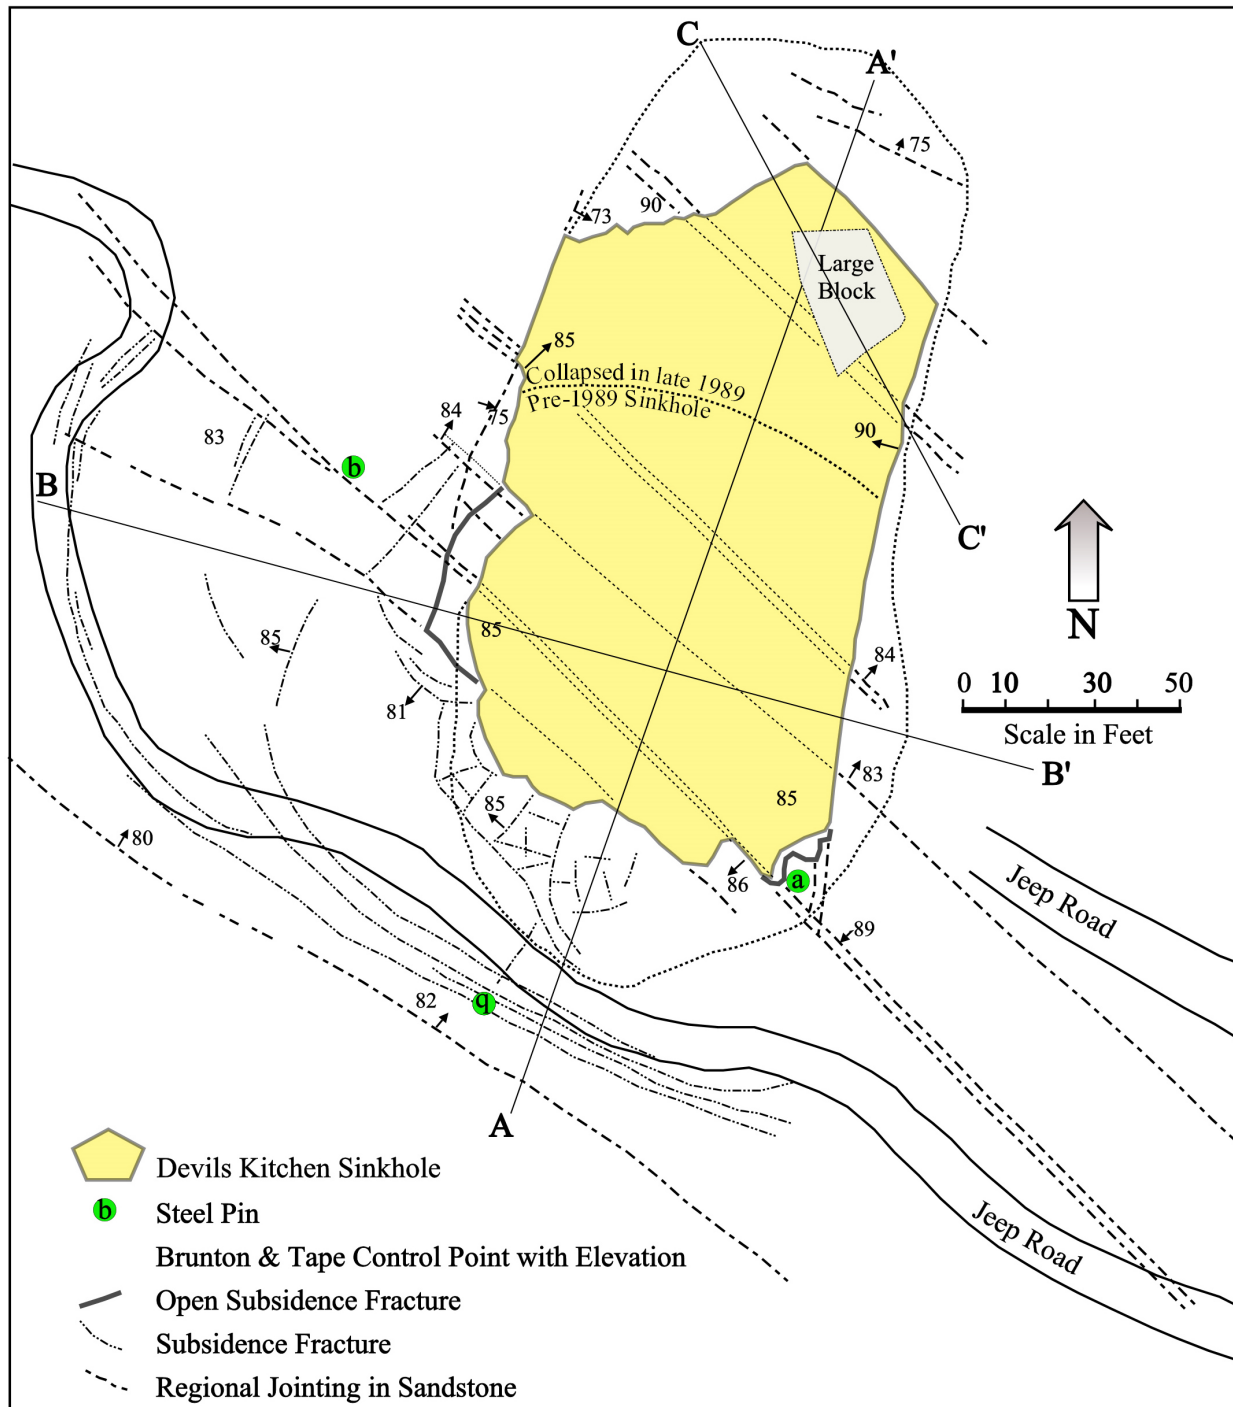
Figure 3. Devils Kitchen sinkhole plan map: Sec. 1, T17N, R5E, Yavapai County, Arizona. Outcrops of Hermit Formation are cut by steep NW-trending joints. Locally a weak and subordinate set of NNE-trending joints also help control sinkhole subsidence. The sinkhole is a surface expression of an upward-migrating breccia column overlying a large collapsed cave opening in the Redwall Limestone, the top of which is estimated to be 660 feet below the edge of the sinkhole. Arcuate subsidence fractures dominate the SW sinkhole corner.

The surface map (Fig. 3) shows a large number of arcuate fracture zones (shown in green) along the southwestern portion of the sinkhole. As indicated on the hazard map (Fig. 7) I believe that over a long enough period of time the sinkhole may expand in this direction. There is no way of ascertaining how long this might take. It could progress by incremental steps, it could collapse in a catastrophic mode, or it might remain much as it now is for several centuries. Monitoring of this area by visitors and professionals alike is necessary over [the] long term to see if any danger signs are developing. The key thing is to be aware of is expanding [or] new open fracture development. These may be warnings of imminent collapse.

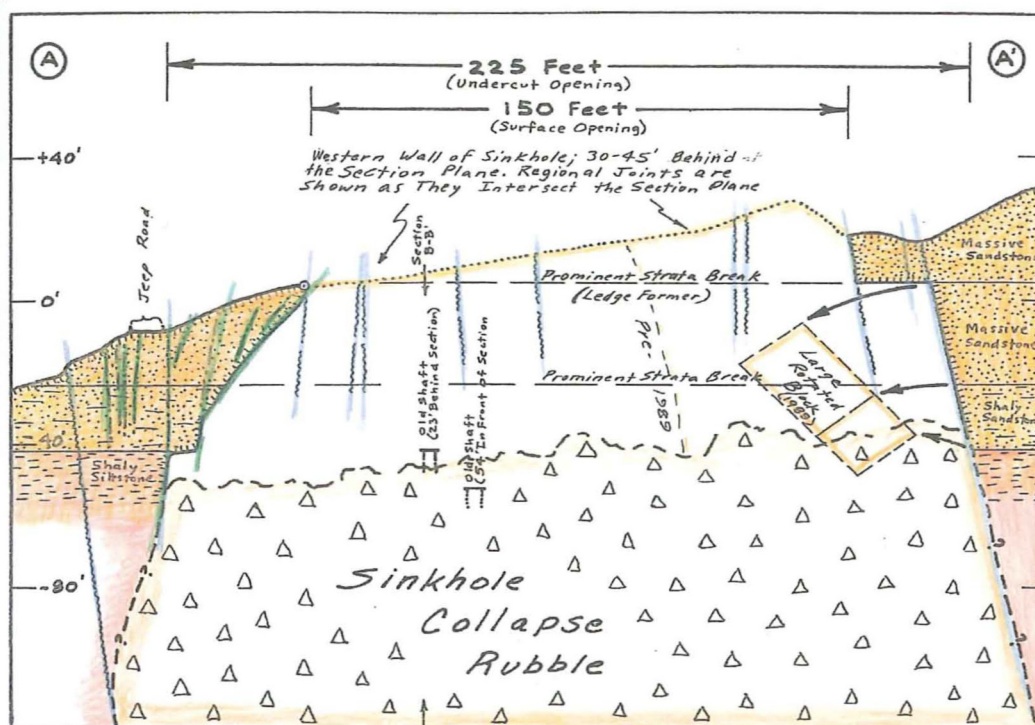
Figures 4, 5, and 6 show selected longitudinal and cross sections across various azimuths over the sinkhole to best illustrate key geologic features. Section A-A' (Fig. 4) shows the long axis of the sinkhole and demonstrates many of the salient features of the upper portion of a sinkhole. Note the arcuate fractures beneath the overhanging south wall (left side). As a column of rock collapses upward its roof is composed of arcuate shells of rock that slab inward into the

Figure 4. Longitudinal section through axis of Devils Kitchen sinkhole. The scale of the section is about 1"=40 feet and views toward the NNW. The overhanging left edge (south) contains three-dimensional arch-like subsidence features marking the oldest portion of the sinkhole. The right edge (north) contains large rubble blocks that collapsed during the latter half of 1989. The sinkhole was reported to have collapsed "in the early 1880s" but may have been pre-dated by a small opening toward the left edge.

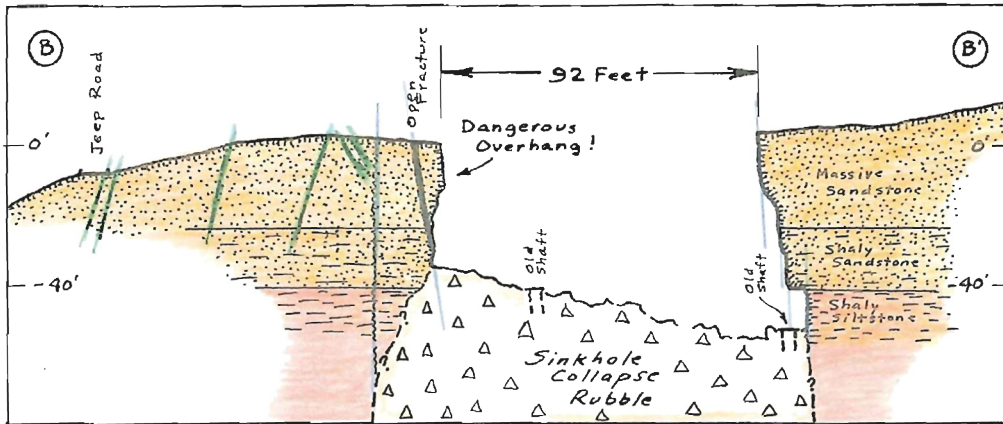
Figure 5. Cross-section through south-central portion of Devils Kitchen sinkhole. The scale of the section is about 1"= 40 feet and views toward the NNE. A large detached block on the left edge (west) is in imminent danger of falling and exhibits 5-inch openings in surface fractures. Attempts to sink shafts in the floor of the sinkhole by "old-timers" indicates how little they understood of the process that formed the cave-in. Collapse breccia may extend for 800 feet below the sinkhole floor.

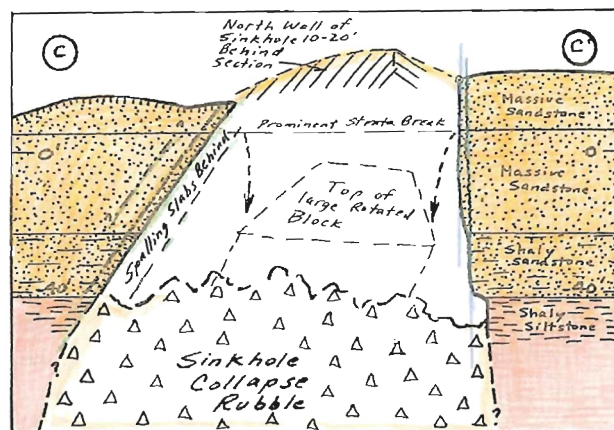
If the sinkhole is viewed today, the new fractures are very evident when compared to the older south wall which exhibits well-rounded cliff edges and a surface weathering patina. The recent collapse has made a highly unstable north wall to the sinkhole and is severely undercut as shown in the sections. Figure 6, in particular, illustrates how the "scaling" or

Figure 6. Cross-section through northern portion of the Devils Kitchen sinkhole. The scale of the section is 1" = 40 feet and views toward the NE. The left edge (NW wall) is strongly undercut by NW-dipping subsidence fractures. The large block of rock which collapsed during 1989 fell southward and rotated into the plane of the section. The right edge of the sinkhole (east wall) is controlled by a NNE-trending and steep-dipping joint set. The upper wall of the sinkhole is dominated by massive sandstone that is being "sapped" from below by a soft shaly siltstone strata.

"slabbing" process works. As support is removed from below by continued settling of the breccia column, the upper sinkhole walls have insufficient strength to hold the weight of overlying rock strata. The collapsing rock tries to form an arch over the zone of subsidence and Figure 6 shows part of one of those arches. This area should continue to spall off over the near future.

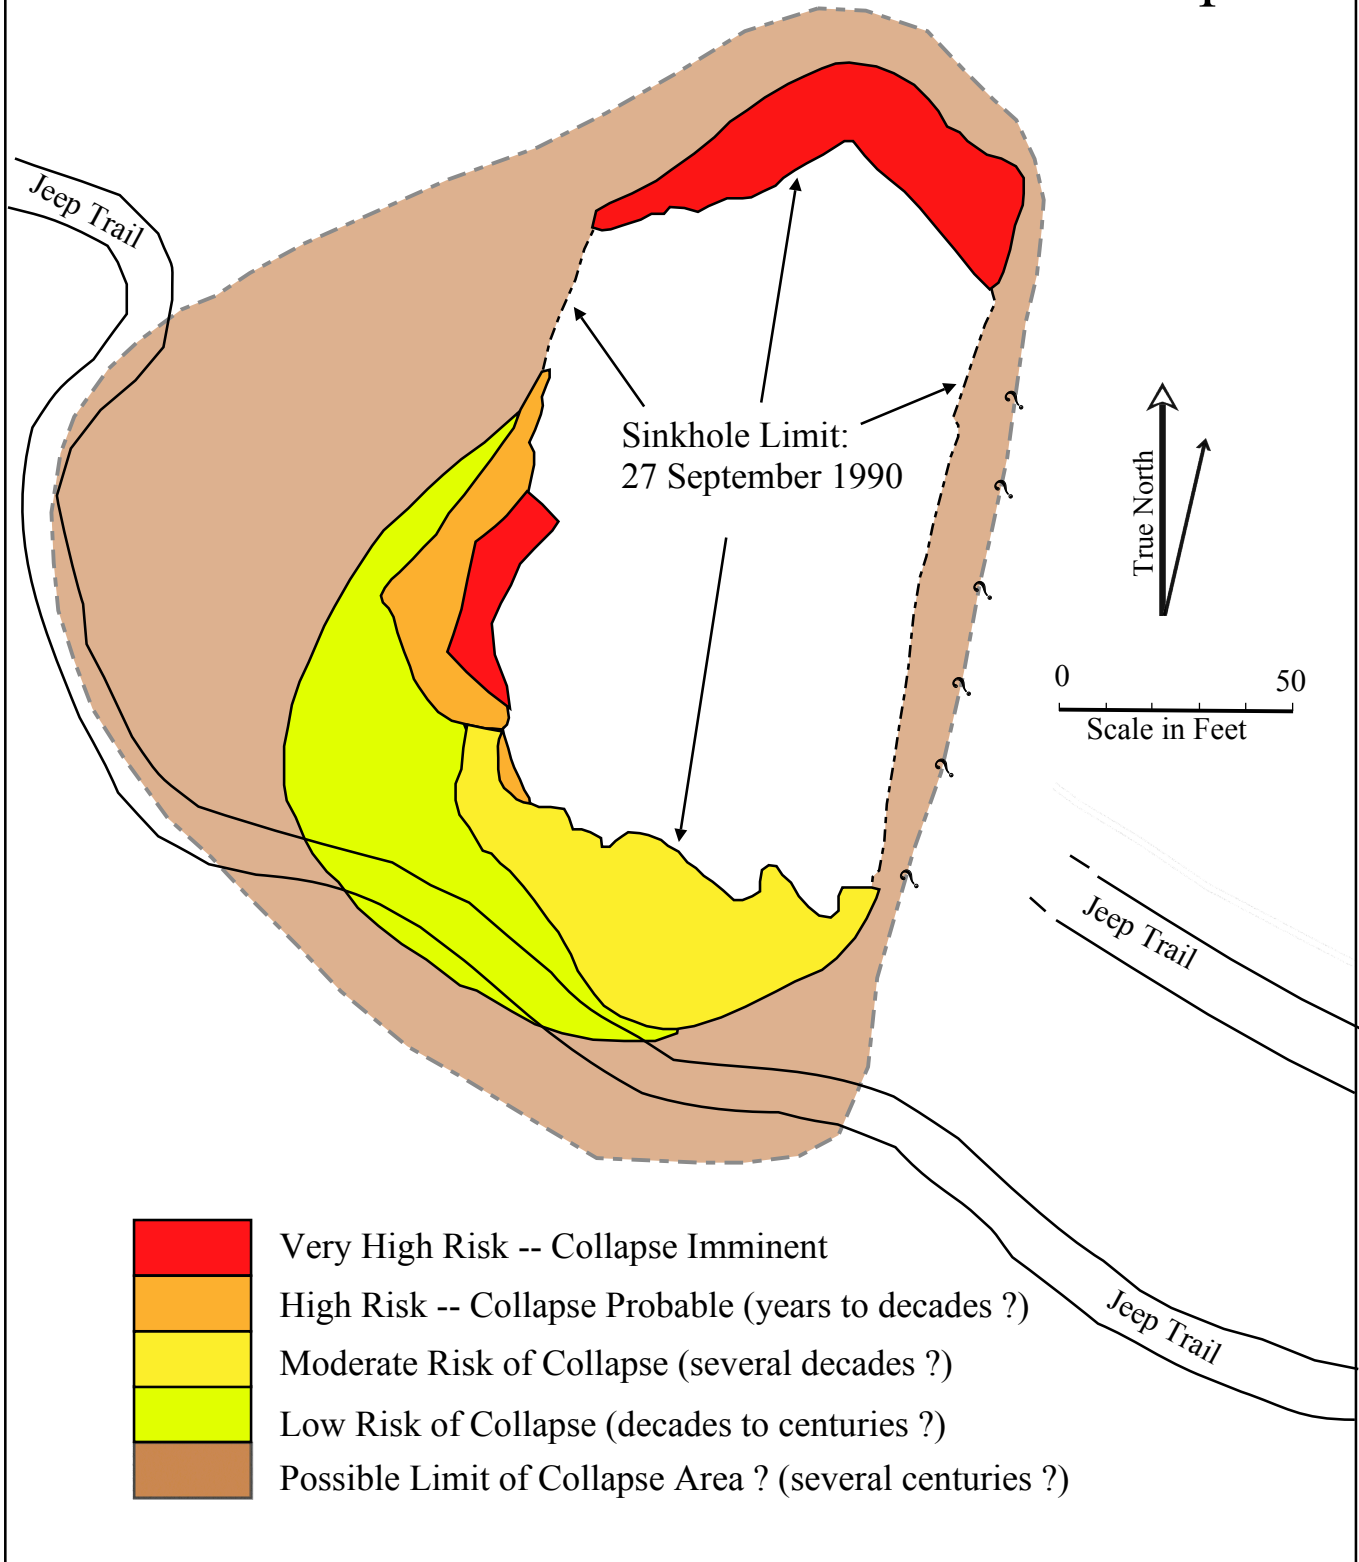
Figure 7. An attempt to quantify future collapse hazards at the Devils Kitchen sinkhole. The nature of sinkhole collapses is such that little accurate prediction can be made because of the inherent instability of the unseen deep-seated conditions that cause their formation. Nevertheless, certain features appear to be obvious and prudent precautions should be entertained because of these possible dangers. This sinkhole appears to be enlarging into a more circular plan outline with time.

The Devils Kitchen sinkhole was formed catastrophically and will continue to enlarge over geologic time. Man's brief occupancy of the area has been too short to fully appreciate the scope of these highly unpredictable developments. Figure 7 attempts to illustrate the potential risk areas at the sinkhole.

Certain edges of the Devils Kitchen sinkhole are at greater risk of collapse while others are deemed "relatively" safe. It should be emphasized, however, that no degree of certainty exists at this site. The area should be kept under investigation over time and safety precautions should be strictly adhered to. The present policy of driving jeeps on tours along the southern access road and viewing from the southwestern corner of the sinkhole is considered by the writer to be about as safe as any other human activity. The obvious danger point is in the extreme south wall where many people walk unknowingly onto a severe overhang. As long as this overhang is pinned-in by the rock buttresses on the west wall (marked in red and orange, the yellow area should remain somewhat locked in place. If the areas shown in red and orange collapse at some time in the near future, as here predicted, the entire situation should be re-evaluated.

Because of the very long periods of time between significant collapses at the Devils Kitchen sinkhole I see no reason to curtail visitations to the site. Additional warning signs should be erected in addition to that already present. In particular, a specific warning sign should be placed at the edge of the unstable block marked in red (dark cross-hatching) on the hazard map (Fig. 7). Also, warning signs on the west side and eastern ends of the north wall should warn hikers to stay back away from the edge.

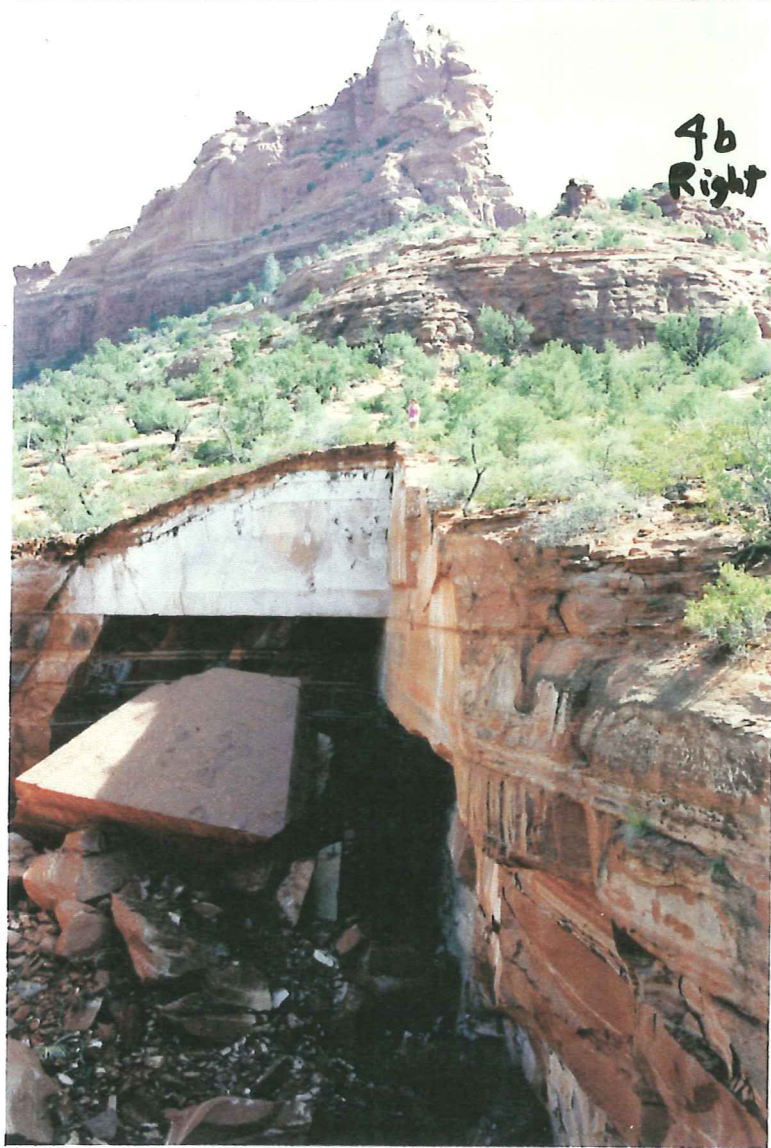
Photo #4; Looking to north-northeast along eastern edge of Devils Kitchen sinkhole. Lighter, caliche-coated NW and NNE joints show position of pre-late 1989 collapse of northern third of sinkhole. Note figure in photo at upper end of sinkhole.

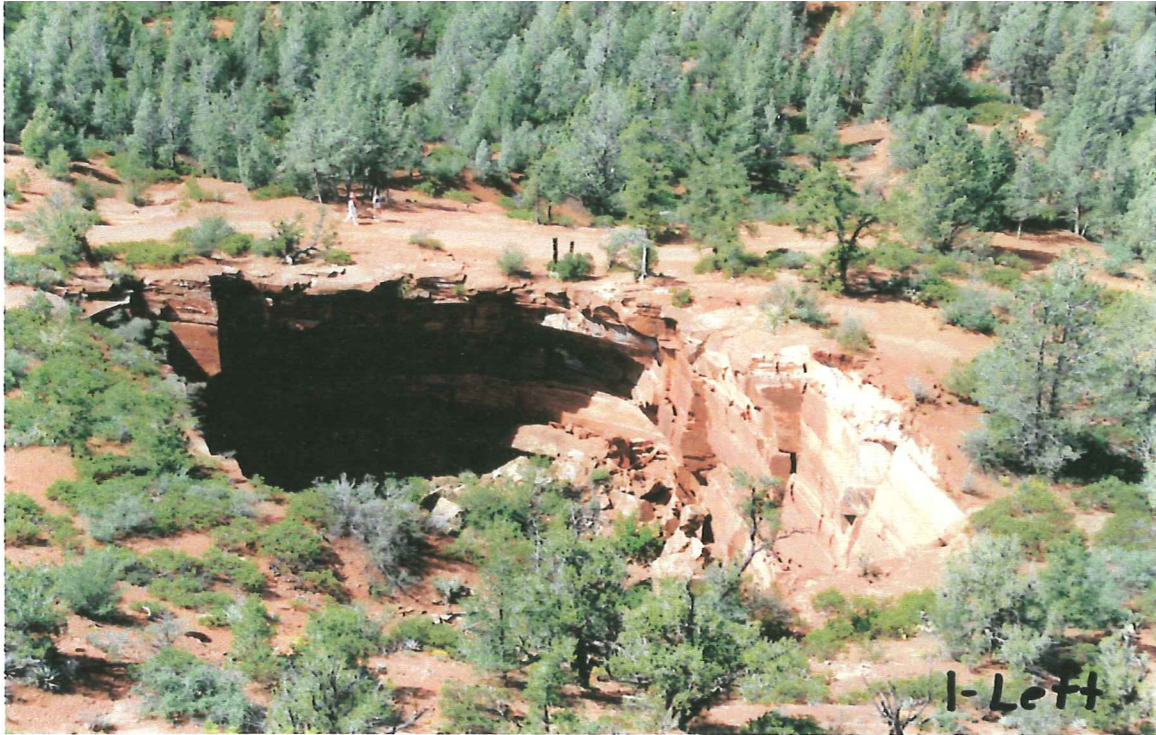
Photo #1, above; View looking SSE into undercut southern edge of Devils Kitchen sinkhole.  
Photo #5, below, View to north of late 1989 collapse rubble of Devils Kitchen. September 1990.

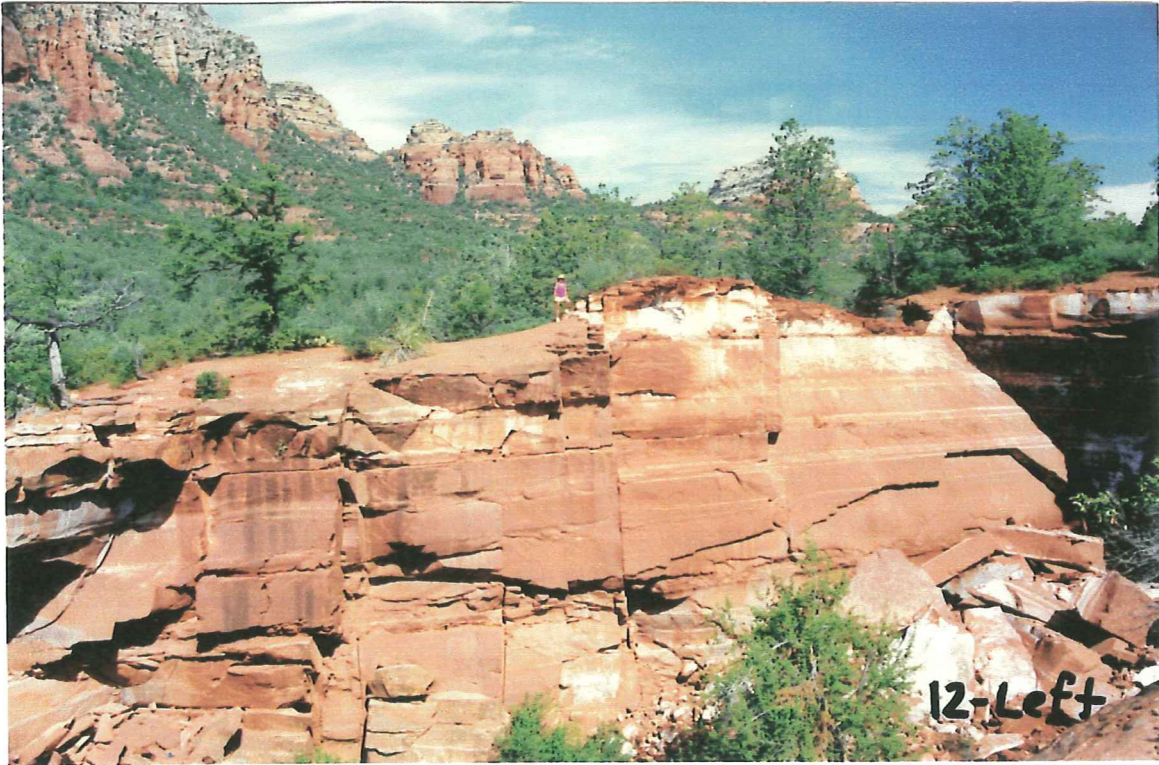
Photo #12, above; View to northwest across sinkhole showing regional vertical joints.  
Photo #14, below; View of SE sinkhole corner showing Hermit formation undercut.

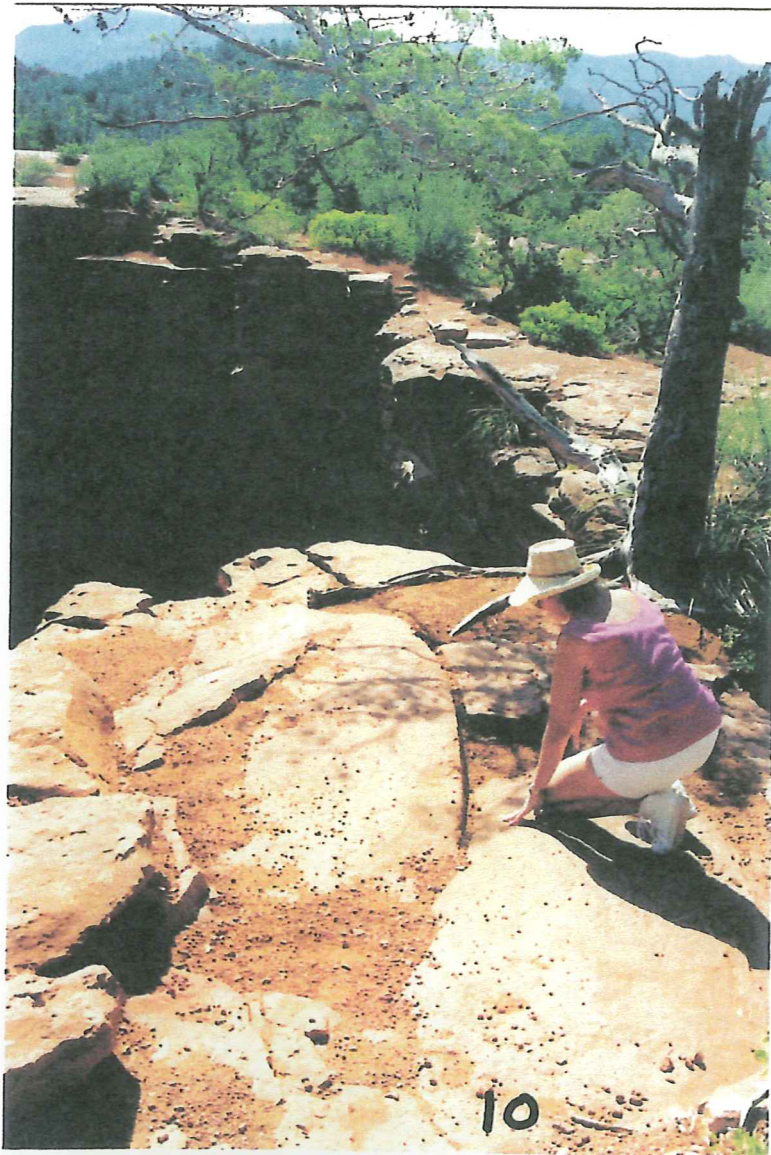
Photo #10; View across the south end of Devils Kitchen sinkhole from its southwestern corner. Localized arcuate fractures in that area dip outward from the sinkhole and they have been superimposed across the near vertical regional rock joint pattern. Several of these curving fractures near the SW corner indicate that the location has already been stressed and broken but not yet collapsed. Arcuate fractures show up on the geologic map as green lines (fig. 3). See Photo #8 on the next page to see where the above photo was taken.

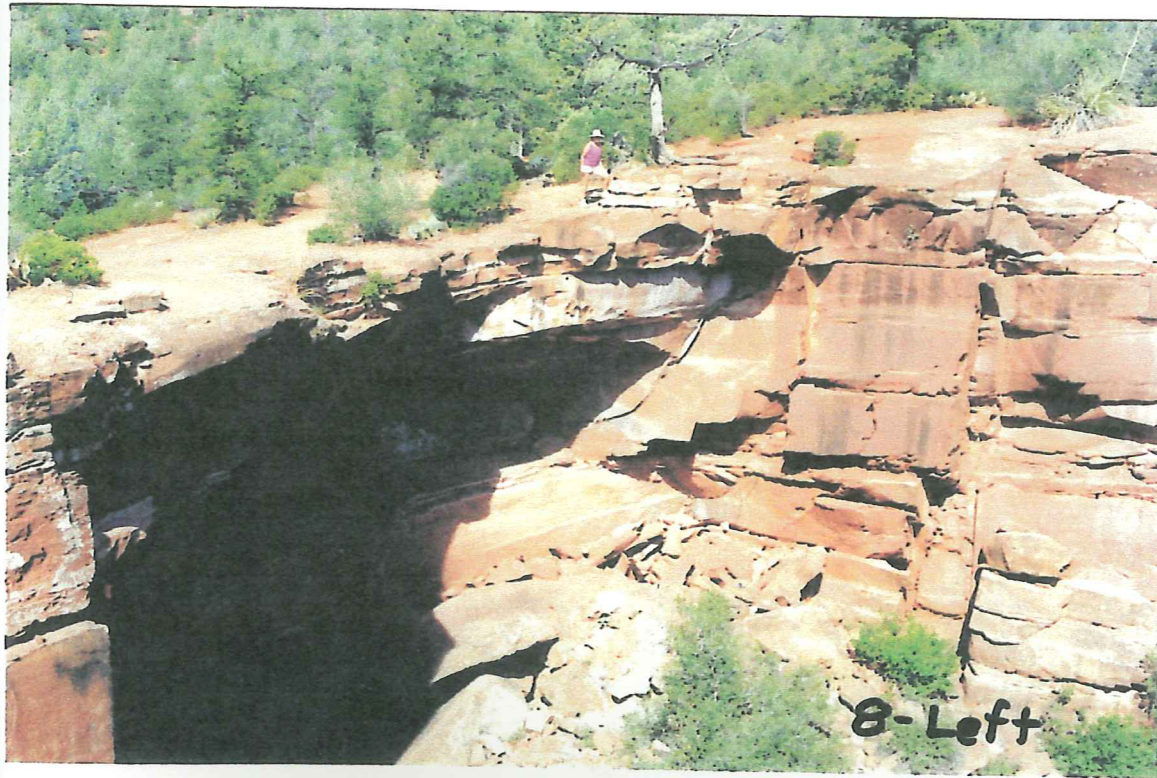
Photo #8; View toward the southwestern corner of Devils Kitchen sinkhole from the opposite wall. The juniper tree near the figure is the same tree as shown in Photo #10 on the previous page. Numerous arcuate rock fractures, open fractures that have been widening in that area in recent years, and a severe undercut indicate that this area is highly unstable and could collapse in the near future. As shown on the geologic map (fig. 3) and on the hazard map (fig. 7), the sinkhole is predicted to enlarge by stages of collapse that will increase the size of the opening toward the southwest. Future catastrophic collapse could reach as far as the jeep access road.
