**VALLEY VIEW WASH
FLOOD AND EROSION CONTROL STUDY FOR
THE CALLE DEL PANTERA AREA
(PHASE II: FLECHA CAIDA FLOOD
IMPROVEMENT STUDY)**

February 15, 1989

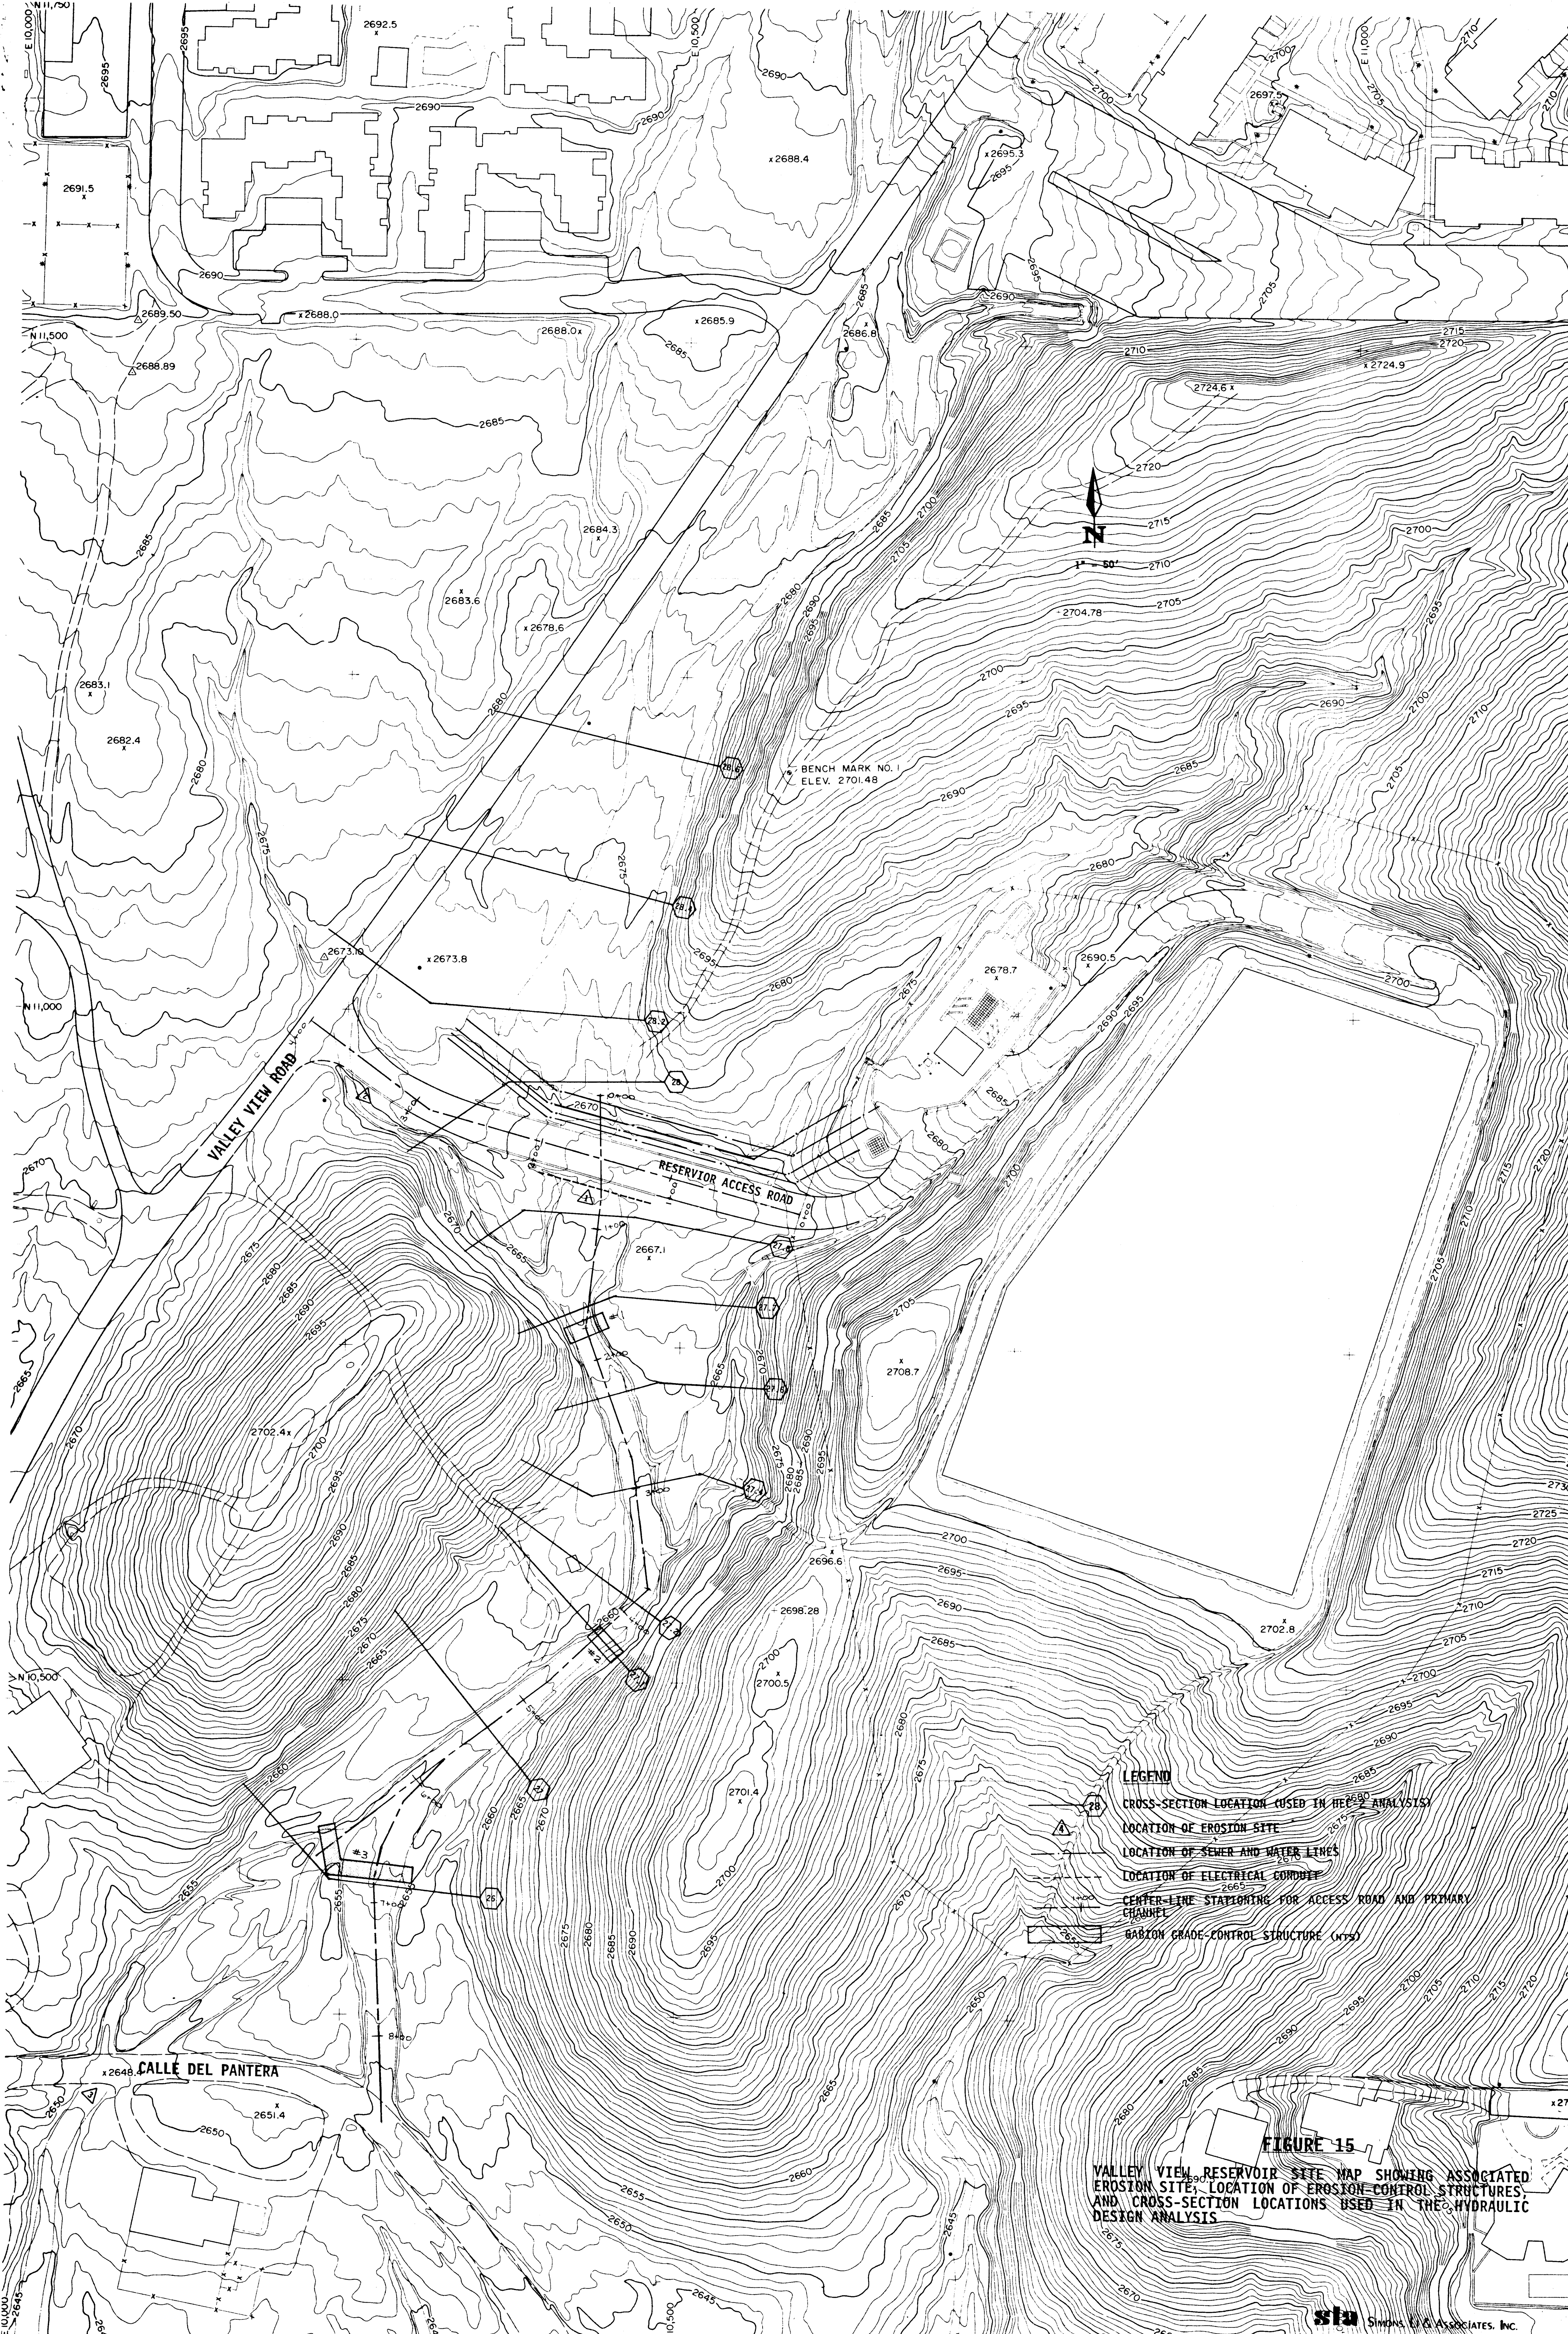
FIGURE 15
 VALLEY VIEW RESERVOIR SITE MAP SHOWING ASSOCIATED EROSION SITE, LOCATION OF EROSION CONTROL STRUCTURES, AND CROSS-SECTION LOCATIONS USED IN THE HYDRAULIC DESIGN ANALYSIS

Although there are several locations within the Calle del Pantera area where long-term degradation is evident, there are only seven locations along the Valley View Wash watercourse that will require special attention, either now or in the near future. These seven locations are shown on Figure 2. A brief description of each of these sites is provided in the following paragraph.

Due to the importance of maintaining access to the reservoir, and due to the severity of erosion that currently exists, a "quick-fix" approach (short-term solution) is needed at Site #1 and, to some extent, at Site #2, while a long-term mitigation plan is designed and funding established. Since the remaining erosion sites are less sensitive, short-term mitigation measures are not needed at this time. However, to control erosion on a permanent basis, the long-term solution relative to these sites could be constructed in phases, as funds become available. It should also be noted that these sites are located on private property, which complicates funding and the right to access.

Based on field observations, Site #6 should be given first priority. Site #7 should be second on the list, followed by Site #5, then Site #4, and finally Site #3. The amount of protection provided will vary from site to site. As previously stated, it is recommend that all erosion-control structures be designed using gabions, as opposed to standard cut-off walls or riprap plunge

Under existing conditions, at Site #5, Site #6, and Site #7 the flow-line elevations on the downstream side of the respective roadway crossings are approximately two to three feet below the roadway elevation. However, at Site #3 and Site #4 the difference between these two elevations (drop height) is limited to approximately one-foot, or less. Again, the severity of erosion at each site is a function of the location of the site with respect to the downstream pivot points; the quantity of flow conveyed in the low-flow channel; and the frequency of flow within the low-flow channel.

Under existing conditions, Site #3, Site #4, and Site #6 are located along the western low-flow swale between Calle del Pantera and Cerco de Corazon Circle. Generally, this channel is not subjected to runoff during the more frequent flow events (i.e., 2-year and 5-year flows). As a result, the severity of erosion is relatively minor, with the exception of Site #6. Since Site #6 is located on the downstream leg of this channel, and is located approximately 485 feet upstream of its natural pivot point, erosion at this location exceeds that at Site #3 and Site #4. Since the stability of the access drive at Site #6 is questionable at this time, this site was ranked number one on the priority list.

Since Site #5 and Site #7 are located along the primary low-flow channel (eastern swale), the severity of erosion at these locations exceeds that associated with Site #3, Site #4 and Site #5. As a result, these sites have received attention in the past in the form of grouted rock protection on the downstream face of the drop and along the adjacent banks. However, these protection measures should fail as the wash continues to degrade.

With regard to the short-term, erosion-control measure associated with Site #1, it is recommend that approximately 140 cubic yards of rock riprap be placed immediately downstream of the access road within the primary channel. The rock riprap should be installed in such a manner so as to form a blanket that is approximately 60 feet long, approximately 18 feet wide, and approximately 3.5 feet thick. The incline of the blanket from the top of the access road to the existing flow line of the primary channel should be approximately six feet horizontal to one foot vertical. The D_{50} diameter of the rock should be 12 inches, or more.

Before the rock-riprap blanket is installed, the existing gunite apron and underlying rubble should be removed. A filter blanket should then be provided before the riprap blanket is installed. In addition, care must be taken to ensure that the electrical conduit that parallels the roadway is not damaged during installation of the riprap blanket. It may be necessary to hand place the rock in the immediate vicinity of the conduit. Once the rock surrounding the conduit is secure, all remaining rock could be dumped in place before it is shapd to form the blanket.

The long-term, erosion-control measures associated with Site #1 and Site #2 will require the installation of three grade-control structures along the Valley View Wash between Calle Del Pantera and the reservoir access road. The location of these structures are shown on Figure 15. The long-term measures associated with Sites #3 through #7, as shown on Figure 2, will require the installation of cut-off walls and splash pads (or aprons) at selected locations. It is recommended that gabions be used to create each of these structures. A typical plan view of the proposed structures is provided as Figure 16. Typical cross-sections are provided as Figure 17.

The first gabion grade-control structure should be located approximately 110 feet downstream of the reservoir access road (see Figure 15). However, in an effort to eliminate the three-foot drop that currently exists on the downstream side of the access road, the crest of this structure should be placed approximately four feet above the existing flow-line elevation at this location. All low areas between the access road and this first grade-control structure should then be backfilled in such a manner so as to create a one percent slope from the crest of this structure upstream to the cut-off walls that currently exist at Site #1 and Site #2.

The two subsequent grade-control structures should be placed such that their crest elevations correspond to the existing flow-line elevations at the respective locations. Based on the locations shown on Figure 15, each structure should be placed at 250-foot intervals. Therefore, the ultimate drop height associated with the first structure would be approximately seven feet. This includes the initial four-foot drop and the ultimate three-foot degradation depth. However, a stepped gabion structure is recommended in order to limit the drop associated with each step to a maximum of three feet. This could be

As previously stated, it is recommend that a gabion drop structure be installed on the downstream side of the access road associated with Site #6. This structure will require the installation of a cut-off wall that is approximately 20 feet long; approximately three feet wide; and approximately six feet deep (i.e., from the top of pavement to the toe of the wall). In addition, a 40-foot-long apron and 43 lineal feet of bank protection should be provided adjacent to and downstream of the proposed cut-off wall (see Figure 16). This

Site #7 might also require implementation of a short-term measure, since it is located along the primary channel (i.e., eastern low-flow swale) and the level of protection that currently exists is not sufficient to protect the roadway with any degree of certainty. Again, long-term features (downstream apron and bank protection) similar to the ones just described in conjunction with Site #6 would address the existing problem for several years, and allow for future additions and/or modifications. The ultimate degradation depth associated with this site was determined to be approximately seven feet.

The existing grouted rock apron at Site #5 should continue to protect the roadway for some time. Therefore, it is not necessary to install a short-term measure at this time. However, as the wash continues to degrade, more of the downstream toe of the existing structure will be exposed, and it will begin to fail. The long-term solution would be to remove the grouted rock apron and install a gabion drop structure, which collectively includes the cut-off wall, the downstream apron, and the bank protection. Again, this structure would be similar to the one described previously; and can be upgraded over time, if need be. The ultimate degradation depth associated with this site was determined to be approximately three feet.

A wait-and-see approach could be applied to both Site #3 and Site #4. However, if Pima County would like to provide some protection at this time, a three-foot-wide by three-foot-high gabion cut-off wall could be installed on the downstream side of the roadway at each location. Again, if the western swale begins to degrade, an apron and associated bank protection could then be added at that time. The ultimate degradation depths associated with Site #3 and Site #4 were determined to be approximately eleven feet and three feet, respectively. However, for the reasons mentioned above, the ultimate depth associated with Site #3 may be overstated.
