**SEDONA SINKHOLES AND GROUNDWATER FLOW:
THE GEOLOGIC HISTORY OF THEIR EVOLUTION
COCONINO AND YAVAPAI COUNTIES, ARIZONA**

Paul A. Lindberg

Arizona Geological Survey
Contributed Report CR-10-C

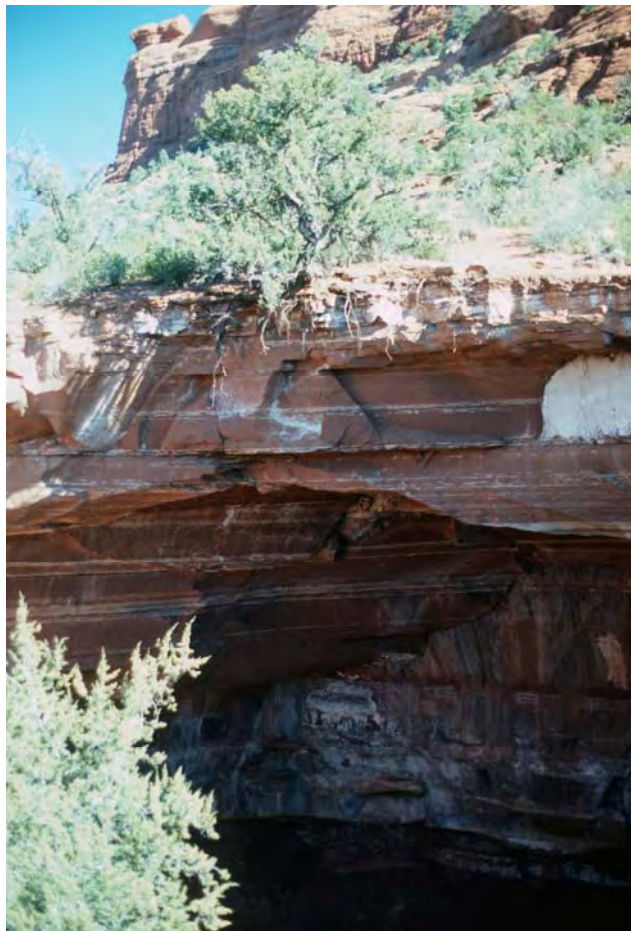
Figure 4. Photo of Devils Kitchen sinkhole, October 1983. In 1989 this northern wall will collapse and the sinkhole would expand substantially. Note tree roots on north face, indicating that rock falls had taken place within previous decades.

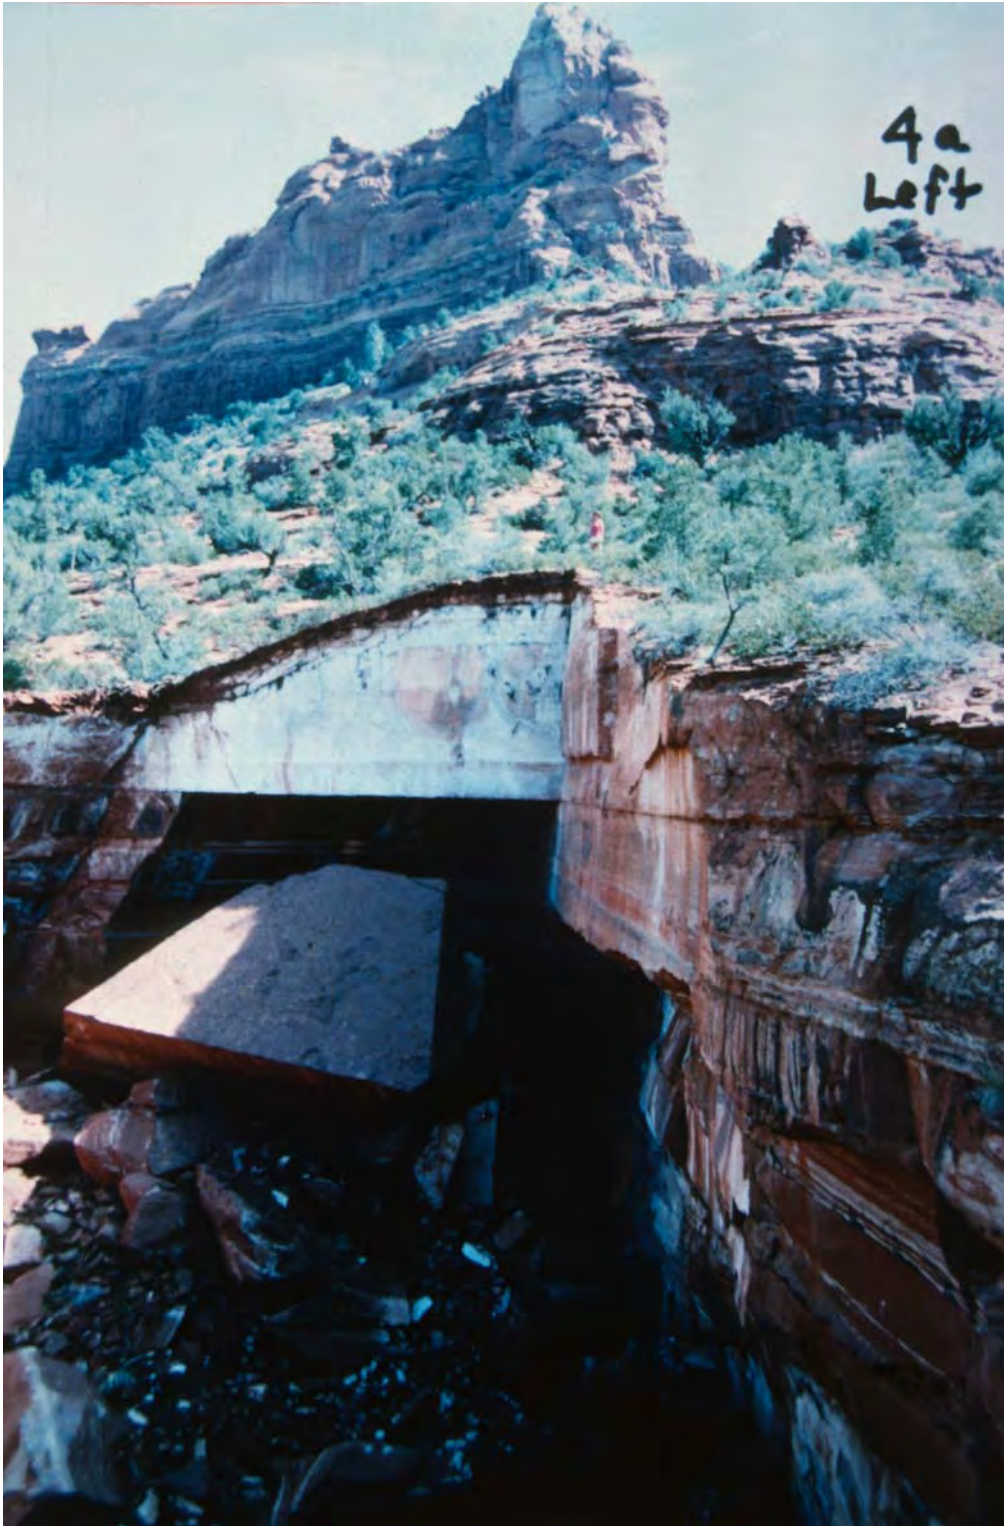
Figure 5. Devils Kitchen after the 1989 collapse. This 1990 photo shows the white coating of caliche on the north and east faces that was left behind on rock joint faces after the collapse. Note the figure at the top end of the sinkhole for scale.

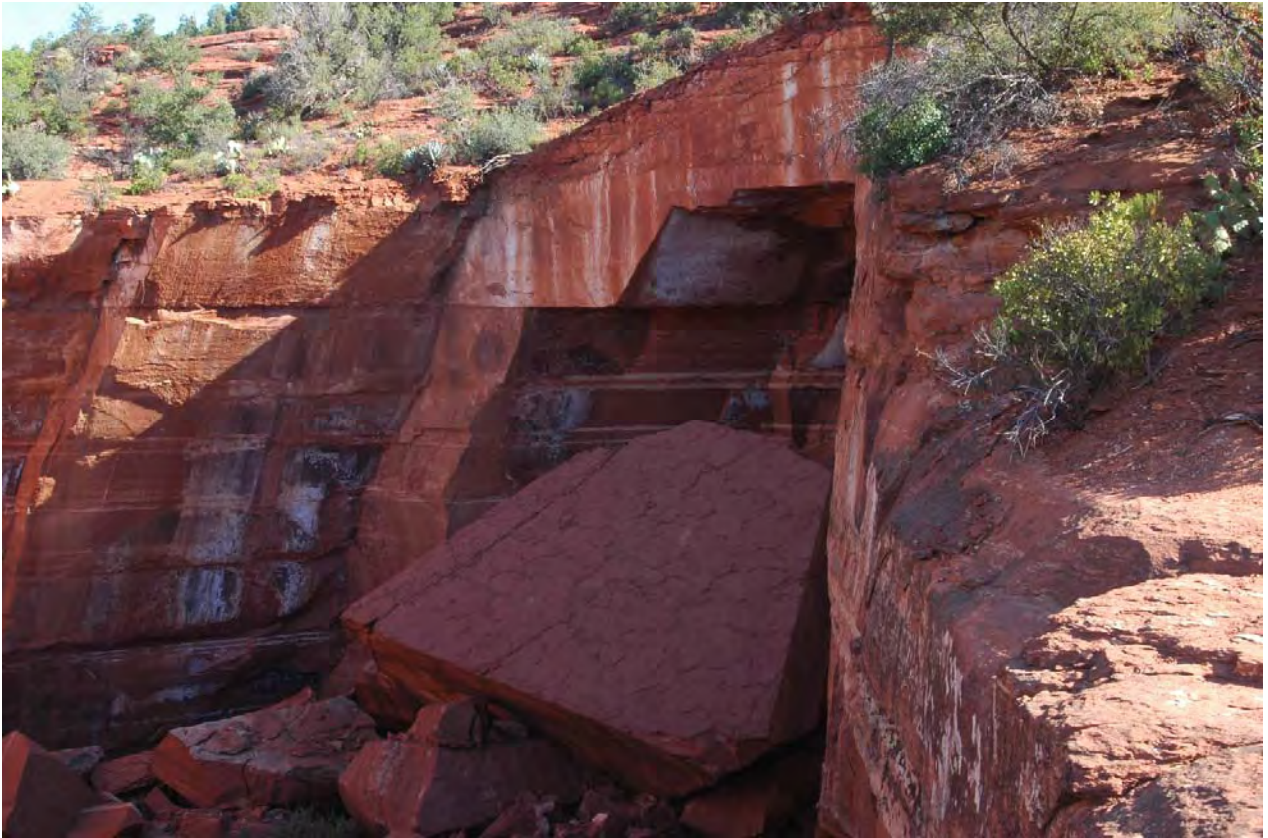
In the fall of 1995 a piece of the northern face fell off and landed behind the large rotated block shown in the 1990 study (fig. 6). Photographs taken in 1983, 1990, and after 1995, show the progression of collapse activity over a 12 year period (figs. 4-6). More recently, rock fall noise has been reported to the U.S. Forest Service but late 2009 examination by the writer has failed to reveal any major changes.

Figure 6. Devils Kitchen sinkhole after 1995 rock fall. This 2009 photograph shows the large sandstone block at the north end of the sinkhole that rotated forward during the 1989 collapse. Another piece of the northern joint face just above it fell off the cliff in 1995 and landed behind the big slab (compare with fig. 5). In the twenty year interval since the 1989 collapse, weakly acidic rainwater has dissolved most of the thin white coating of caliche (CaCO_3) on the near vertical joint face. Geologic plan map (fig. 13) and cross sections (fig. 14) show the rock fall locations. Note the bell-shaped, downward enlarging rock fractures in the northwestern corner of the sinkhole. Arcuate fractures such as this are localized around sinkhole sites and have been superimposed upon the arrow-straight and nearly vertical northwest-trending rock joints.

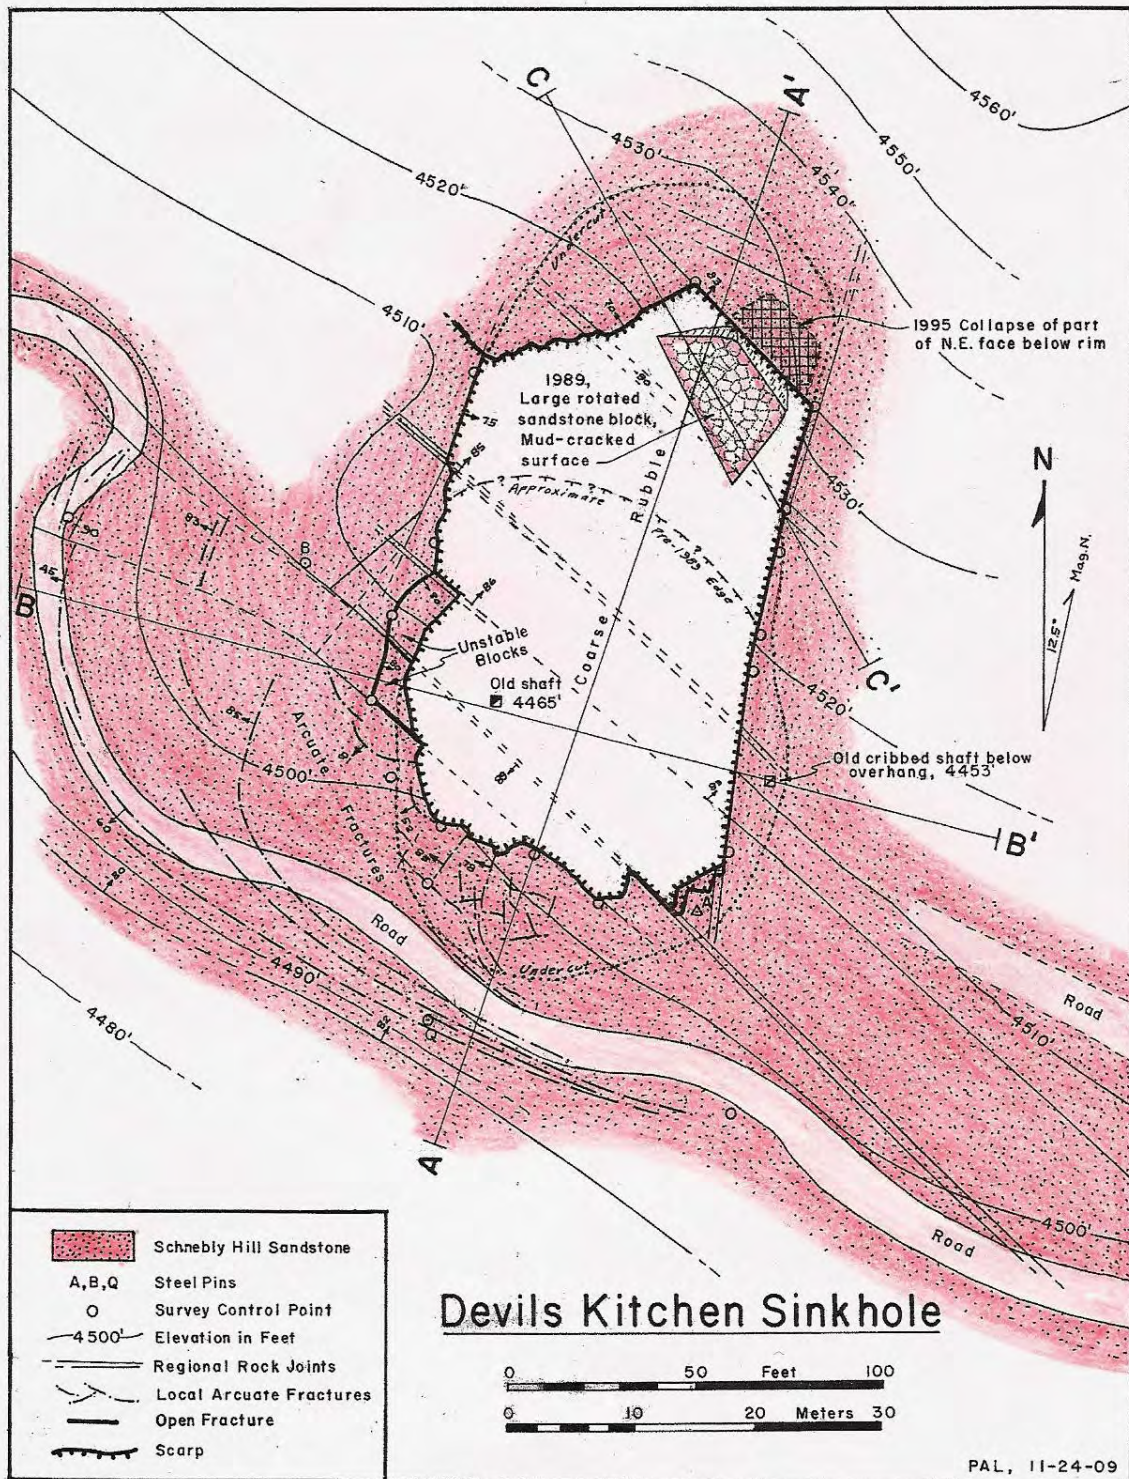
During the mapping of the sinkhole for the jeep franchise and the U.S. Forest Service in 1990, the writer recorded the typical northwest- and north-northeast trending near vertical joints that define the sinkhole boundary. Field checks were also made in late November 2009 and January 2010 that refined the earlier drawn geologic map and sections of Devils Kitchen (figs. 13 & 14). The 1990 study discovered the existence of superimposed localized arcuate fractures that dip outwardly from the sinkhole, thus creating a downward widening, bell-shaped collapse feature around the southwestern corner of the sinkhole (Lindberg, 1990). That feature indicated that bedrock in the entire southwestern corner of the sinkhole has already been broken by withdrawal of support from below, but the ground has not yet collapsed.

Figure 13, Geologic map of Devils Kitchen sinkhole as of 2009. In 1989 the northern third caved in and in 1995 a large chunk (cross-hatched) fell out of the north face. Joints trend NW-SE but superimposed arcuate fractures in the SW corner indicate broken rock.

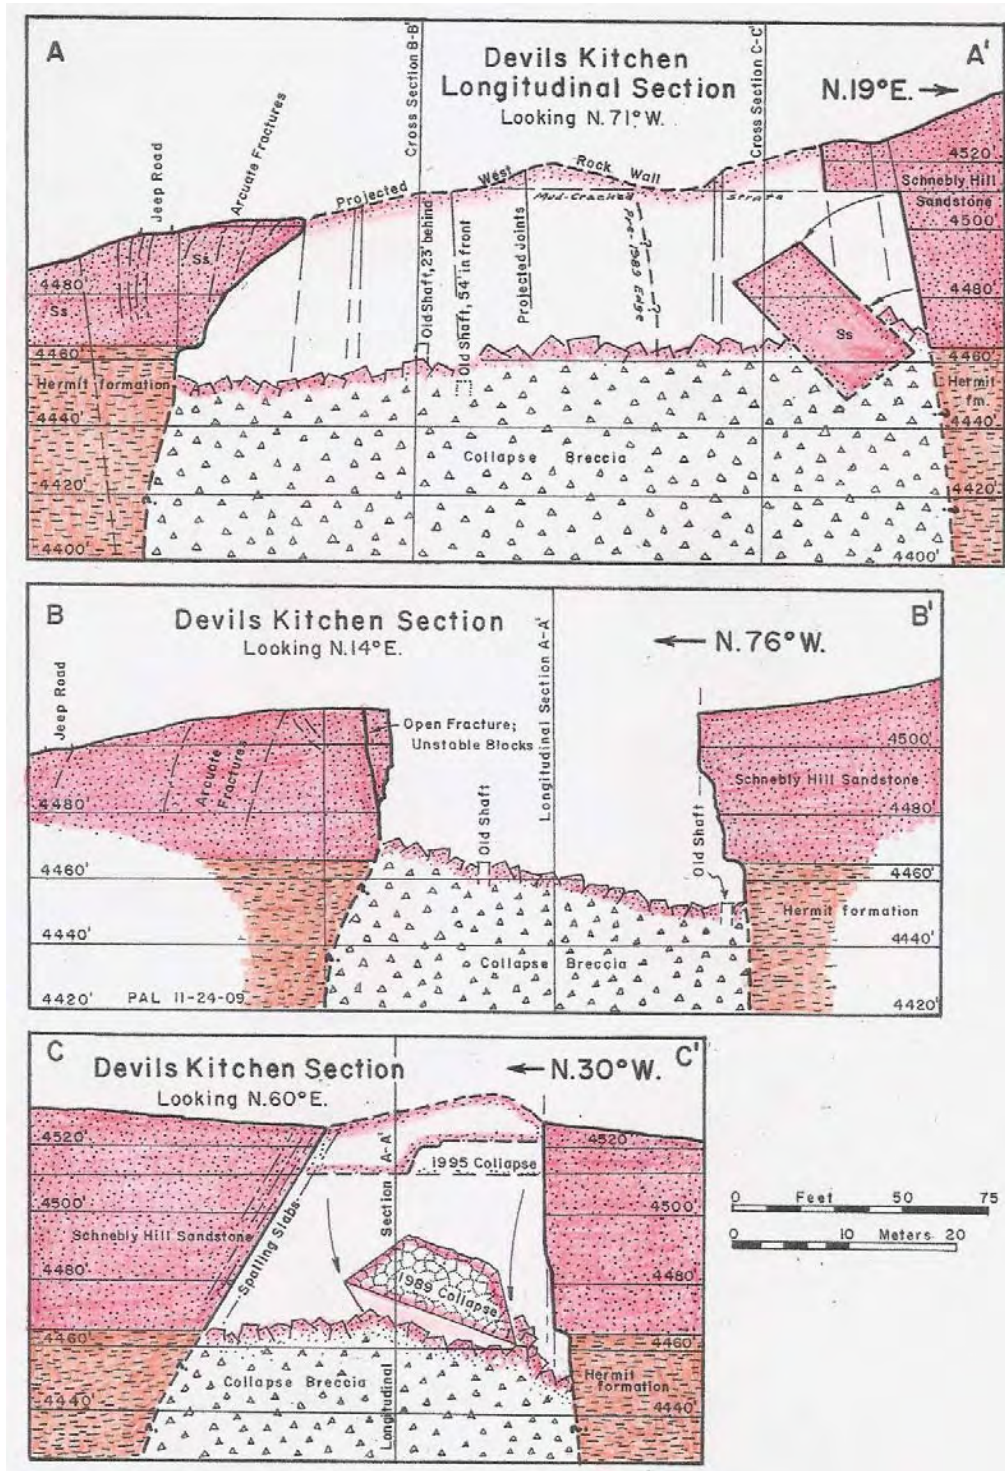
Figure 14. Sections through Devils Kitchen sinkhole. **A**, Longitudinal section viewed in the direction of regional rock joints. Note how the breccia-filled collapse opening enlarges downward. **B** & **C**, Cross sections that also show the downward widening collapse, especially within the underlying Hermit formation.

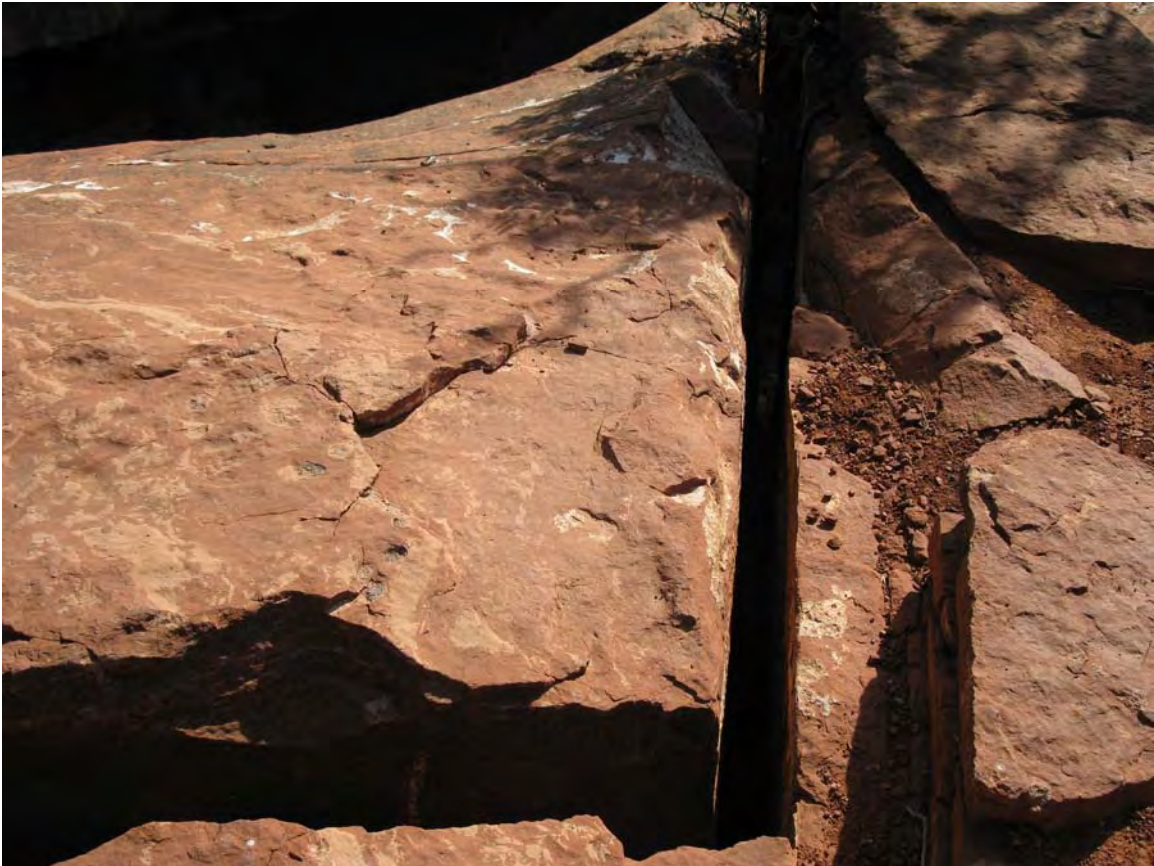
The 1990 study discovered severely fractured bedrock surrounding the southwestern corner of the sinkhole. One particular rock fracture on the west side has been widening over the past several decades and will eventually fail catastrophically (fig. 15). A re-write of the 1990 study has appeared as an on-line article of *Arizona Geology*, a publication of the Arizona Geological Survey (Lindberg, 2009). Recent newspaper articles also describe present day conditions at the Devils Kitchen sinkhole (Ayers, 2010; Maresh, 2010).

One open fracture, in particular, has been enlarging over the years (fig. 15). In the early 1970s the north-south crack was visually estimated at ~2 inches (~5 cm) wide, but as of November 23, 2009 the opening measures 7-9 inches (18-23 cm) in the southern block and 11.5 inches (29 cm) in the companion northern block. Frost heaving and rock wedging are currently widening this fracture toward the breaking point. When failure does occur at this location, the “horizontal arch” formed by two large sandstone blocks are predicted to unload much of the southwestern corner of the sinkhole and generate a larger collapse (figs. 13 & 18). Arcuate fractures extend outward from the corner for at least 90 feet (27 m) and over the next several centuries the sinkhole is expected to enlarge substantially toward the west and southwest.

Figure 15. Open fracture in west edge of Devils Kitchen sinkhole. This fracture has been widening over the past several decades. What was once a 2 inch (5 cm) break is now 7-9 inches wide (18-23 cm). Frost heaving and rock wedging will ultimately cause this piece, and another similar block to the north, to break loose and “unload” the southwestern corner of the sinkhole in a future collapse. The entire outcrop to the southwest of this fracture has already been broken with arcuate fractures.

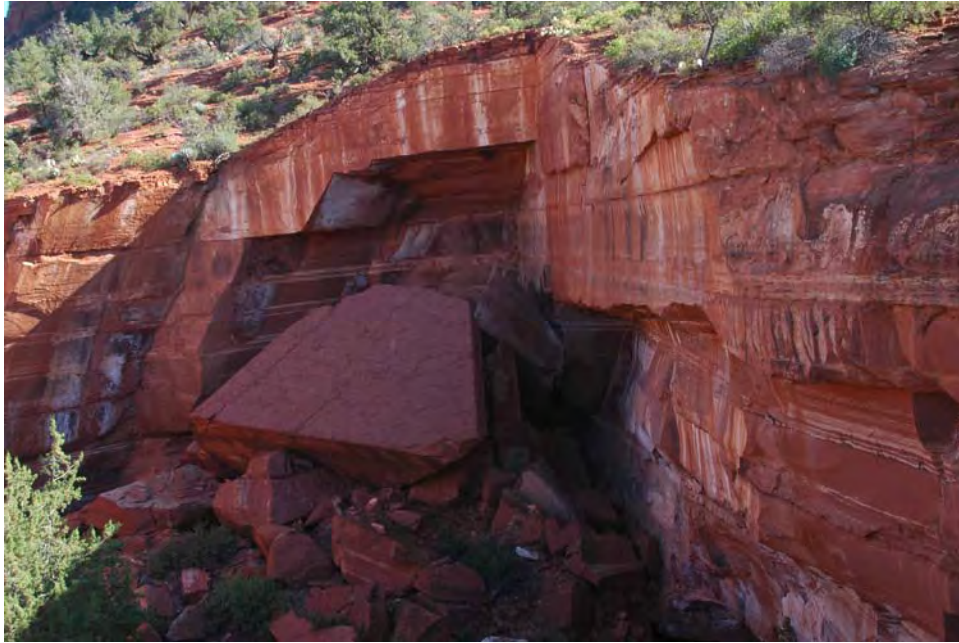
Figure 16. Devils Kitchen sinkhole in September 2008. Note the fresh, angular rock breaks and vestige of white caliche that marks the pre-1989 boundary of the sinkhole.

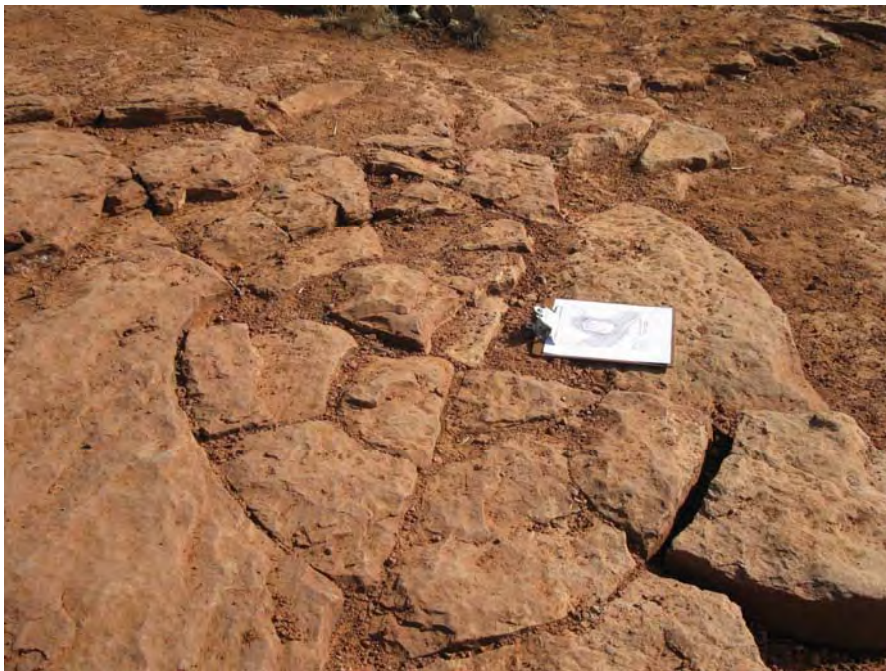
Another distinctive characteristic of sinkholes is found at Devils Kitchen where localized arcuate fractures indicate significant bedrock strain release. Local arcuate fractures have been superimposed on older regional rock joints that are straight as an arrow, indicating that the ground has been stressed to the point where rock breakage has taken place but bedrock has not yet collapsed. The southwestern corner of the Devils Kitchen sinkhole contains scores of arcuate fractures, many of which display dips that point away from the sinkhole opening, thus indicating that a bell-shaped downward withdrawal is already underway beneath the broken surface (figs. 3-6, 14 & 17).

Figure 17. Example of arcuate fractures in bedrock. Rock fractures such as this are only found in areas where subsurface collapse has already broken the surface outcrop. These fractures occur at the south end of Devils Kitchen sinkhole. Note how the arcuate fractures have been superimposed on the straight regional joints. Clipboard shows scale.

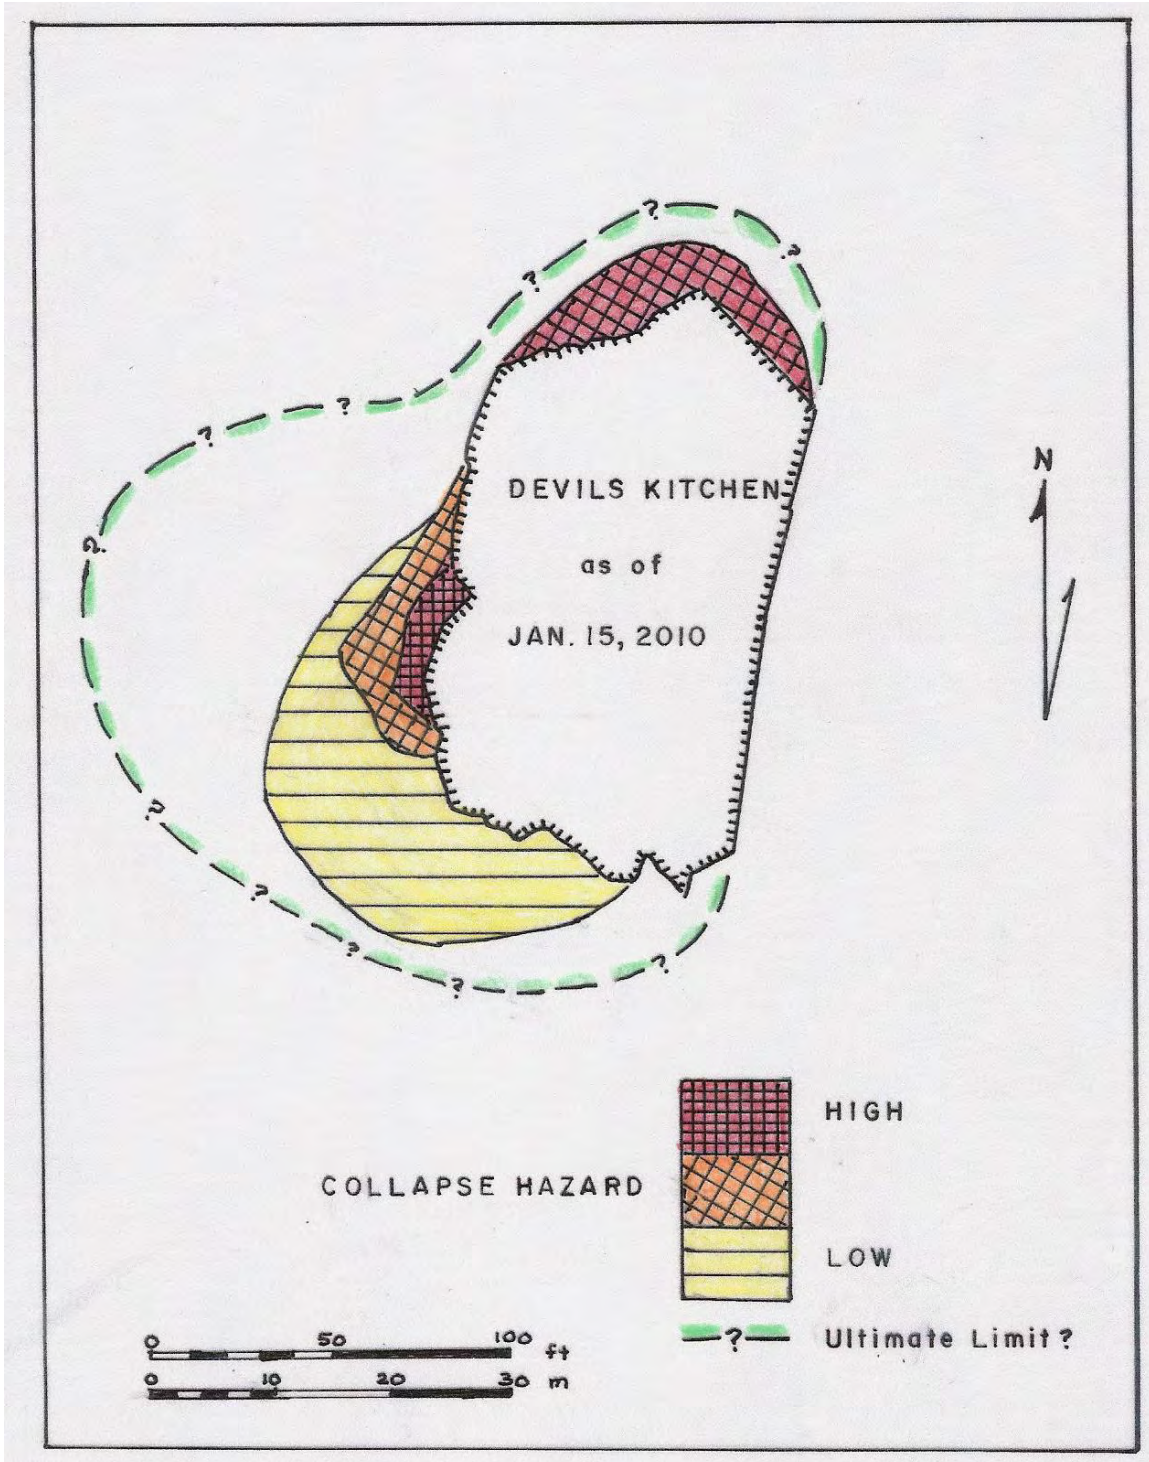
Figure 18. Predicted collapse hazard at Devils Kitchen sinkhole. Based on existing map information and past historic rock falls, the above map shows where additional collapse is likely to occur in future years.

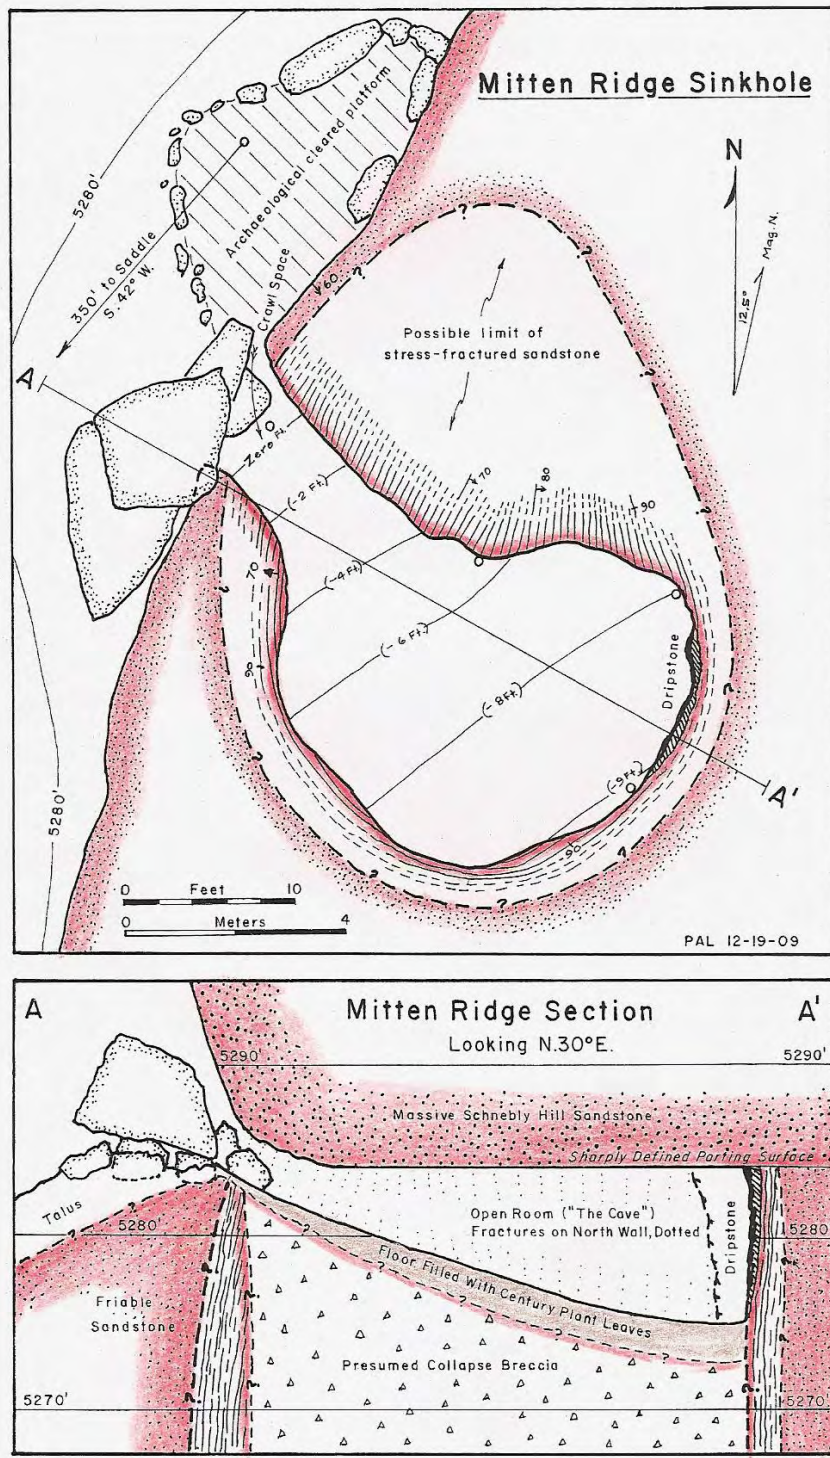
On October 3, 2009 the site was mapped in detail. Since prehistoric occupancy, and apparently in post-occupation time, several large sandstone blocks have spalled off from the overhanging cliff face above the opening to the sinkhole. That has partially blocked the present narrow crawl space entry into the room. *Large and unstable cliff blocks lying directly above the entrance are precariously perched and could fall at any time!*

Figure 19. Map and section through Mitten Ridge sinkhole. This unusual sinkhole contains abundant narrow, steeply oriented stress fractures within the collapsed area but is capped by massive, unbroken Schnebly Hill Sandstone. Known as the "Cave" by long time residents, this small site was once occupied in prehistoric time.

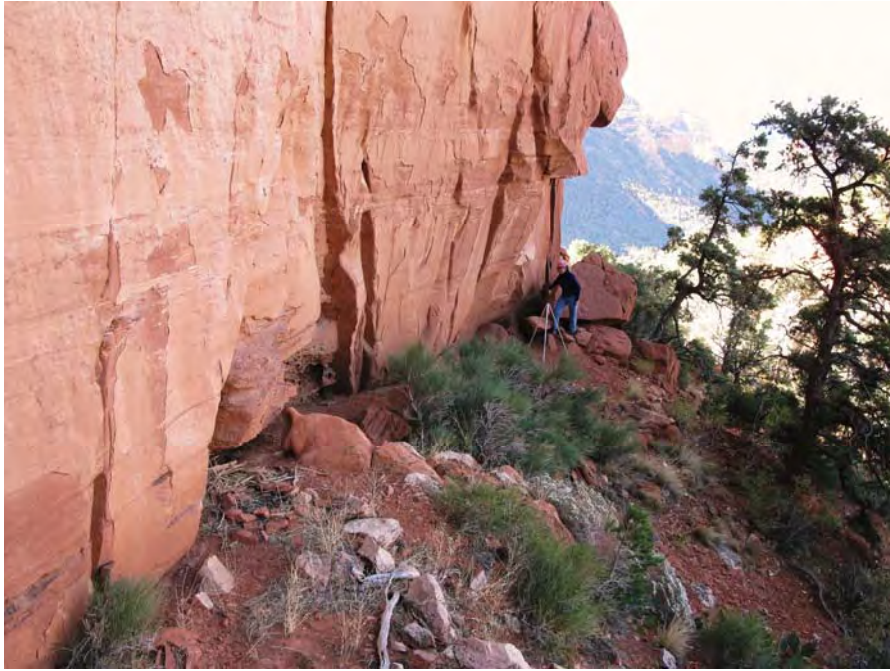
Figure 20. Entrance to Mitten Ridge sinkhole. Small prehistoric clearing lies to north of crawl space into the “Cave”. Note fractured and unstable cliff rocks above opening.

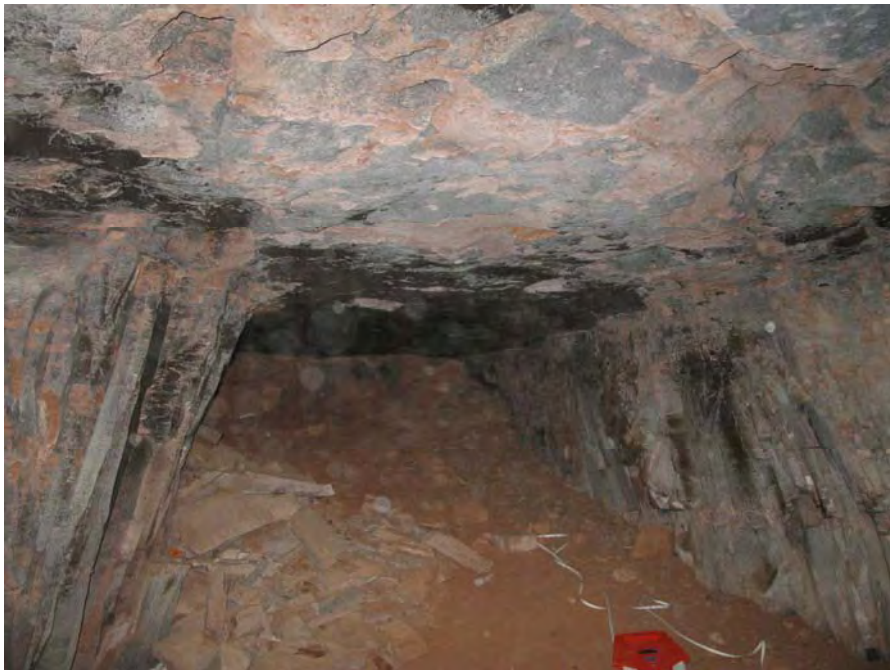
Figure 21. Interior of Mitten Ridge sinkhole. The walls show abundant, closely spaced stress fractures in Schnebly Hill Sandstone that widen downward. Massive sandstone caprock appears to be unbroken, indicating that this is the extreme top of a column of collapse breccia. Note the black soot from prehistoric occupancy on the ceiling.

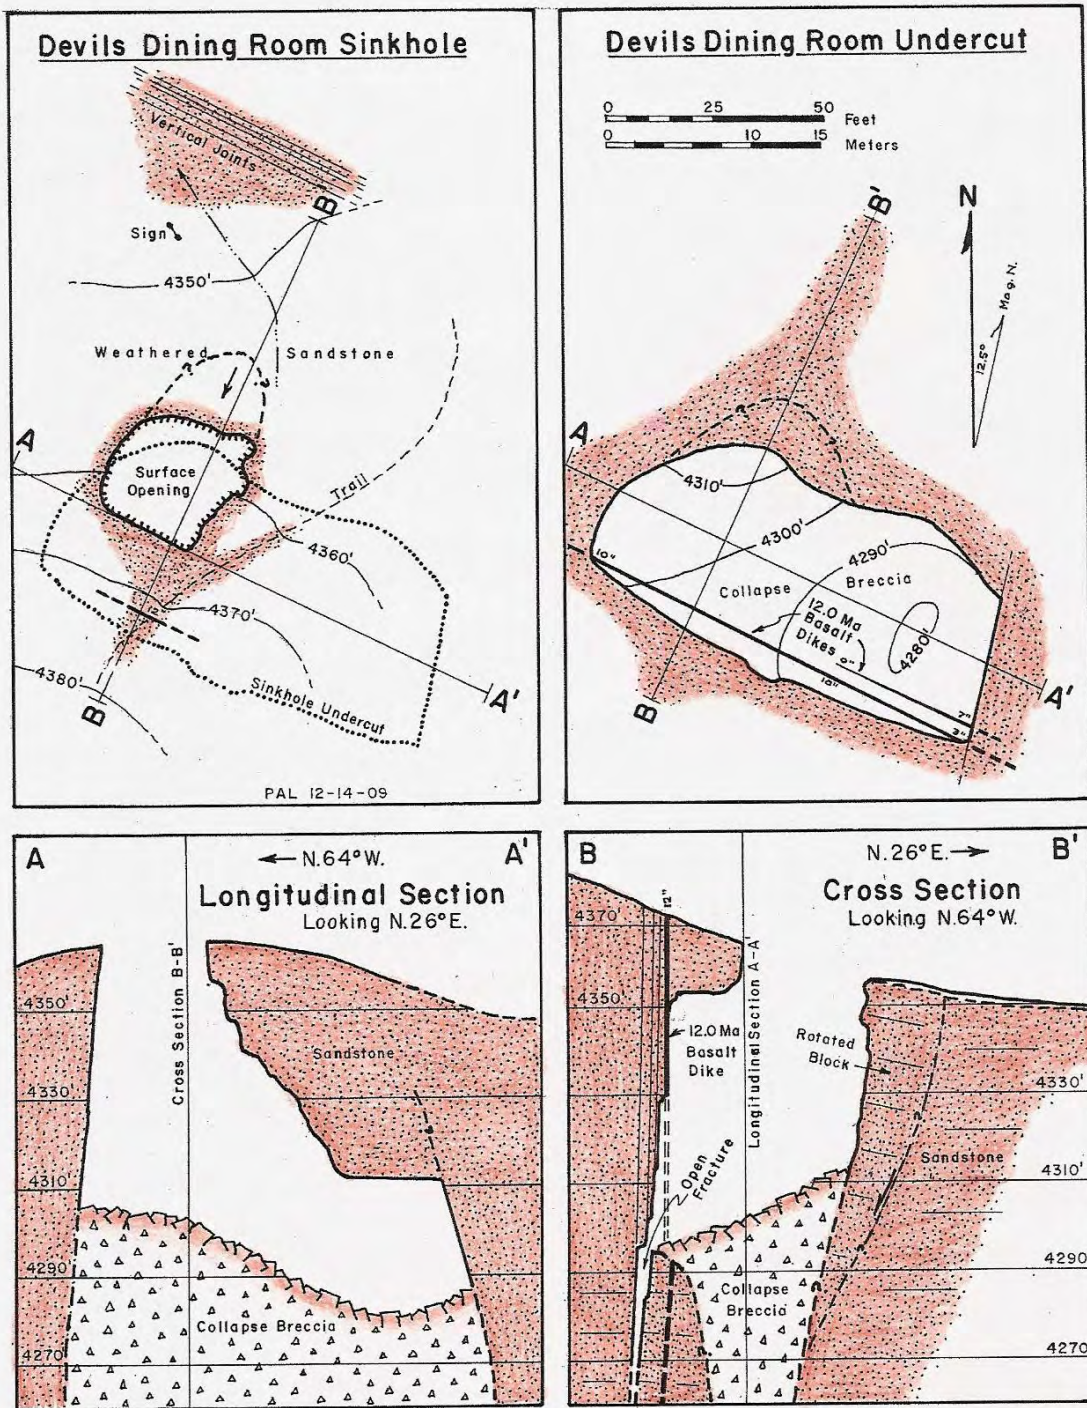
Devils Dining Room sinkhole is situated near the top of the Hermit formation where overlying Schnebly Hill Sandstone has been eroded away. When viewed from inside the opening, it becomes clear that a large block on the northern side of the hole had been dropped and rotated with a 15° dip to the north (Cross Section B-B' in fig. 22). The rotated block appears to have dropped several tens of feet during an older collapse event, but soil and weathered sandstone obscures its exact surface boundary. Also evident in the underground opening is a narrow vertical crack that extends downward for a considerable distance as a block rotated inward (fig. 22, B-B').

Figure 22. Map and sections through Devils Dining Room sinkhole. The undercut portion of the sinkhole is substantially bigger than the surface opening and is elongated sub-parallel to regional rock joints (Section A-A'). Section B-B' shows the 12.0 Ma basalt dike that cuts bedrock in the direction of regional rock joints. The dike had to have been intruded before sinkhole development. The north wall shows evidence of an old collapse.

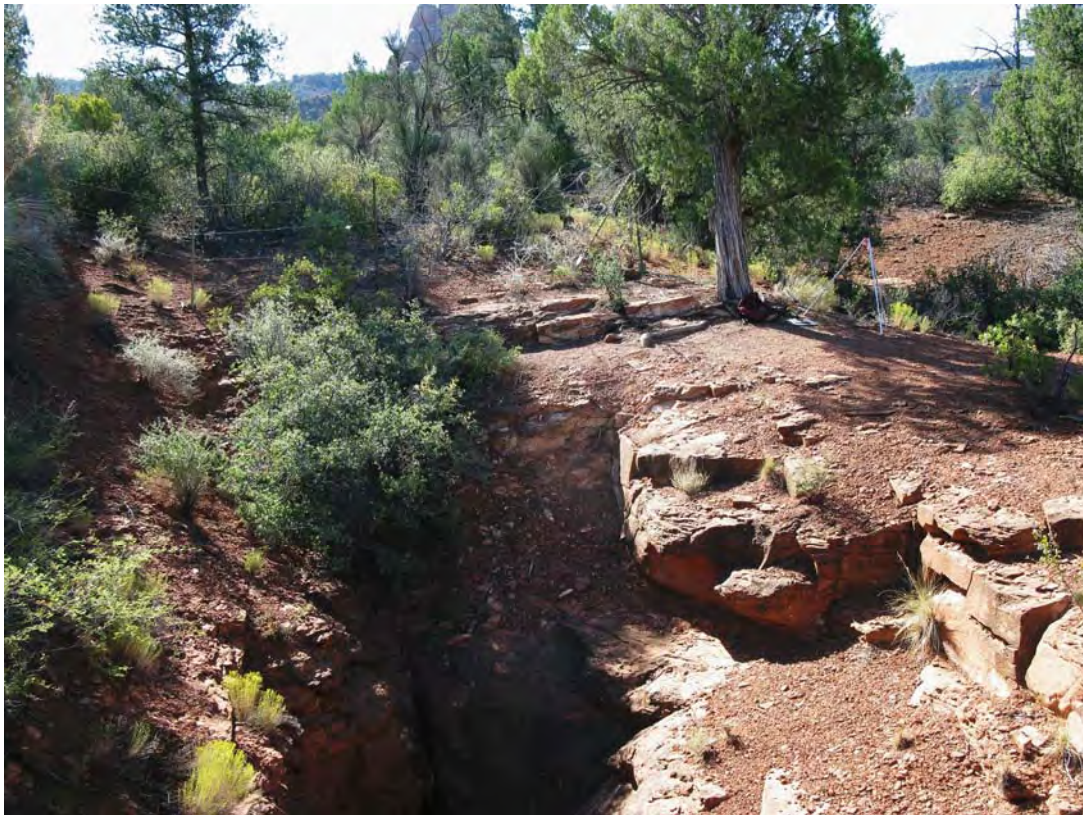
Figure 24. Surface view of Turkey Trail sinkhole. View is to the southeast in the direction of regional rock joints. A small 5 by 10 foot rock opening deeper down leads into the larger underground opening. Most surface water in this area is shunted around the surface opening. Brunton compass tripod and clipboard show scale.

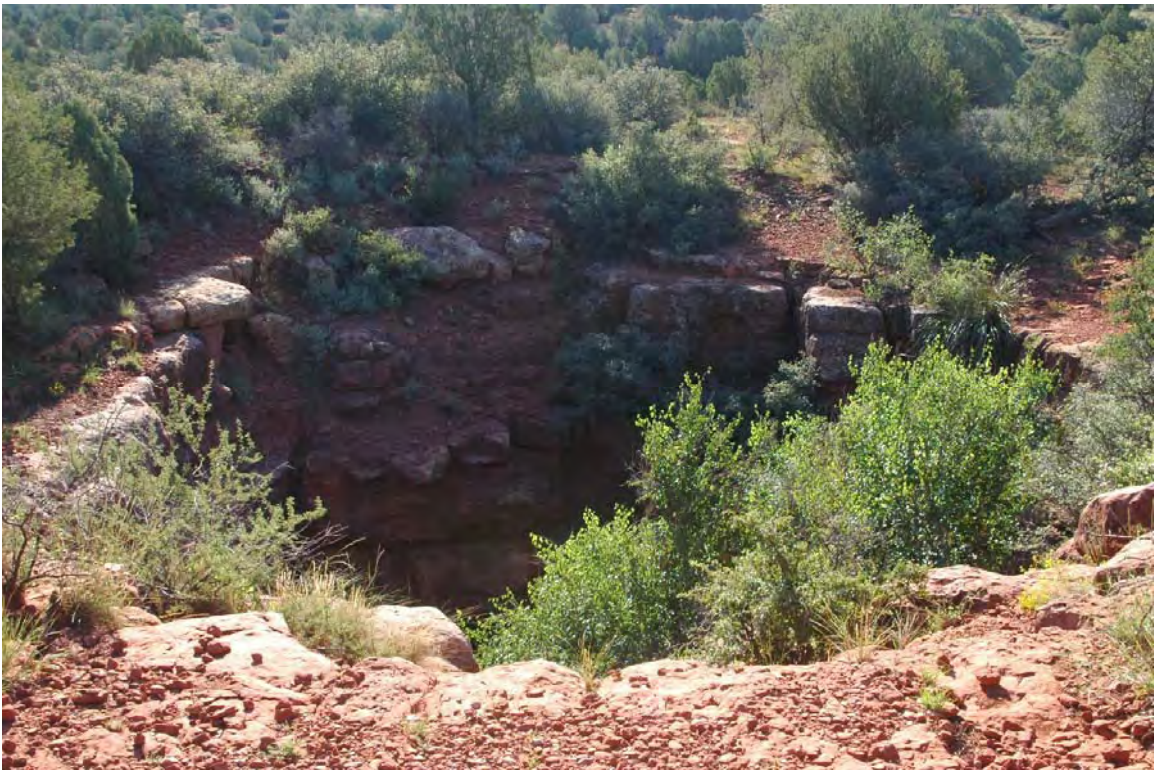
Figure 27. Surface view of Nolan Draw sinkhole. View is looking toward the east-southeast. Surface rocks are well rounded and appear to have been stable for many years.

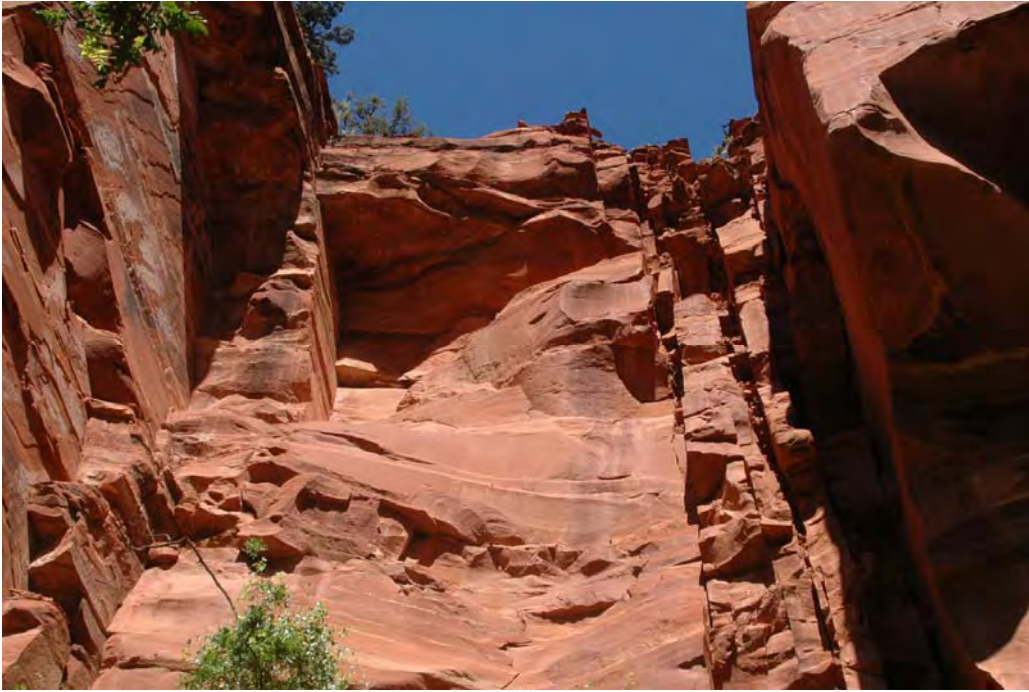
Figure 32. Northwest-trending joints on west wall of Red Canyon sinkhole. Drain is 98 feet (30 m) directly below these fractures.

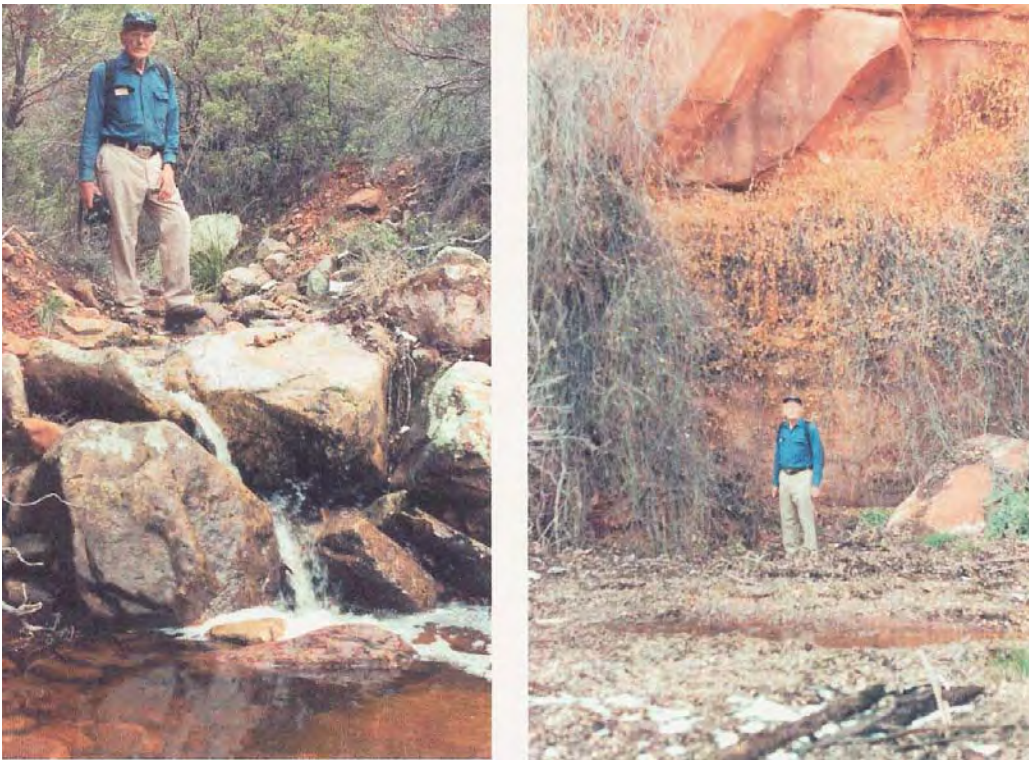
Figure 33. Snowmelt flowing into Red Canyon sinkhole. On March 12, 2001 a visual estimate of ~1 cubic foot per second of water flow was entering the sinkhole and rapidly draining at the far western side below the cliff shown in Figure 32.

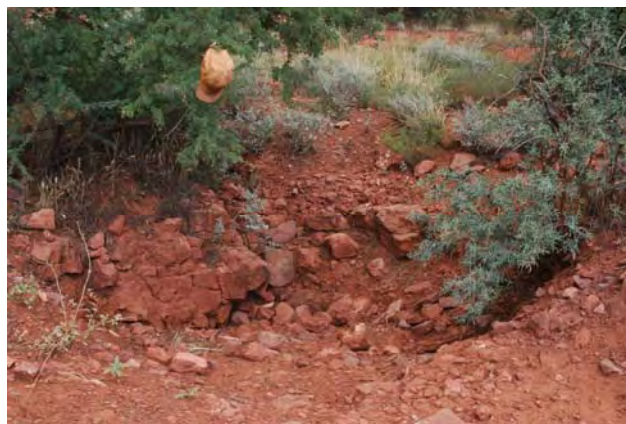
Figure 36. Photograph of 4543 sinkhole. Despite its small size, Air pressure changes allow air to exit or enter, indicating the presence of a large cavity below ground level.
