City of Bisbee Comprehensive Transportation Plan

Task Assignment
MPD 34-10

Final Report

February 20, 2012

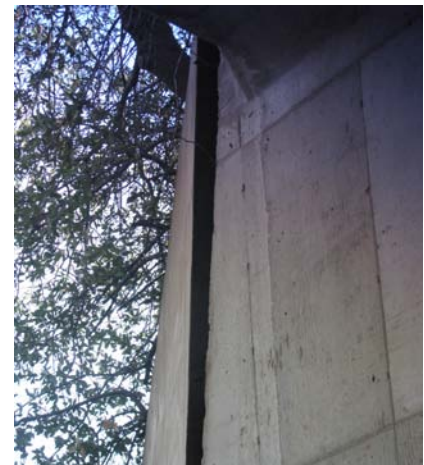
Spring Canyon Structure

The condition of the Spring Canyon Bridge (Structure # 10540) under SR 80 is being monitored by the ADOT District Engineer's office. The wing walls of this structure are separated from the headwall (see photo to right). At present, the district has not yet identified a priority need for a structure rehabilitation project.

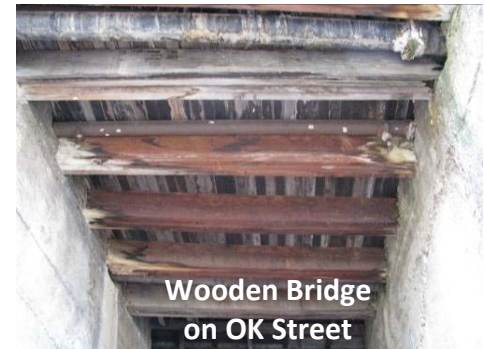
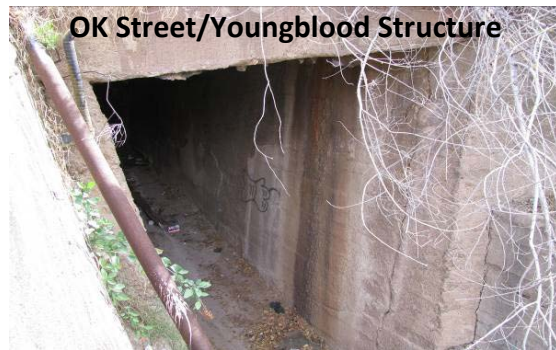
Three structures were found in Old Bisbee that are not in the regular rotation for inspection. Two of these structures are on OK Street. One of these structures (labeled A on Figure 20) is found near Brewery Gulch and consists of timber decking with built up timber beams. Based on visual observation, the beams are either 4 – 2x8 beams or 4 – 2x10 beams spaced approximately 5’ on center (C/C). The decking is in poor condition and shows strong evidence of failure. The roadway surface is asphalt.

Per Bisbee officials, during recent rehabilitation work on homes uphill of the structure, a temporary structure was placed over the limits of the wooden bridge so that the trucks would not overstress the structure. This structure is in need of immediate replacement in order to bring it up to standards and allow continued use of OK Street.

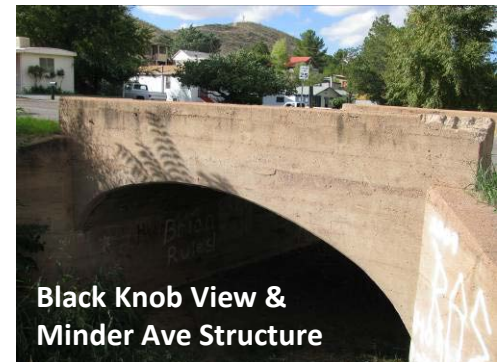
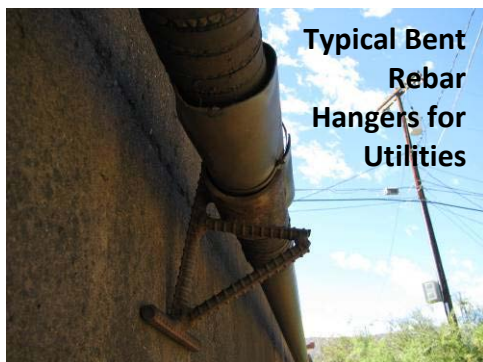
The second structure (labeled B on Figure 20) is located at the intersection of OK Street and Youngblood. This structure is a concrete slab bridge over a drainage way. The structure is in fair condition. The underside of the structure shows signs of efflorescence and overall aging since the structure is approximately 80 to 90 years old. There is a large vertical crack in the downhill side of the abutment wall. The crack shows no sign of recent movement and looks to be stable. There are some signs of deterioration due to water intrusion and vegetation growth on the canal walls. Overall, the structure needs little rehabilitation work and should be added to the biennial inspection list along with the other structures located within the City of Bisbee.

The third structure (labeled C on Figure 20) is on Minder Avenue just north of Black Knob View. This structure is a concrete arch and is in fair condition. The railing on the structure needs repair or replacement due to a vehicle collision. There is some minor cracking and efflorescence due to the structure being about 64 years old.

Overall, all of the structures, except the wooden bridge, are in fair condition, mostly because of the age of the structures. The biggest issue would be the lack of a barrier/guardrail on each side of the structures. The rails need to be upgraded to meet current AASHTO crash standards.

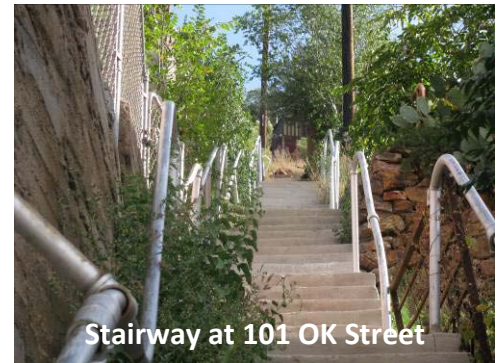
The stairways themselves are generally in fair condition. Some of the stairways occasionally have water running down the middle of the stairways that is contributing to their overall degradation. Most of the stairs currently do not meet current code for both height and depth of the treads. Some of the stairways have been recently rehabilitated by either the property owners or the City of Bisbee. Most of the repairs that have been recently completed are in good condition and should extend the life of the stairway for another 10 to 15 years without major rehabilitation work from the City. A few stairways are in need of immediate rehabilitation due to erosion of the subbase of the stairway.

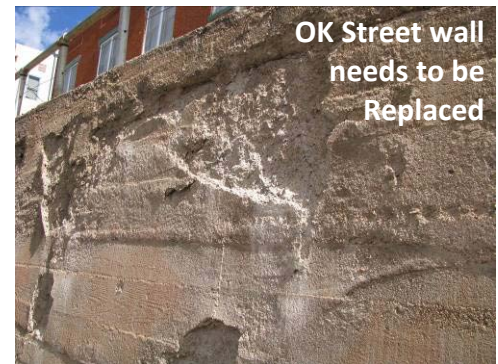
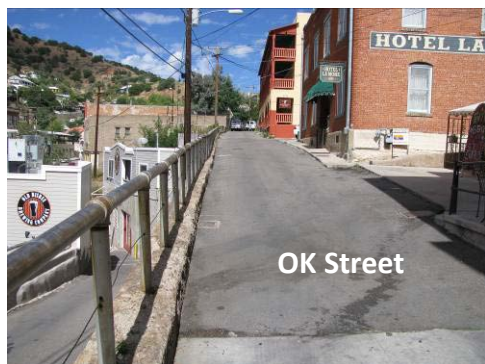
The wall located on OK Street at Review Avenue is a classic example of a wall at the end of its useful life. The wall crumbles when touched and the above supported roadway is showing stress cracks due to movement of the wall away from the roadway. The wall needs to be replaced as soon as possible due to its state of disrepair and its potential impact on the use of OK Street and access to property owners.

There are several walls located throughout Old Bisbee that have been rehabilitated by the property owner or the County. The repairs consisted of a shotcrete face to restore the integrity of the wall without totaling replacing the structure. Many of the repairs are in very good condition and will extend the useful life of the wall another 10 to 15 years.

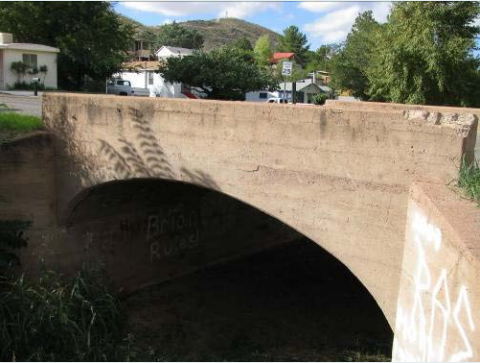
N/A	N/A	Concrete Arch	Concrete	Good Condition - Some minor cracking / efflorescence. Heavy vegetation on the upstream side. (See Pictures 109-115)			X				Structure is in fair condition and only the railing on the superstructure needs repair due to a vehicle hit. Age of the structure is ~64 years.
