Ganado/Burnside Area Traffic Circulation Study

WORKING PAPER 1: EXISTING AND FUTURE CONDITIONS July 2015

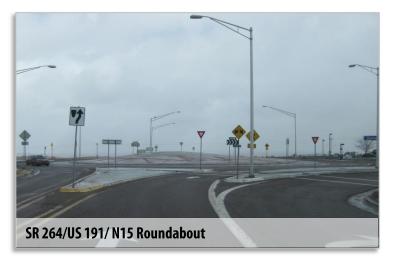
- N15: Paved roadway in poor condition from 0.5 mile south of SR 264 intersection to study boundary.
- N27: Paved roadway in fair condition
- N151: Unpaved roadway in poor condition
- N9101: Unpaved roadway in poor condition
- N9102: Paved roadway in poor condition from SR 264 intersection to 0.2 miles north of intersection
- N9034: Unpaved roadway in poor condition
- Co. 420: Unpaved roadway in poor condition

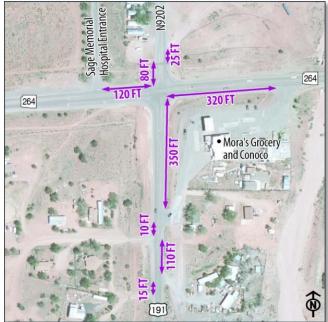
Current Driveway Spacing in Ganado

Access management guidelines for driveway spacing often range between 150 feet to over 300 feet. The Salt River Indian Community utilizes the City of Scottsdale's *Design Standards & Policies Manual* for managing access for high capacity corridors that provide commuter access to Scottsdale; minimum driveway spacing required by the City of Scottsdale includes 165 feet for minor collectors and 250 feet on minor arterials. The City of Somerton requires driveways along major arterials to have a minimum spacing of 200 feet in commercial and residential areas, while the City of Casa Grande requires a minimum driveway spacing of 200 feet on major arterials in commercial areas and 150 feet on minor arterials. Coconino County's Engineering Design and Construction Manual states that driveways are not permitted within 50 feet of a street intersection, 25 feet of a guardrail end, and within 100 feet of a bridge.

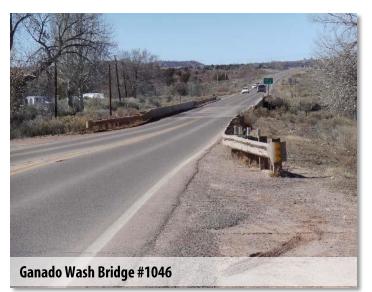
ADOT bridge inventory data was accessed to determine the condition of structures along SR 264 and US 191. Within the study area, ADOT's Bridge Inventory identifies three structures along SR 264. Table 5.4 presents the sufficiency rating for each of these structures. As listed in the table, Ganado Wash Bridge (structure #1046) has a sufficiency rating of 25.9 and is eligible for replacement. As noted in Chapter 2, the structure is scheduled for replacement in 2016. As illustrated in the figure to the right, the bridge is not wide enough to accommodate pedestrian or bicycle traffic, forcing pedestrians/bicyclists to use the travel lanes to cross the bridge.

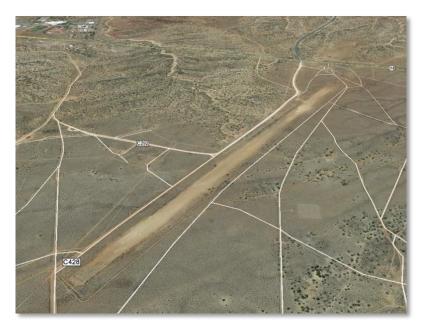
In order to gain a better understanding of all of the factors contributing to the regional transportation conditions, it is important to consider air travel. Located along N9304 is the Ganado Airport that primarily serves medical transportation to and from Sage Memorial Hospital. The Ganado Airport covers approximately 47 acres and has one runway designated 18/36 with a dirt surface measuring 4,500 by 80 feet. According to the *2000 Arizona State Aviation Needs Study*, the Ganado Airport has multiple obstructions and issues that require mitigation in order to safely accommodate air traffic , including: no line of sight between runway ends, water on runway and gulleys after heavy rain, livestock present.

A master plan and initial design (2008) for a 6,600' x 75' paved runway has been completed. The design called for paving the runway; installing runway lighting; constructing a 250 sq. ft. building, pilot waiting area, rest room, and installing utilities.

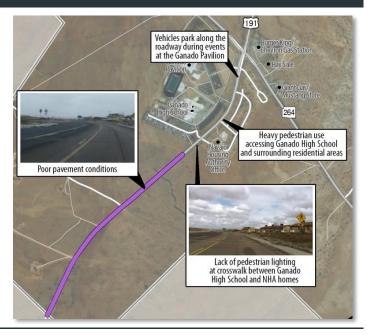
- By 2035, projected to operate at LOS C, if no roadway improvements are made.
- The pavement condition is generally in fair to poor condition with cracking, raveling, and surface bleeding. Additionally, the corridor has curbed shoulders within the study area; however, they are in poor condition.
- The corridor is heavily utilized by pedestrians accessing the Ganado High School, the Chevron Gas Station, and the residential housing development.
- During events at the Ganado Pavilion and the school gym, vehicles have been known to park along the roadway when parking capacity is exceeded.
- Street lighting for school and residential areas on the N15 corridor is lacking.

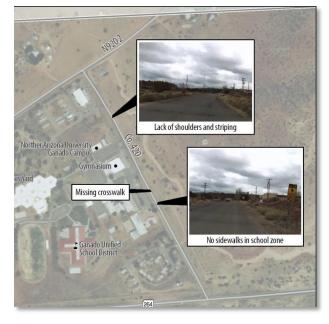
Located in Ganado, County Route 420 is a two-lane, paved roadway that intersects SR 264 east of Ganado Unified School District. The roadway provides access for residents and students to the schools. This road is frequently used by school buses to access the bus storage yard, as well as utility trucks accessing Ganado Lake. As a major access route to the school, the corridor is designated as a school zone with a speed of 20 mph. The road surface is in good condition; however, there are no shoulders or sidewalks along the road.

- Pedestrian sidewalks and crosswalks needed for students to safely access the school.
- Frequently utilized by school buses to access the bus storage yard, as well as utility trucks accessing Ganado Lake.
- Road surface is in good condition; however, there are no shoulders along the road.
