HWR No. 01-010

*An Evaluation of Hydrologic and Riparian
Resources in Saguaro National Park,
Tucson, Arizona*

Kathryn J. Baird
Robert Mac Nish
D. Phillip Guertin

Department of Hydrology and Water Resources, and
University of Arizona Research Laboratory for Riparian Studies
University of Arizona
Tucson, Arizona 85721

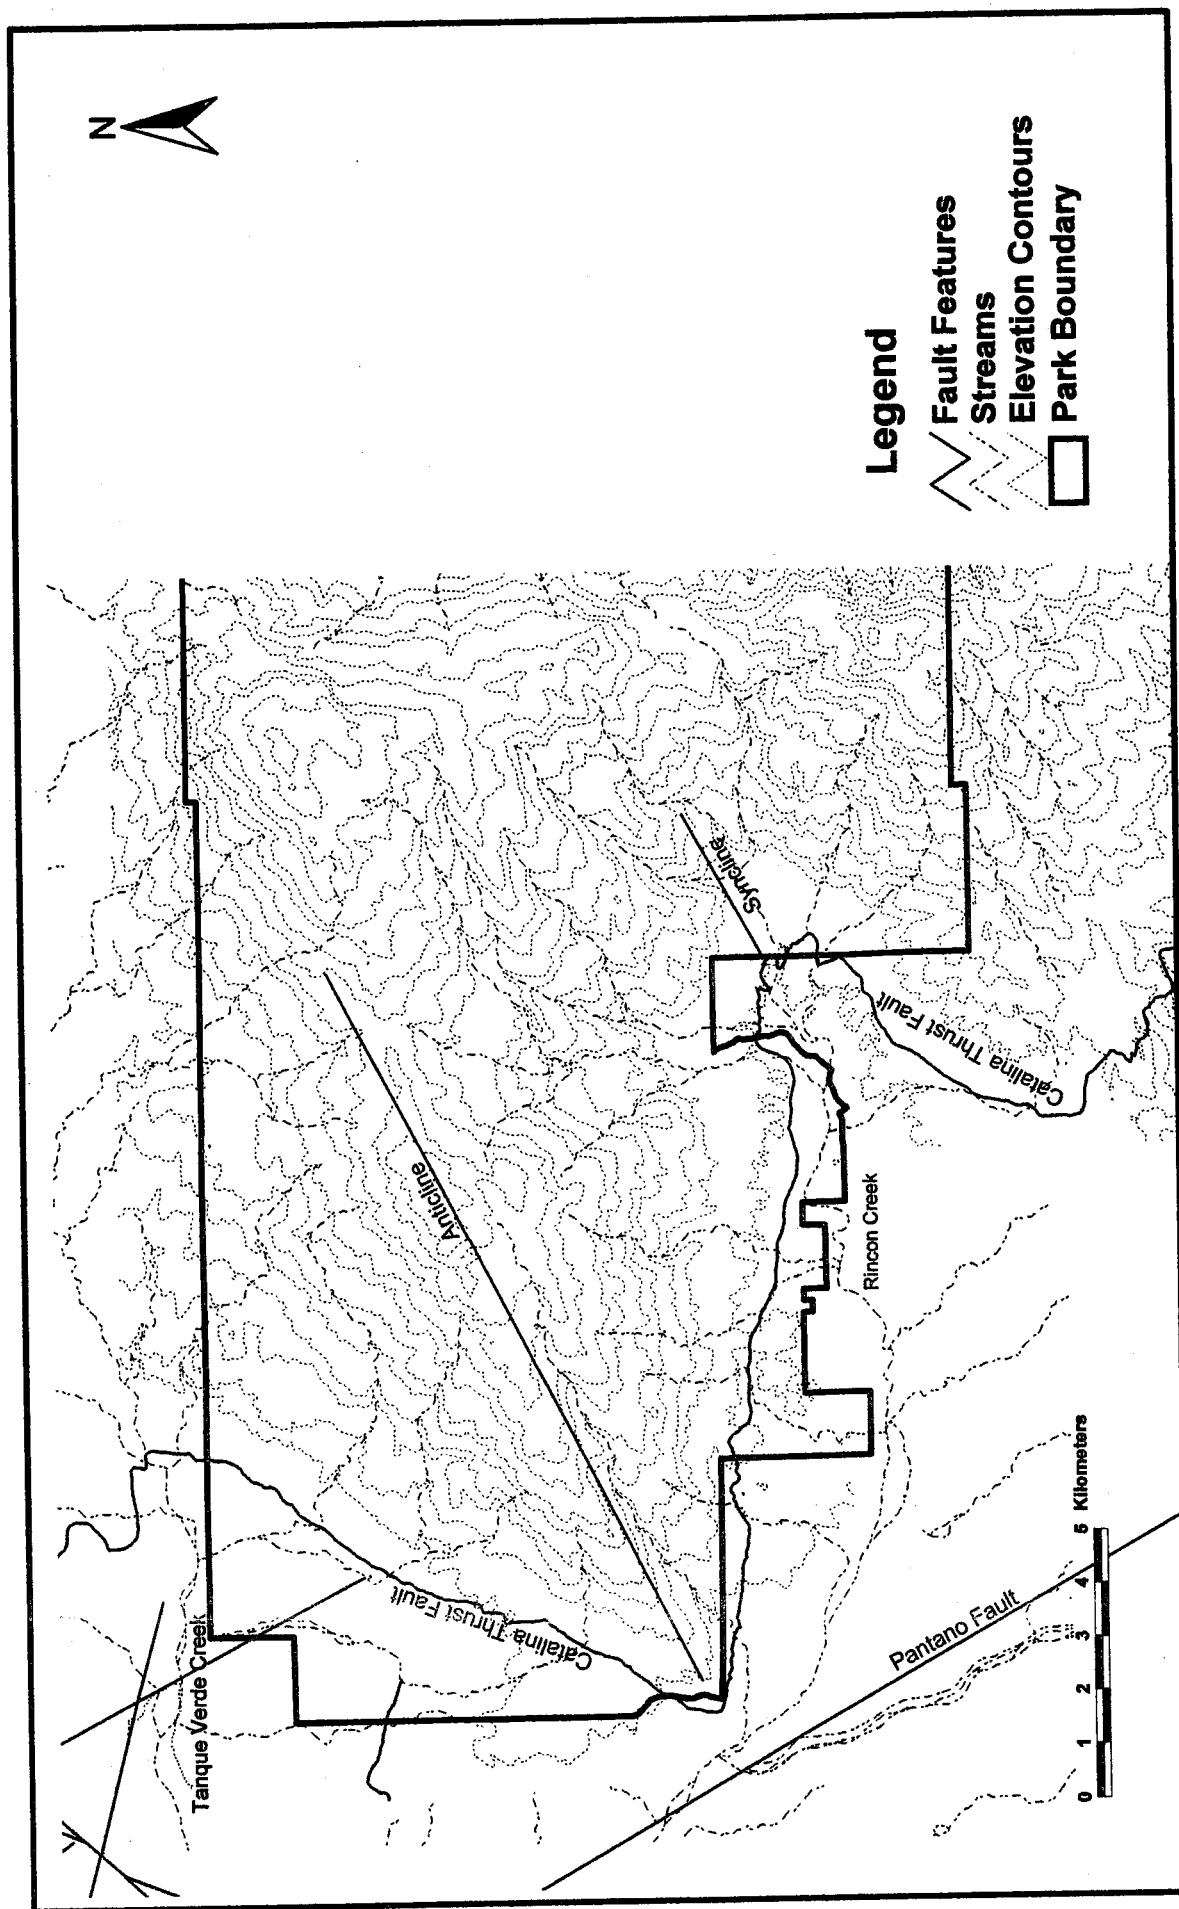
Figure 3. Major Faults in the vicinity of Rincon Creek.

Thorman and Drewes (1981) did not map the Rincon Creek area in as much detail as they did mineralized areas. However, their descriptions suggest that either disharmonic faults reactivated during the glide faulting, or imbricate glide faults branched off the Catalina fault when it was reactivated creating a series of small structural basins. These basins extend from the point where the outcrop of the Catalina fault crosses Rincon Creek to Sentinel Butte. Such structures may extend westward beyond Sentinel Butte, but the unconsolidated alluvium deepens to the west and we found no visual evidence to suggest their existence. A hypothetical cross-section of the nature of the structures creating the small structural basins is illustrated in Figure 4. While no attempt was made to map faults during this study, the alternation of bedrock outcrops in the channel of Rincon Creek with alluvial floored channel segments is consistent with the presence of such structures. These features are observed in the middle basin area as far west as Sentinel Butte.

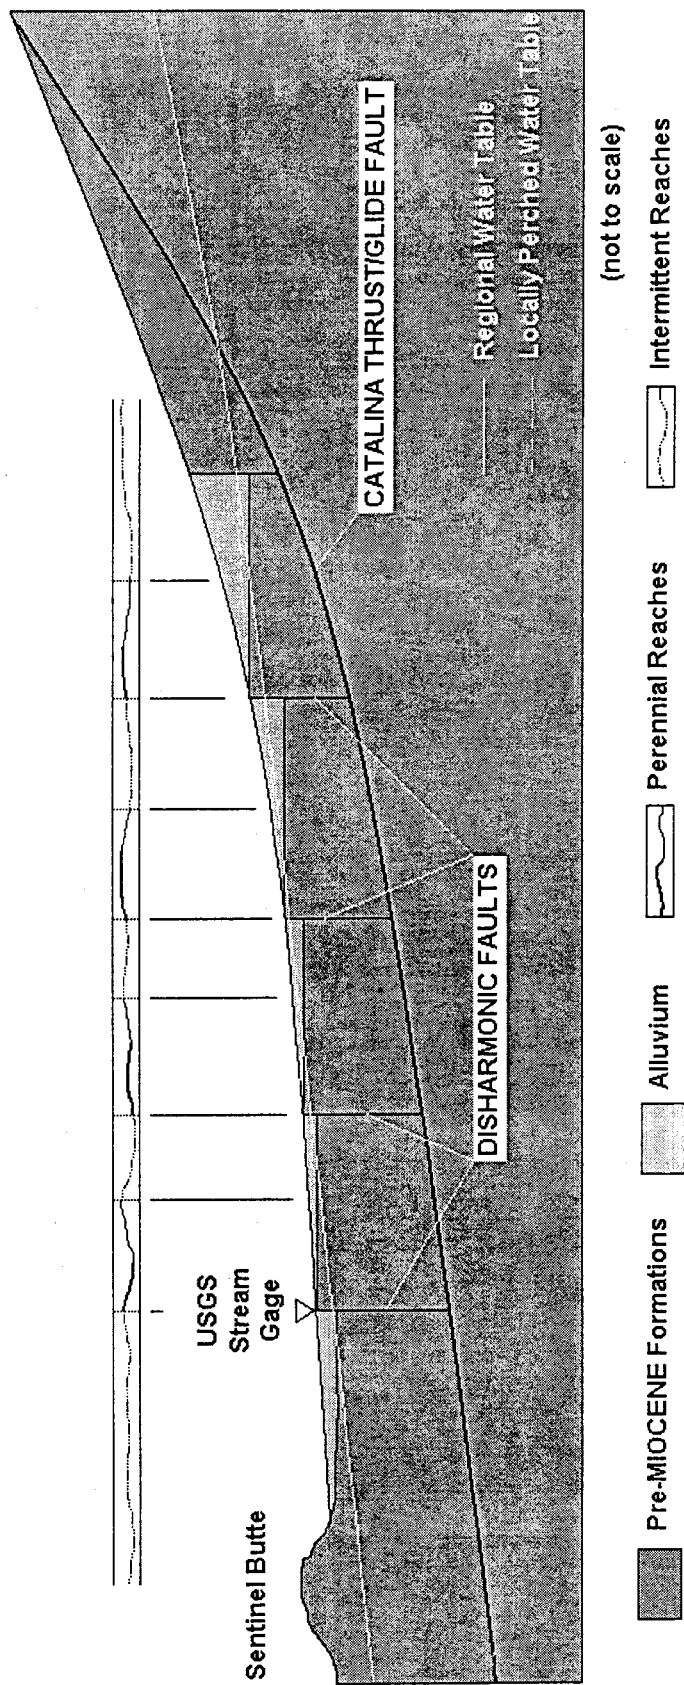
Figure 4. Schematic Cross-section along the axis of the Rincon Valley syncline from Sentinel Butte to the outcrop of the Catalina Fault.

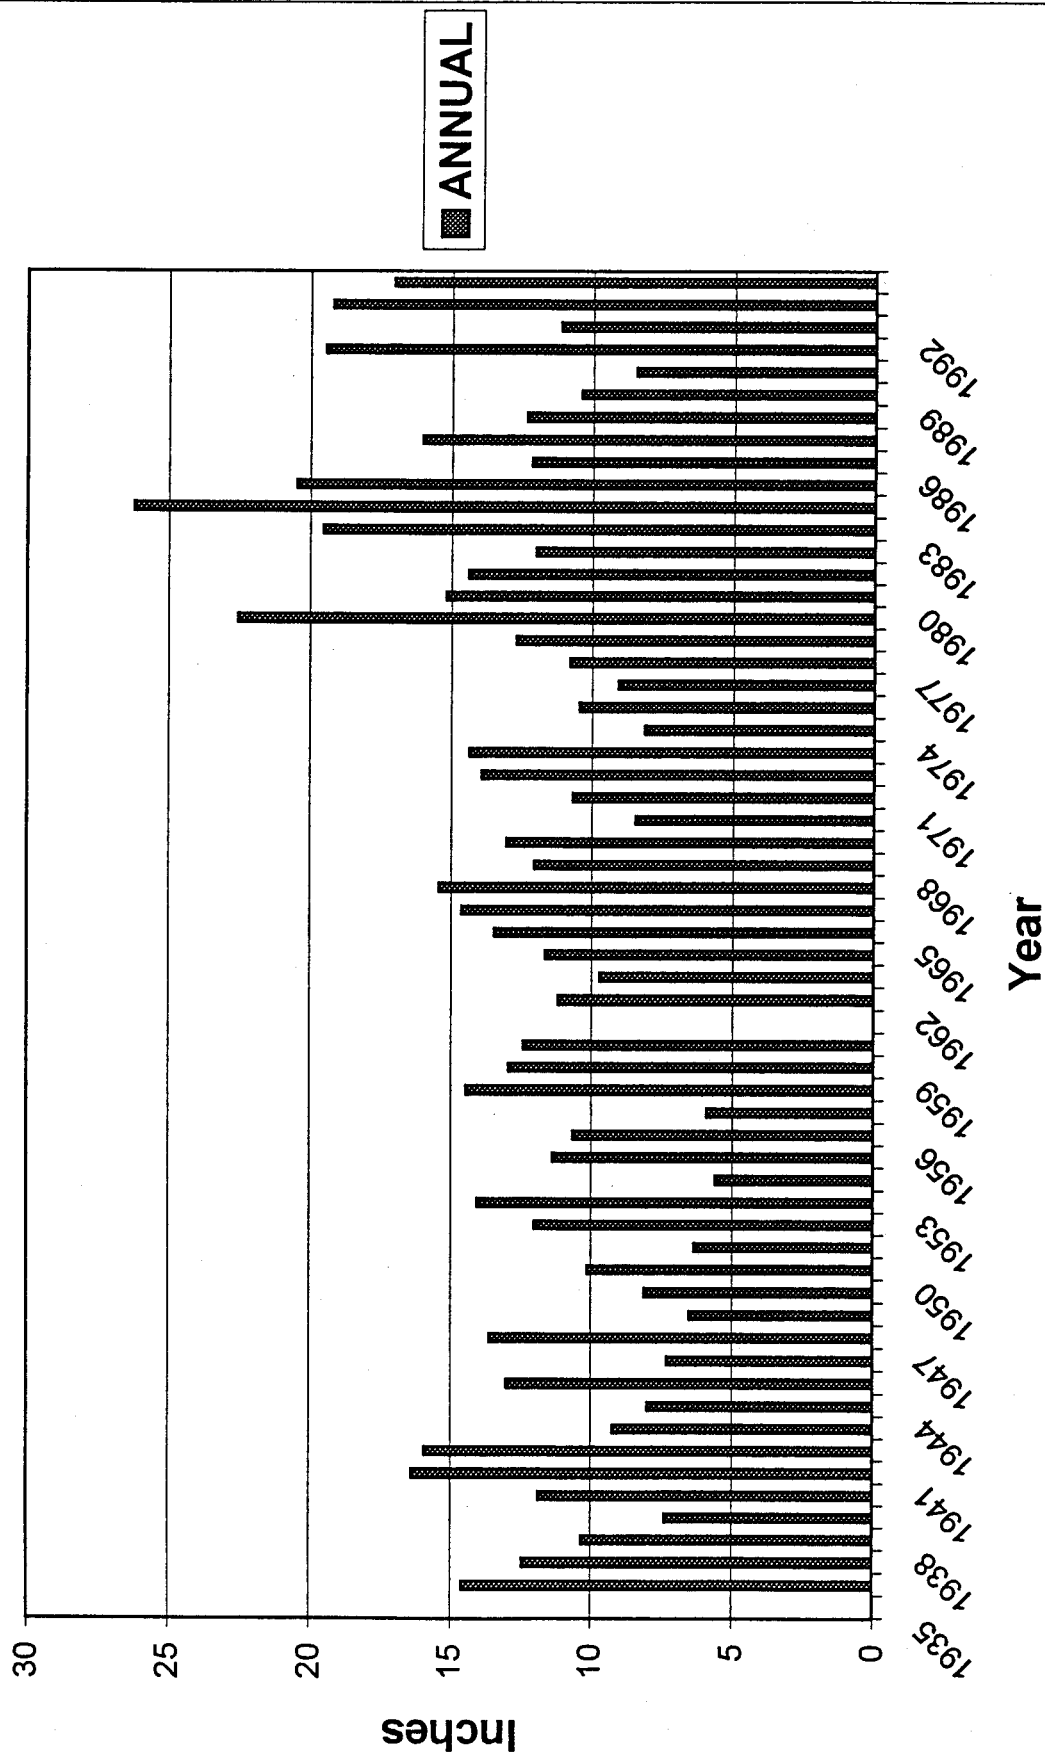
Figure 5. Total annual precipitation in inches, Tucson Magnetic Observatory (1935-1993)

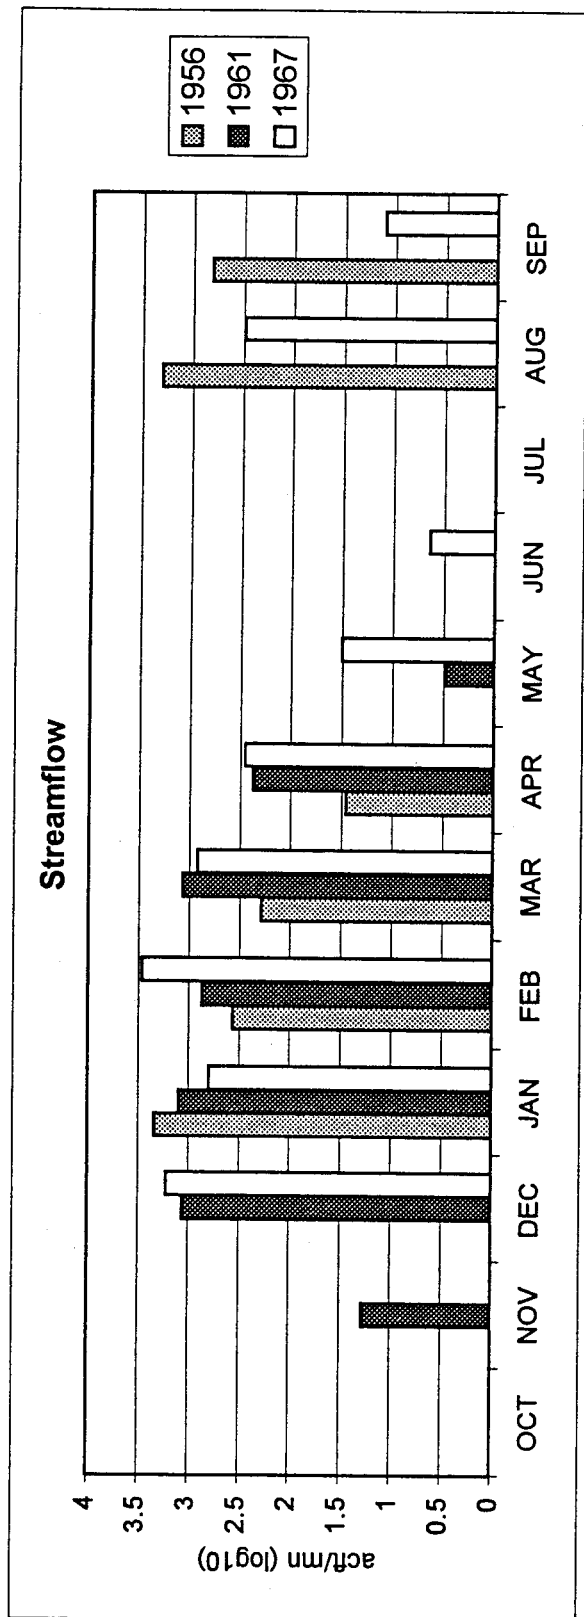
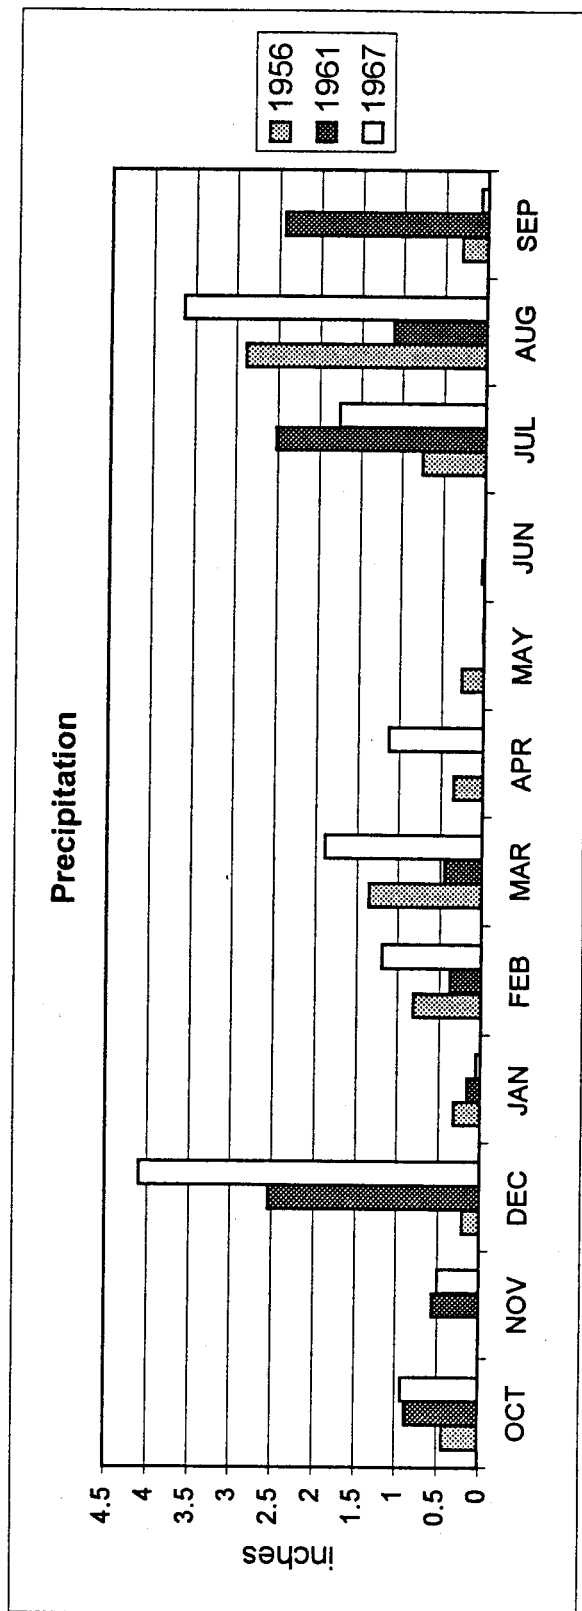
Figure 6. Total monthly precipitation at TMO (top) and total monthly streamflows (acre feet month) Rincon Creek. Data from three relatively wet years.

To get a rough idea of how Rincon Creek responds to precipitation events, monthly precipitation measured at the observatory was graphed against monthly stream flow on Rincon Creek. Several assumptions are inherent in this comparison. The first is that rainfall at TMO reflects conditions on the Rincon Creek watershed. In the winter with the large, slower moving frontal storms common to the Tucson area this isn't a bad assumption. However, summer precipitation falls as a result of very localized convective thunderstorms and conditions can vary greatly from one location to the next. Figure 6 shows three relatively wet years while Figure 7 reflects three drier years. None of these years represent extreme years. In both cases, there is a general pattern of increasing stream flow in response to increased precipitation. Note that on both figures streamflow is calculated on a log-scale that accentuates low flows.

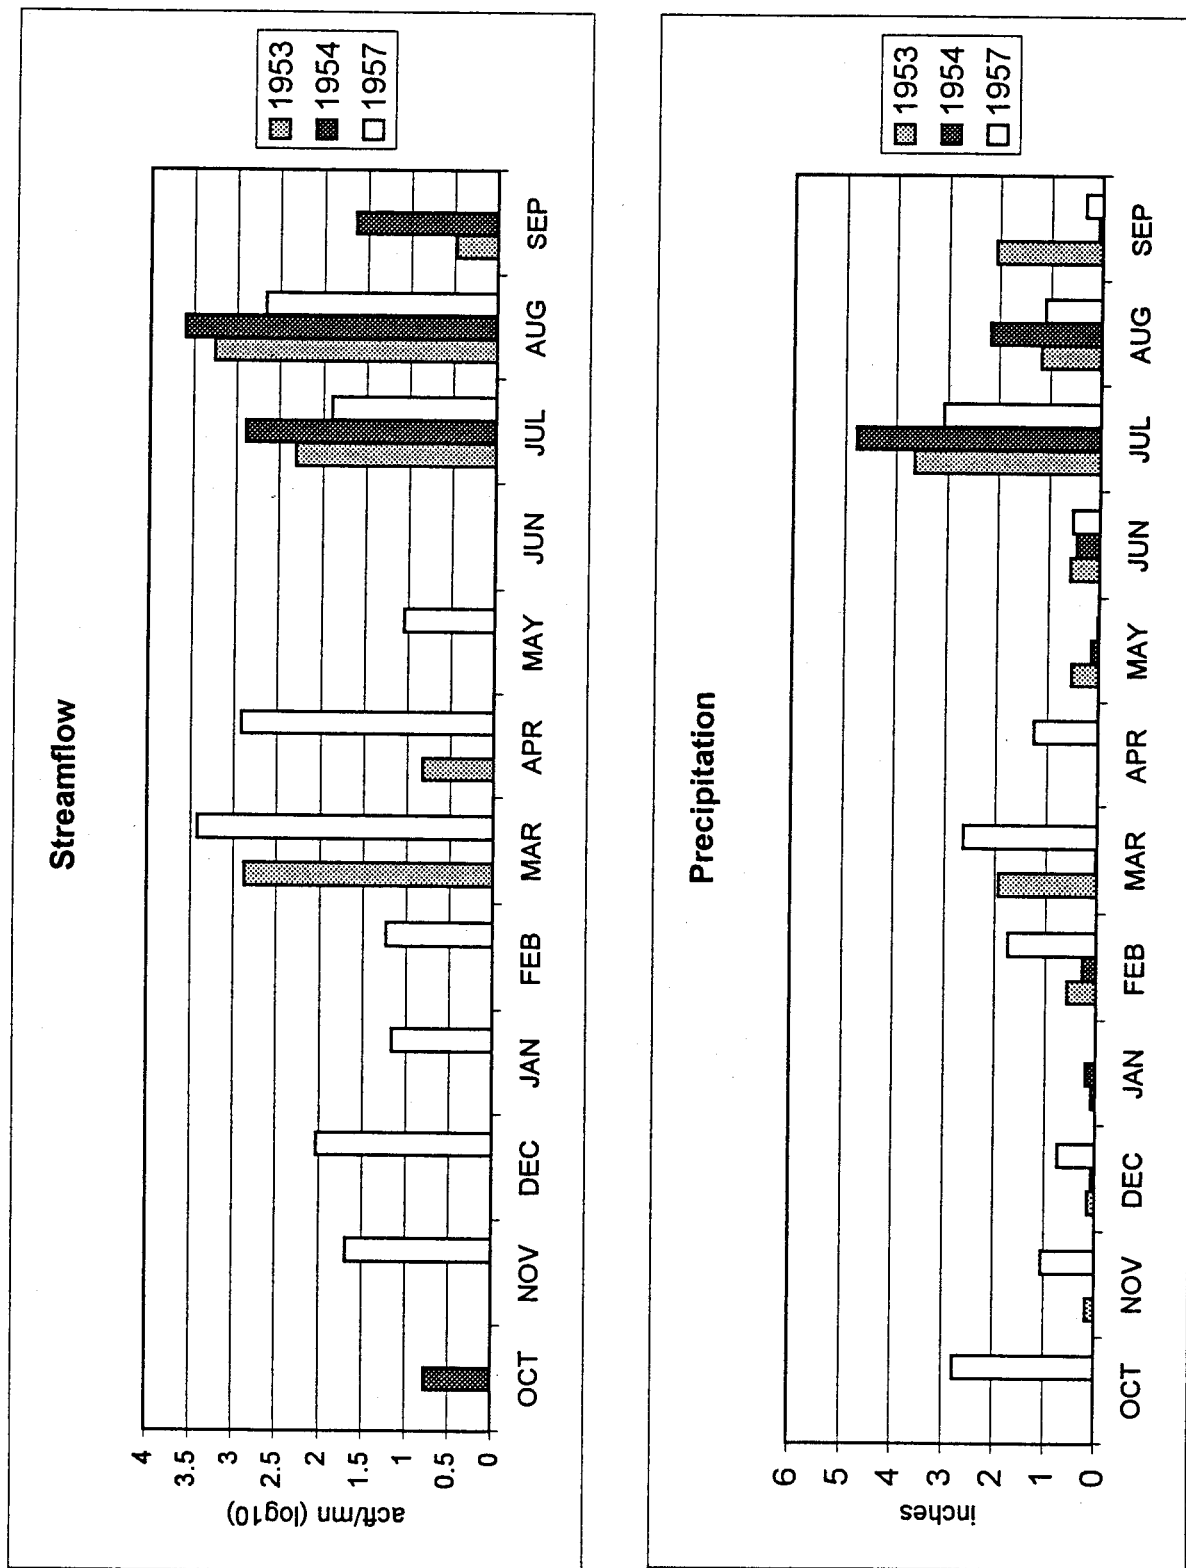
Figure 7. Total monthly precipitation at TMO (top) and total monthly streamflows (acre feet month) Rincon Creek. Data from three relatively dry years.

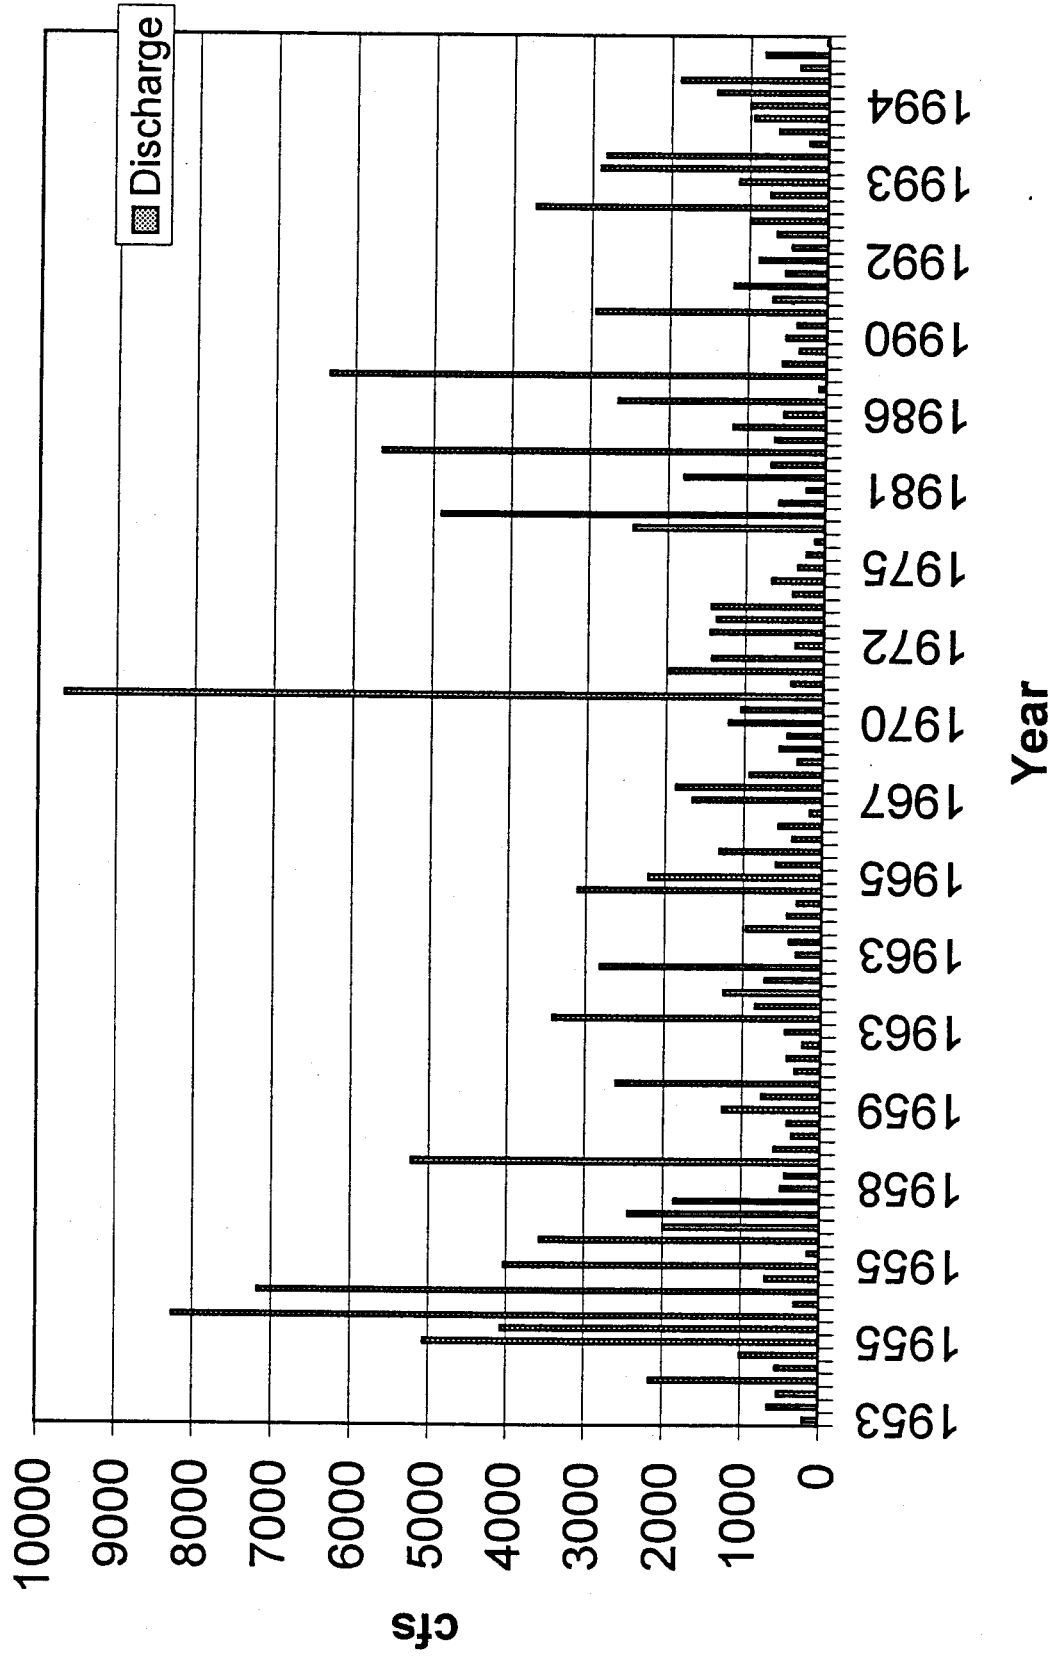
Figure 8. Historic peak streamflows (cubic ft./sec), Rincon Creek.

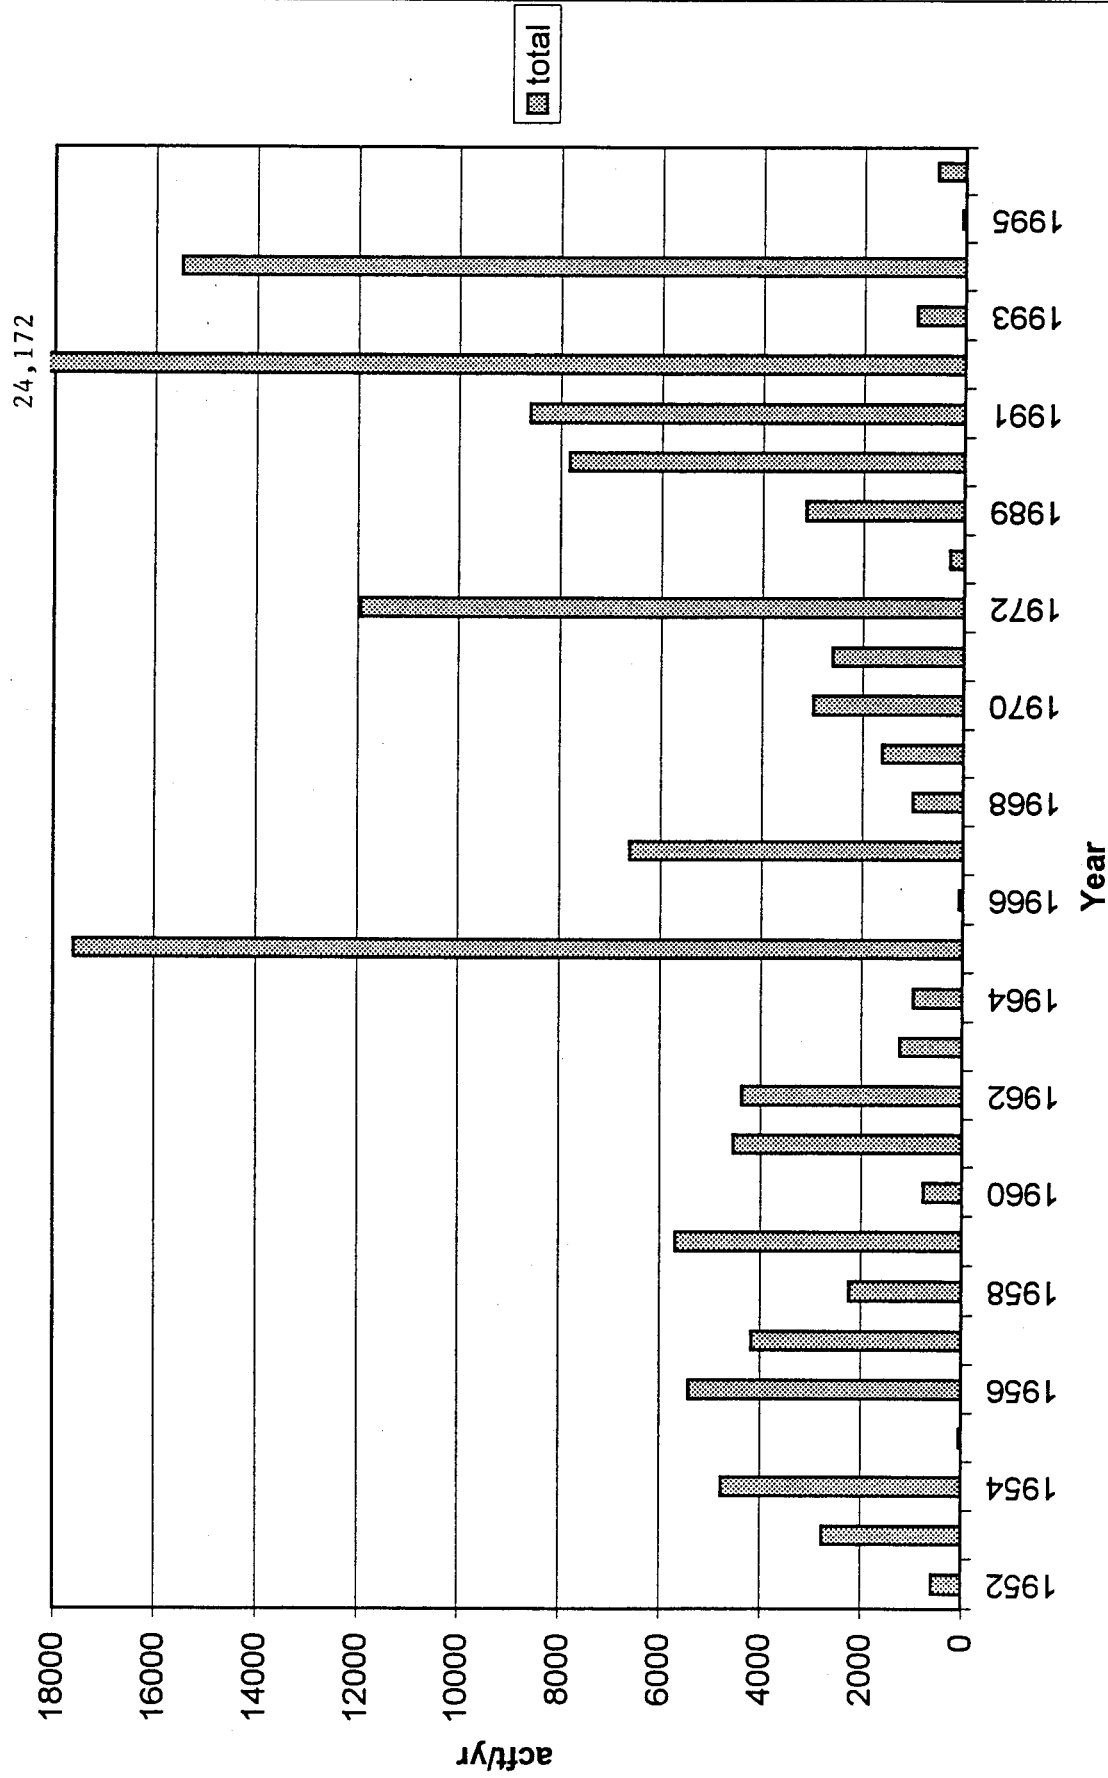
Figure 9. Total annual streamflow (acre-feet/year) for years 1952-1973 and 1989-1996, Rincon Creek.

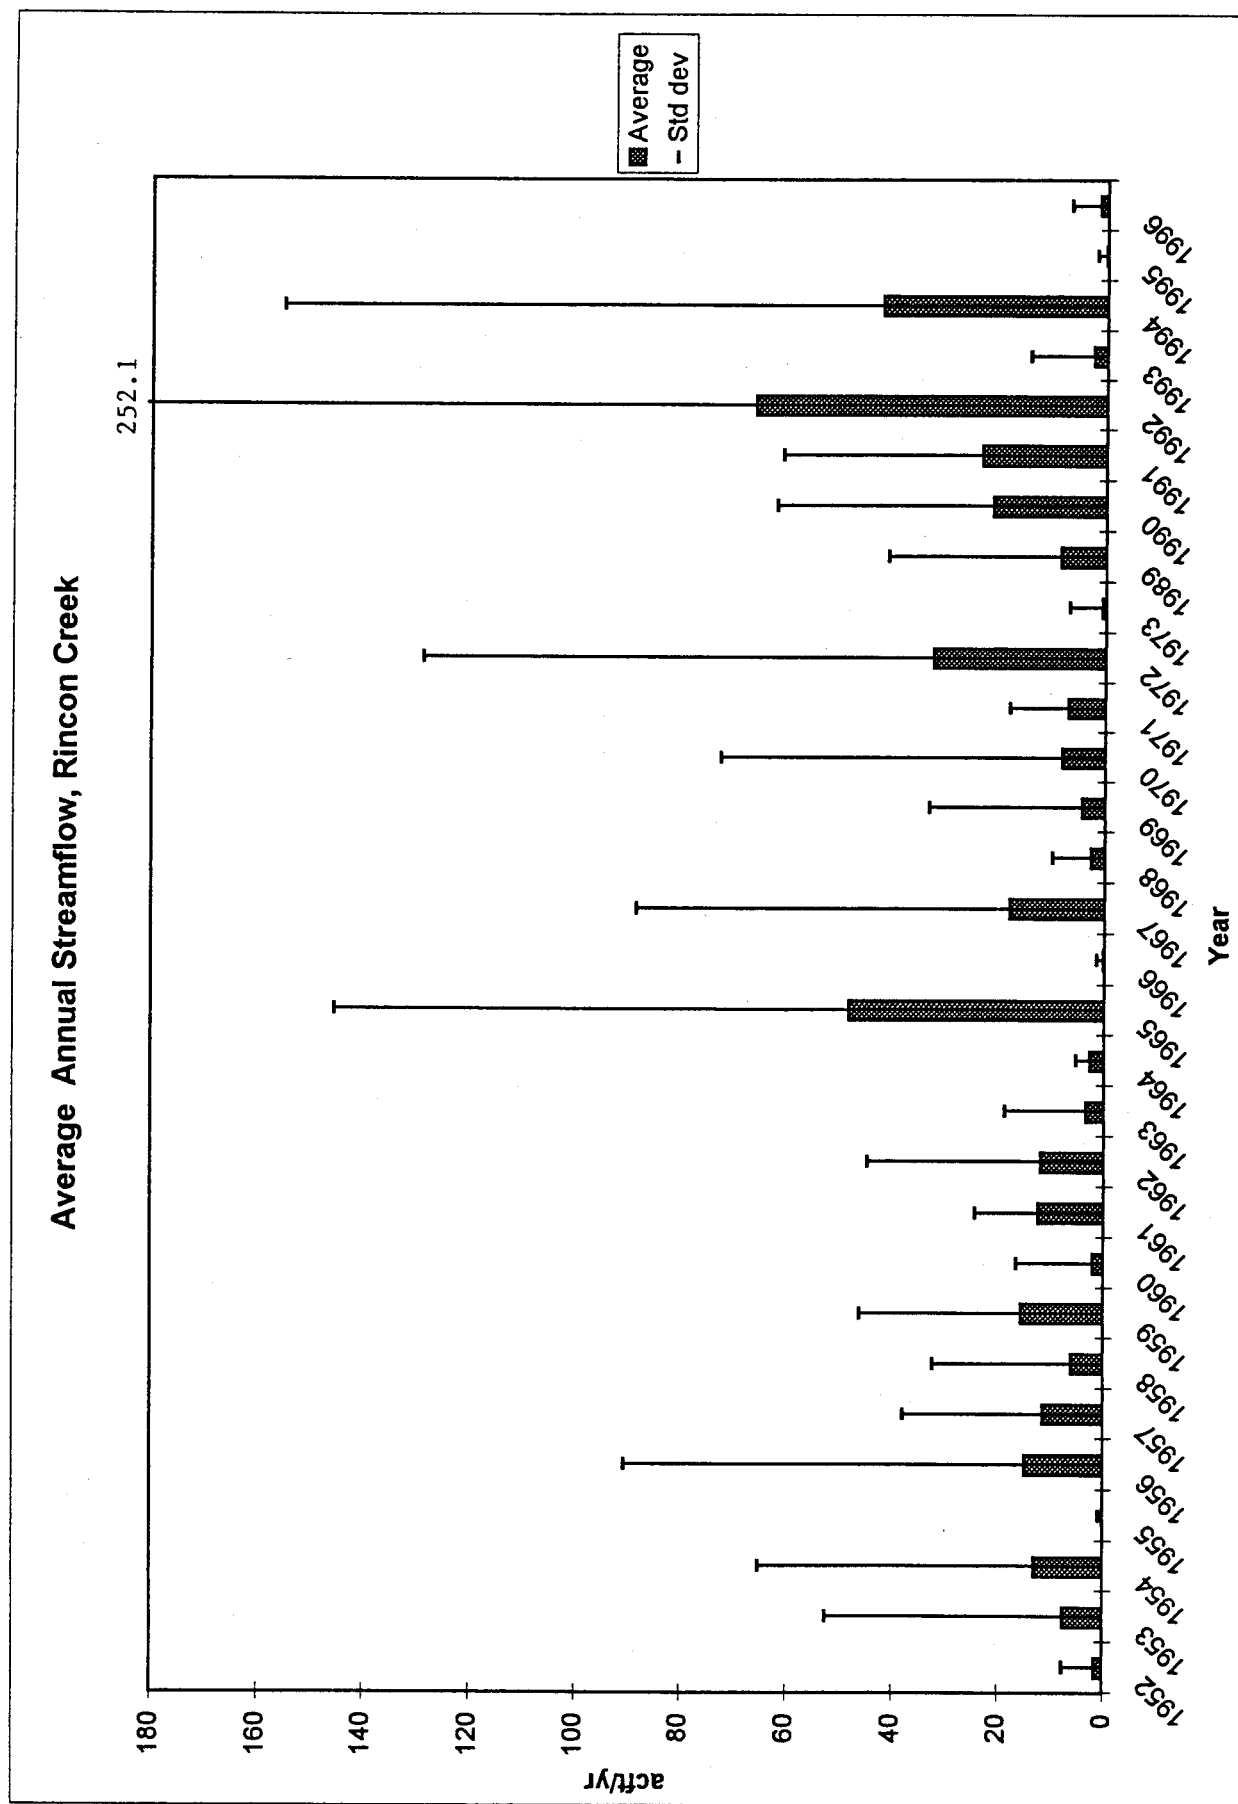
Figure 10. Average annual streamflow plus one standard deviation (acre ft/year), Rincon Creek.

Due to the skewed distribution of flows and the high number of no-flow days, it is often more telling to look at the standard deviation around the mean flow. Figure 10 graphically illustrates the wide fluctuations calculated for each mean. The fact that Rincon Creek has years where the calculated average daily flow equaled or exceeded the total annual flow of other years speaks to the extreme variability in hydrologic conditions.

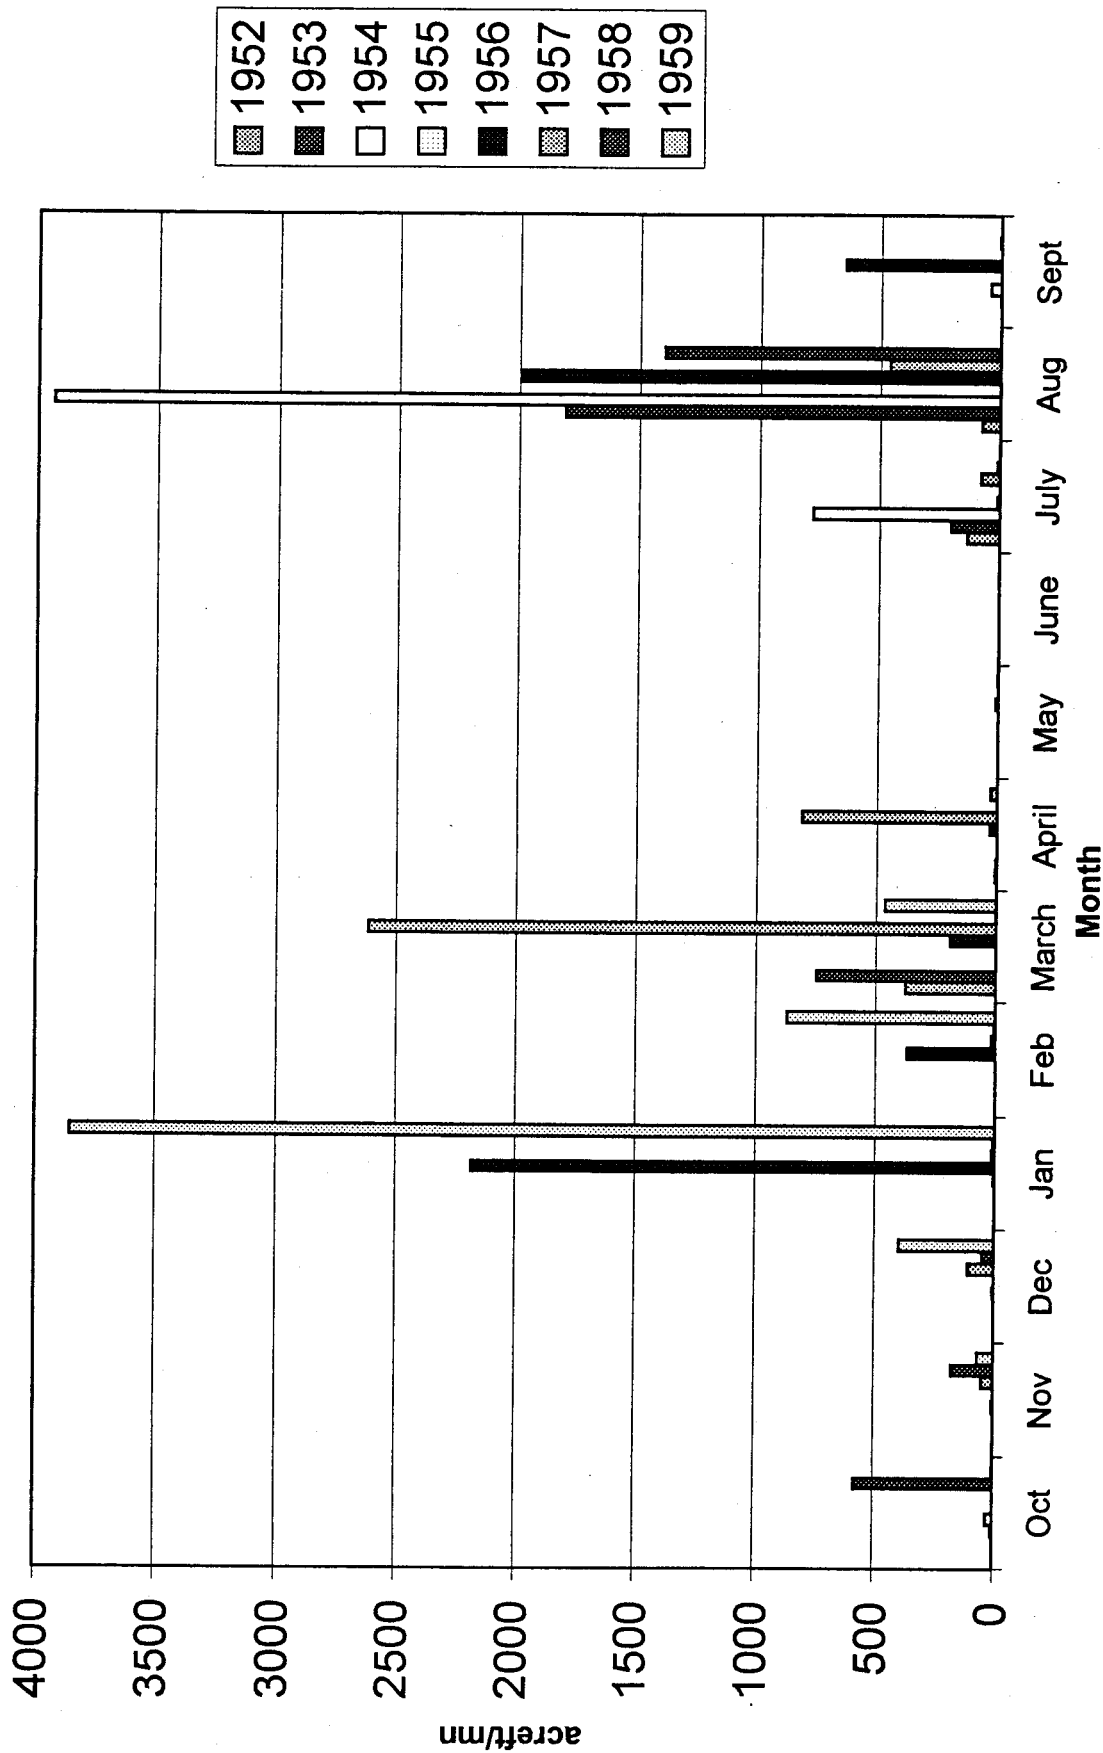
Figure 11. Total monthly streamflow (acre ft/mn) calculated from average daily cfs, Rincon Creek (1950s).

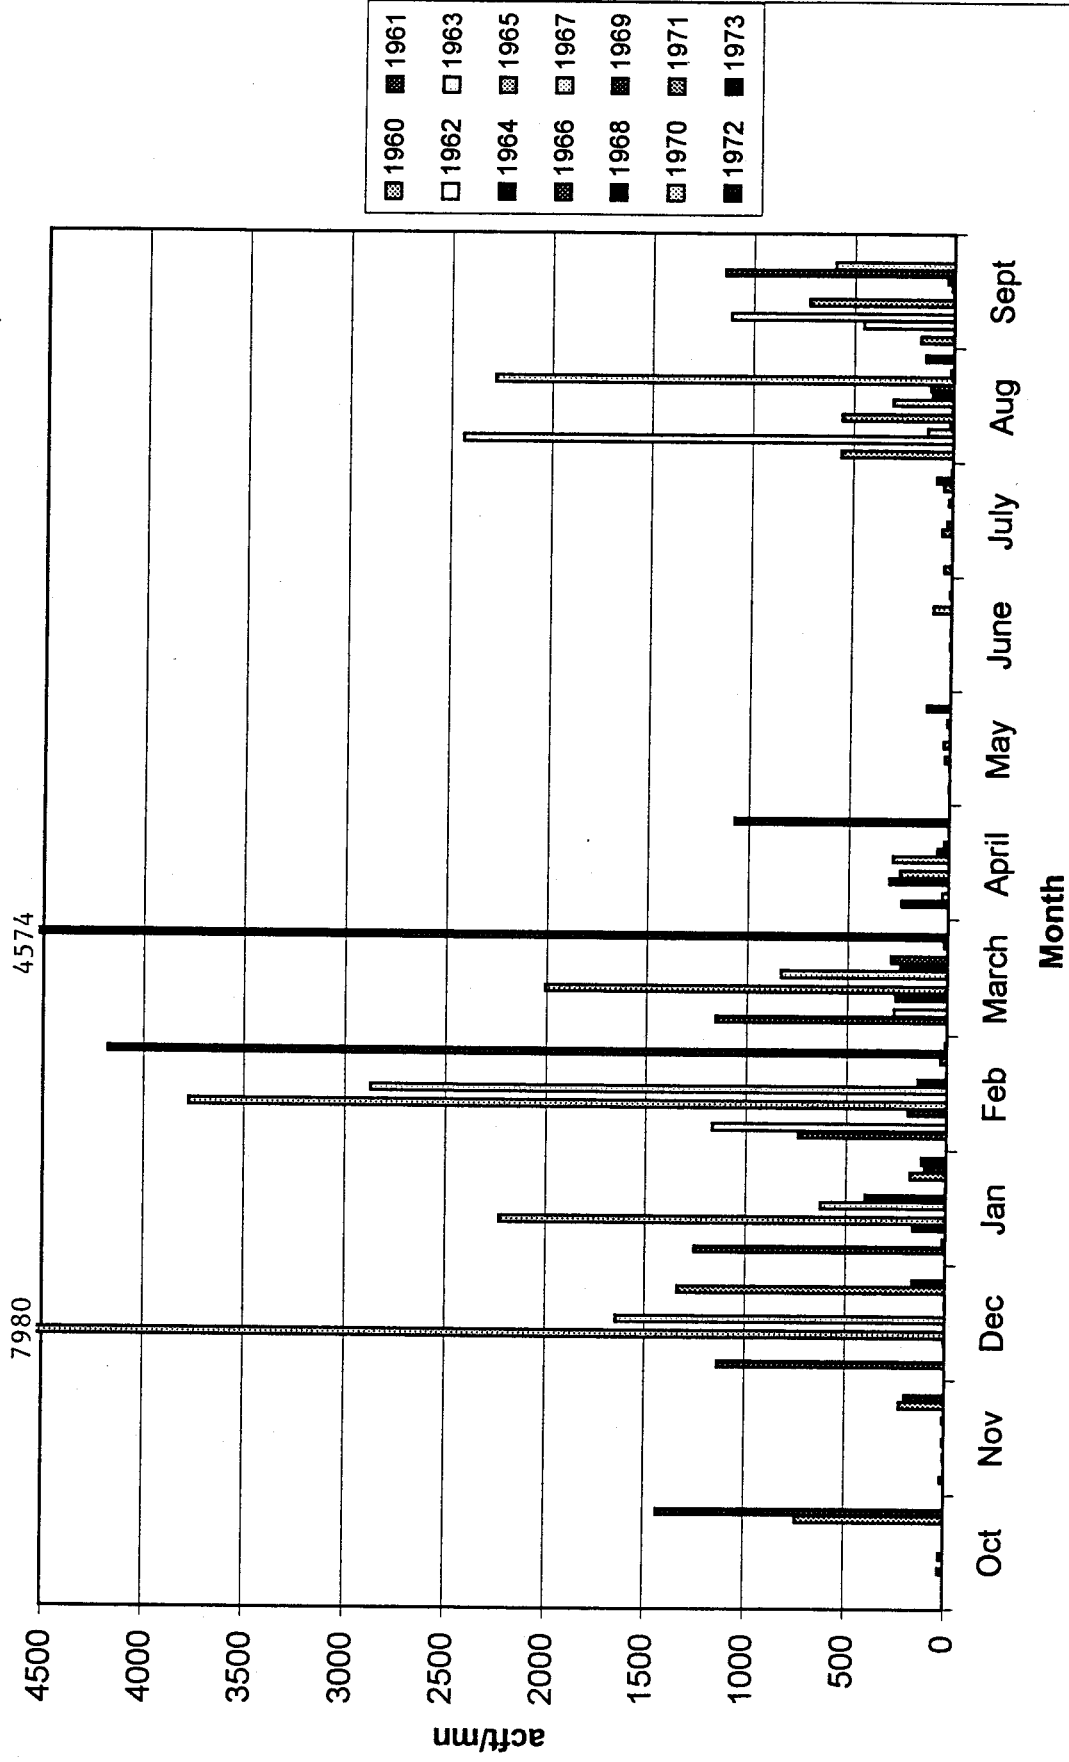
Figure 12. Total monthly streamflow (acre ft/mn) calculated from average daily cfs, Rincon Creek (1960-1973).

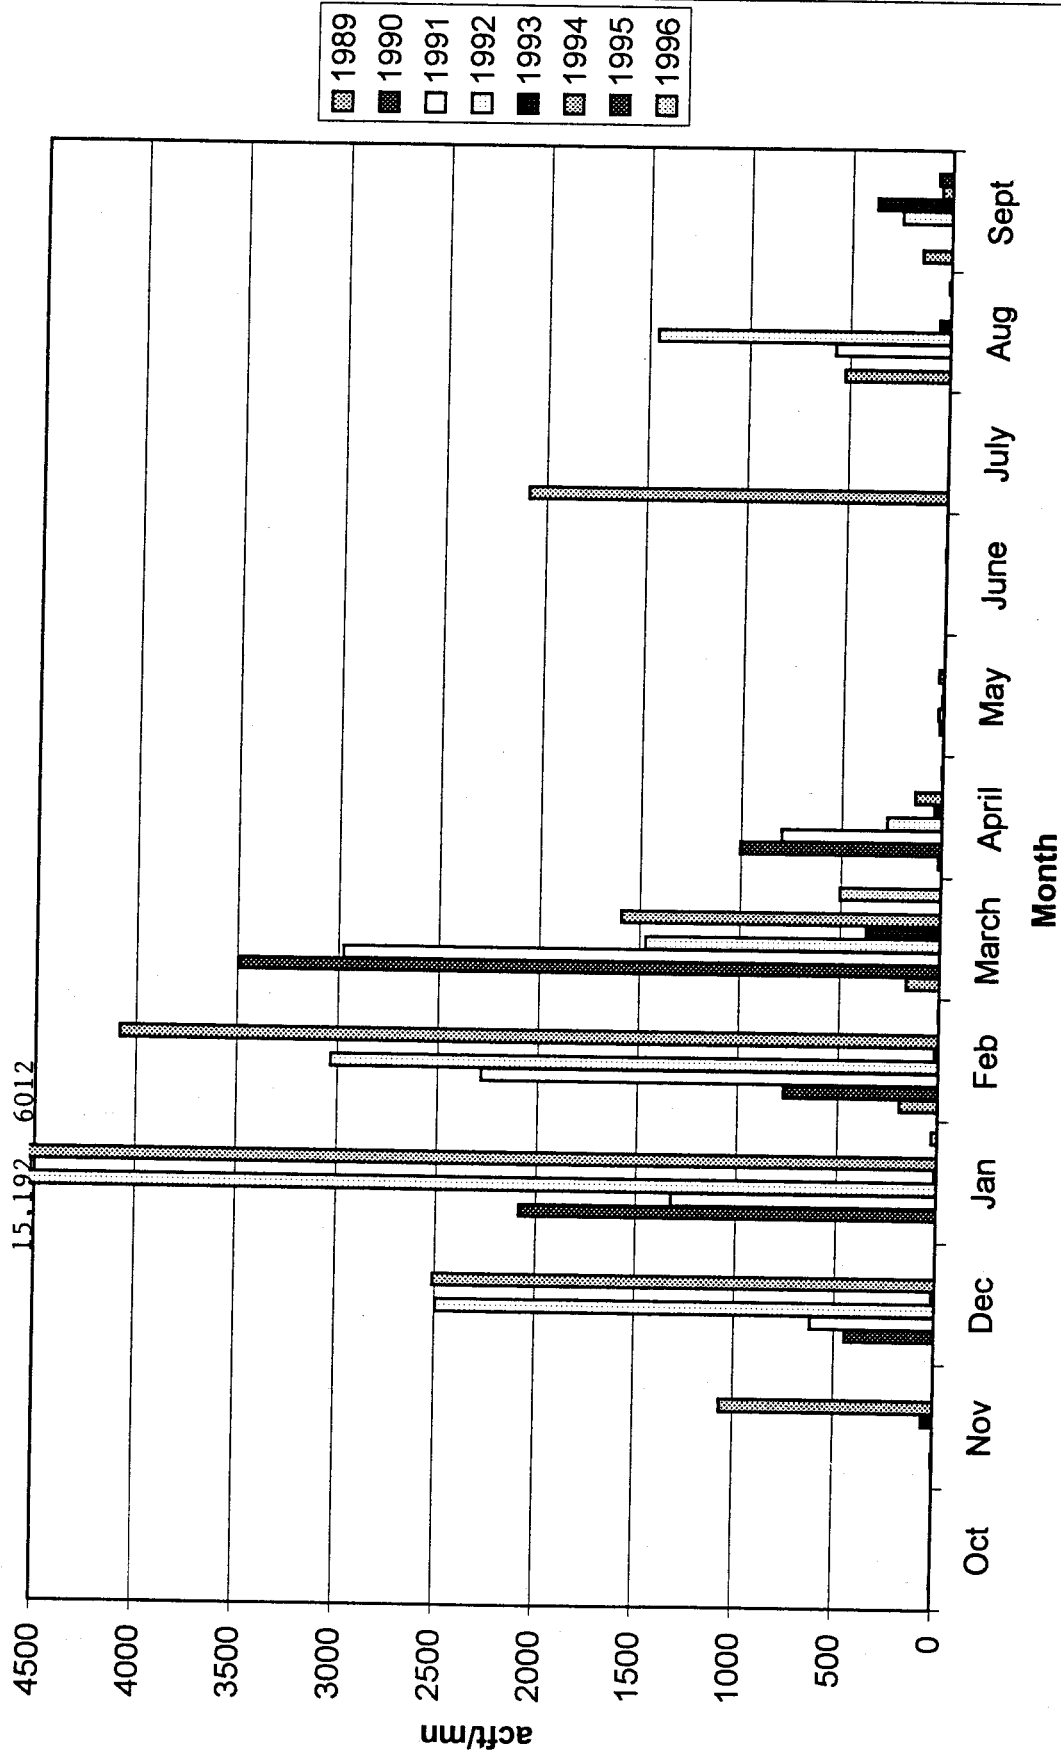
Figure 13. Total monthly streamflow (acre feet/month) calculated from average daily cfs, Rincon Creek (1989-1996).
