HWR No. 01-010

*An Evaluation of Hydrologic and Riparian
Resources in Saguaro National Park,
Tucson, Arizona*

Kathryn J. Baird
Robert Mac Nish
D. Phillip Guertin

Department of Hydrology and Water Resources, and
University of Arizona Research Laboratory for Riparian Studies
University of Arizona
Tucson, Arizona 85721

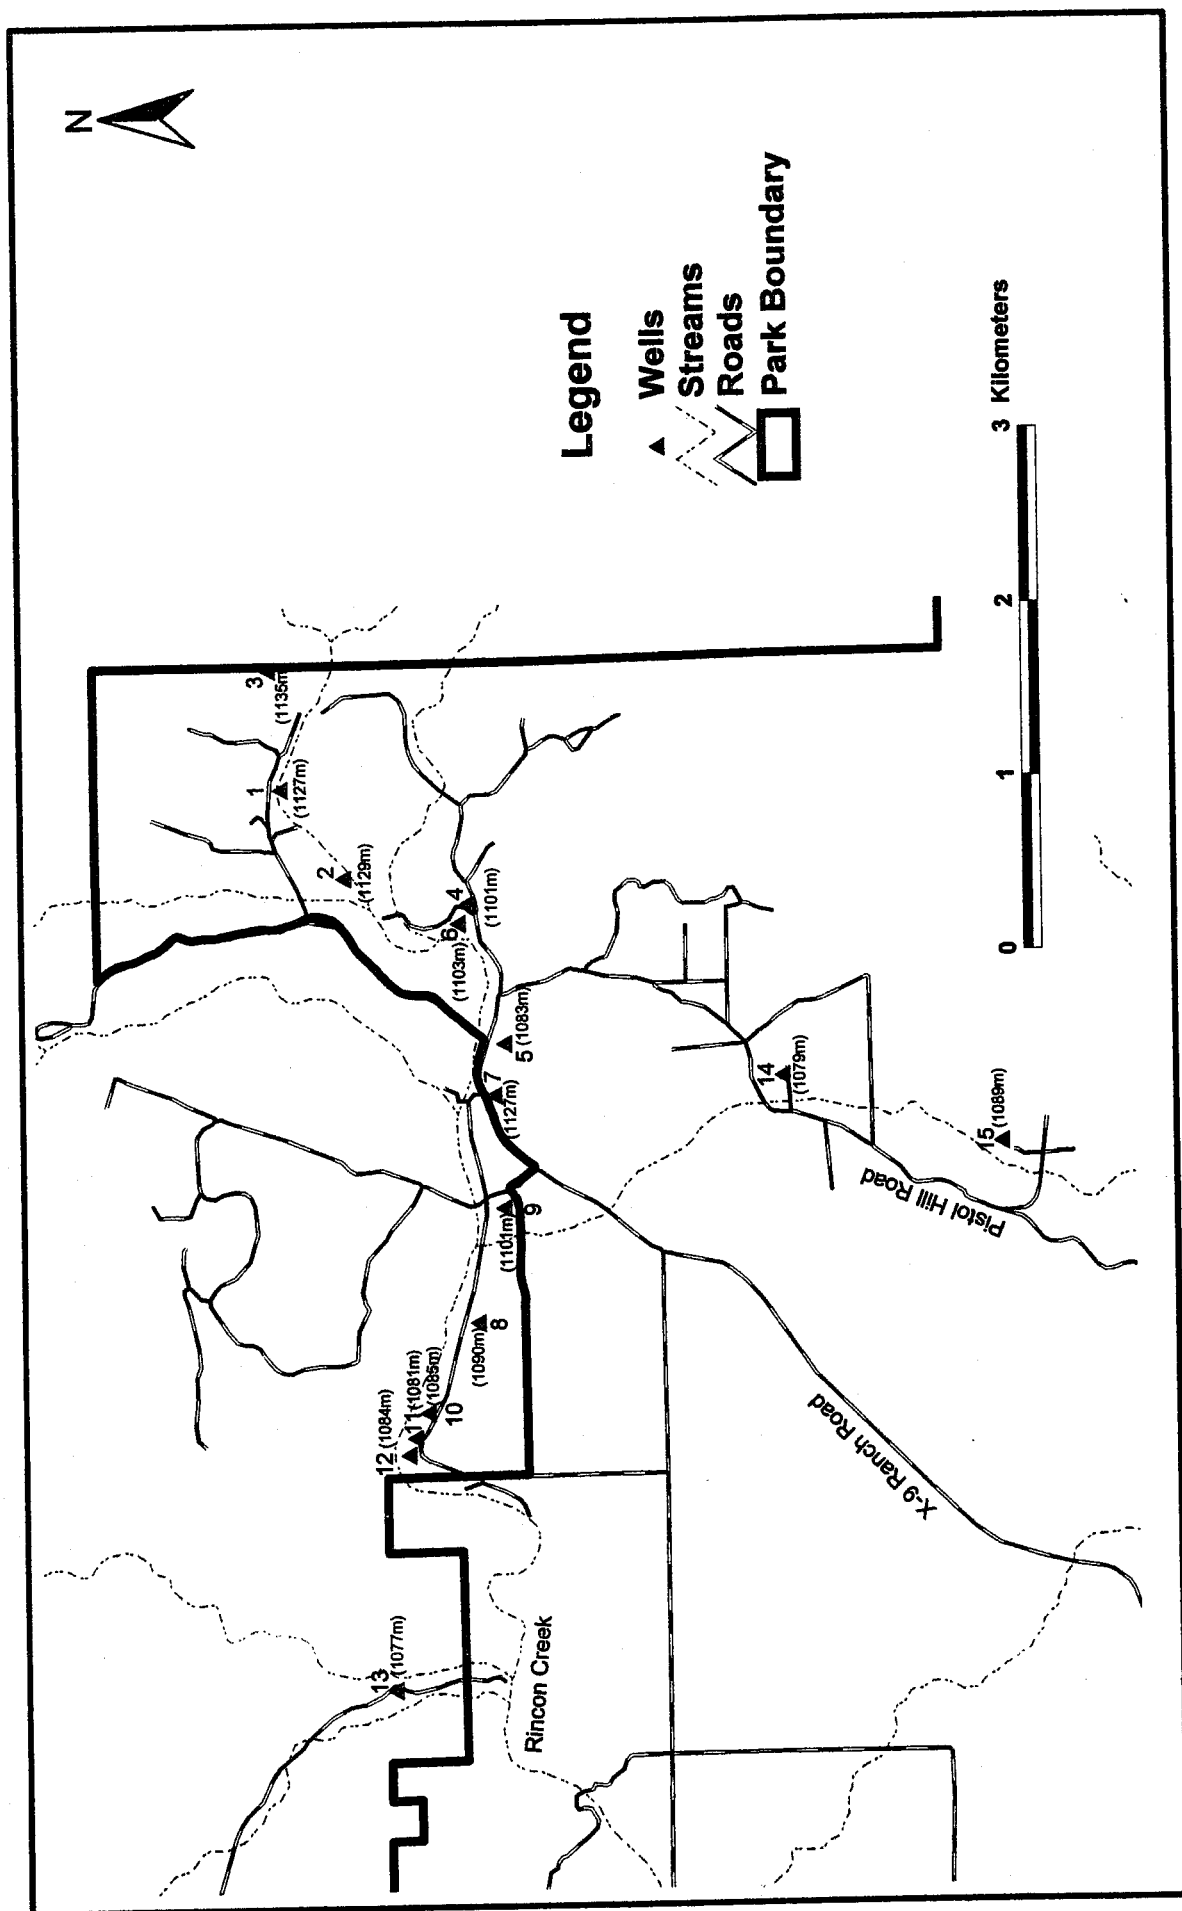
Figure 14. Existing well locations with reported water table elevations (meters above NGD).

Well data was collected for the entire Saguaro National Park area including the following six USGS township (T) and range (R) parcels: T14SR16E, T14SR17E, T14SR18E, T15SR16E, T15SR17E, and T15SR18E. This information has been forwarded to the Parks. Table 3 lists the wells that lie within or adjacent to the expansion area, the northern section of T15SR17E, and the primary focus of this study. If only one measurement date is given it coincides with the well drilling process. In only five cases were repeat water level measurements taken. Figure 14 illustrates water table elevation and the approximate location of the wells with sufficient location data.

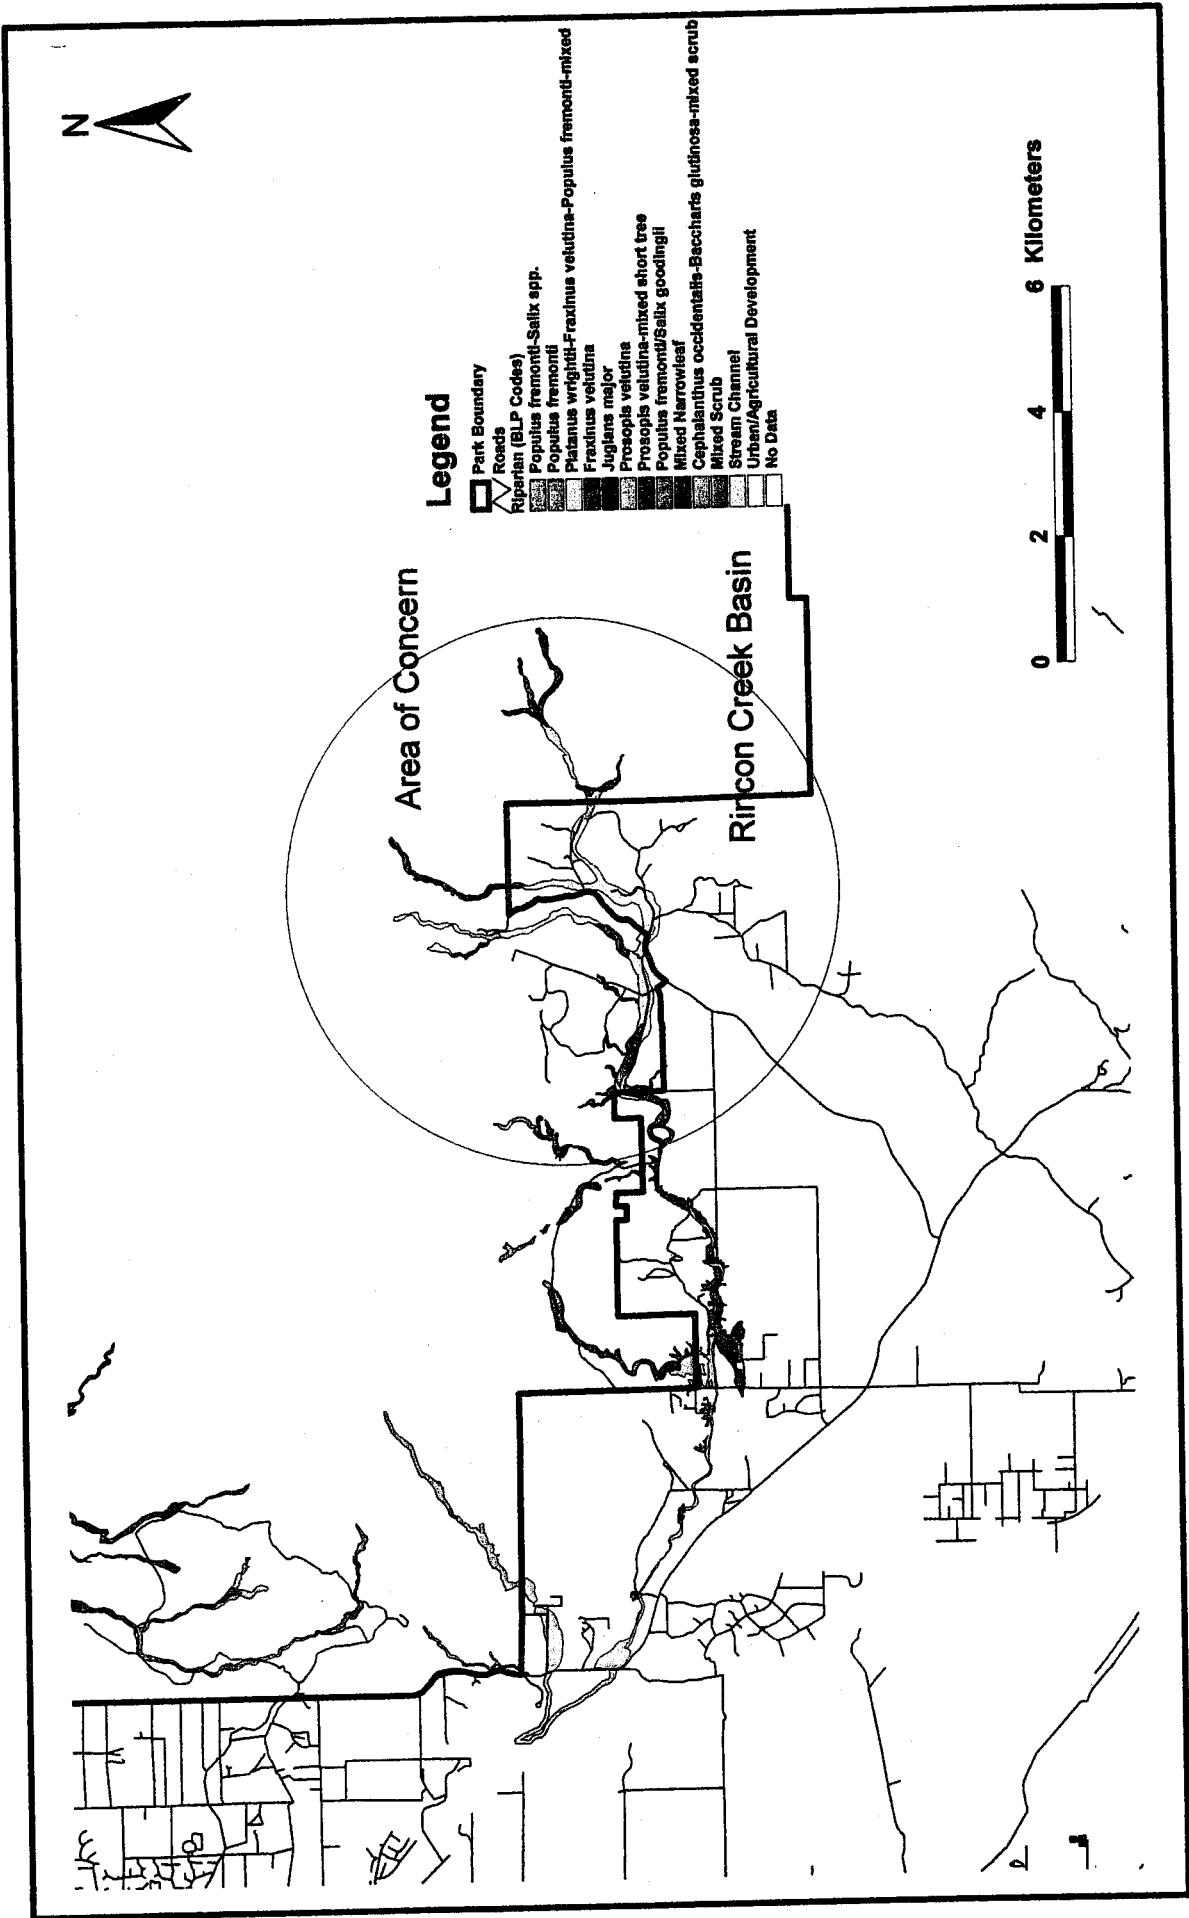
Figure 15. Riparian areas: Rincon Creek and tributaries.

Chimenea, Madrona and upper Rincon Creeks all support valuable habitats (Figure 15). At the higher elevations, 1000-1220 meters, mixed narrow leaf community dominates. This habitat type is characterized by *Prosopis velutina*, *Acacia greggii*, *Parkinsonia* spp., *Chilopsis linearis*, *Celtis* spp., *Baccharis salicifolia*, and *Cephalanthus occidentalis*. Based on previous mapping efforts *Gossypium thurberi*, *Jatropha cardiophylla*, *Muhlenbergia* spp., *Celtis pallida*, and *Lysiloma microphylla* also contribute to this vegetation type. Considered a xeroriparian community, this habitat type is an important resource to the Park. Below 1000 meters, these reaches are dominated by a more typical riparian community of *Platanus wrightii*, *Fraxinus velutina* and *Populus fremontii* with pockets of just *Fraxinus velutina* interspersed.

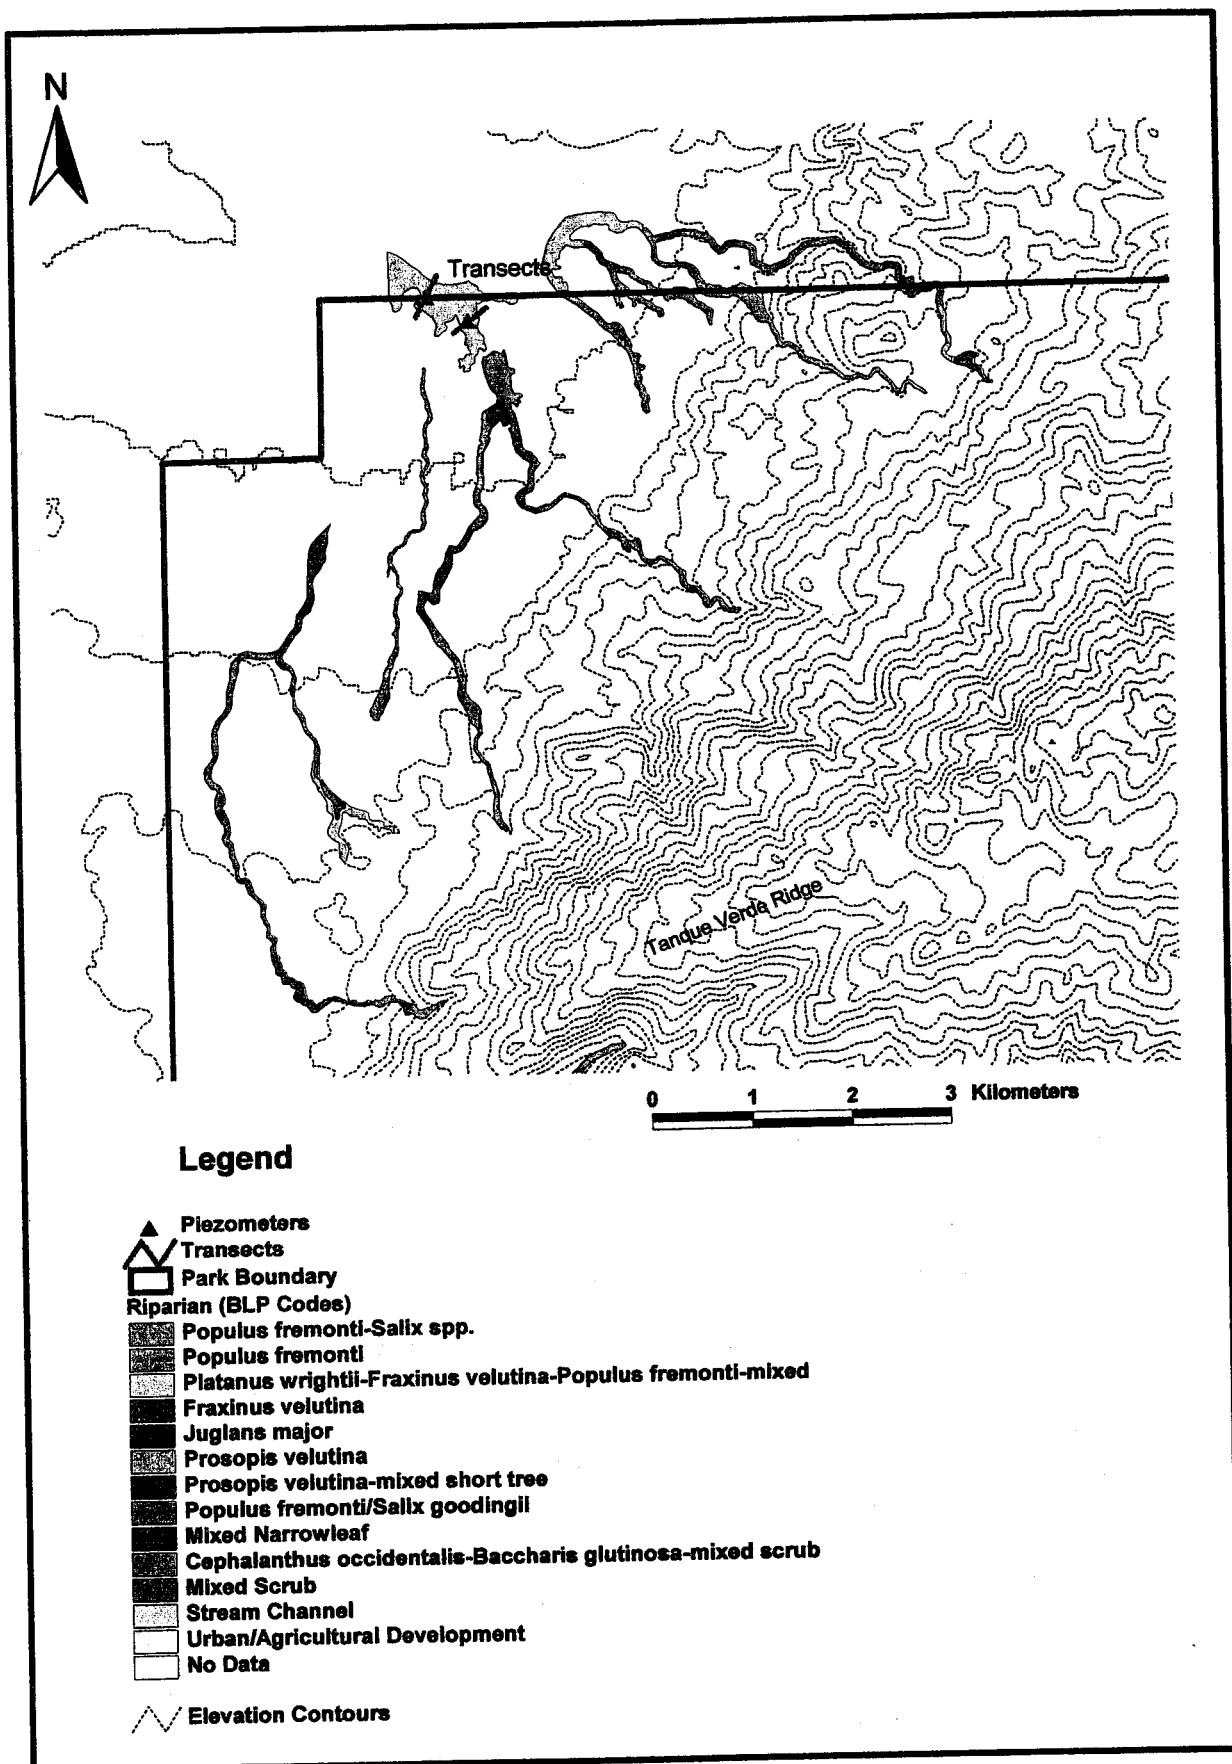
Figure 16. Riparian areas: Tanque Verde Creek tributaries.

Task 2. Streambed: Annual cross-sectional survey of the four transects on Rincon Creek (locations noted on Figure 17), on selected upper watershed tributaries of Rincon (locations to be field determined) and the two Tanque Verde bosque transects (Figure 16).

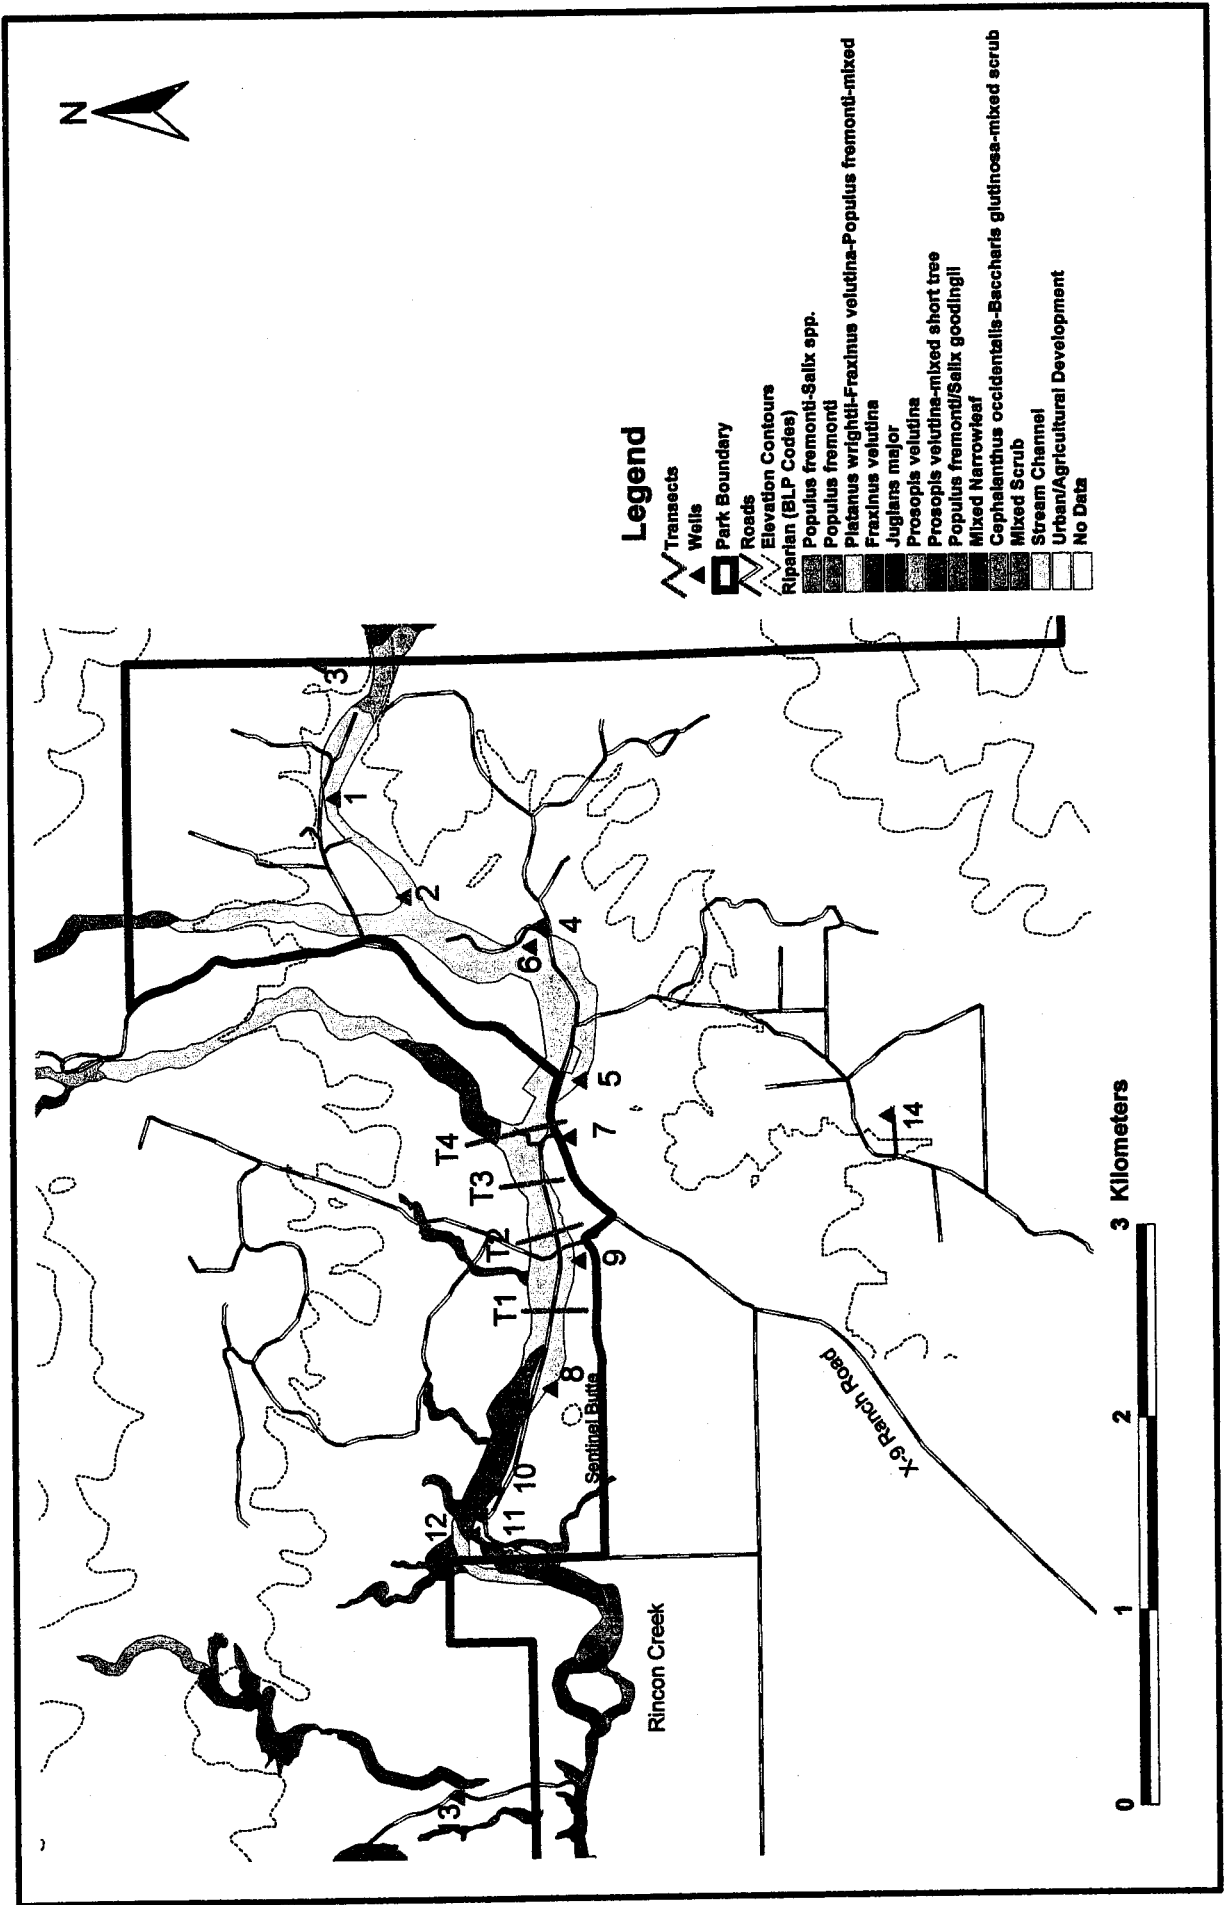
Figure 17. Middle basin riparian areas: Rincon Creek.
