Groundwater Level Changes in the Tanque Verde Valley UPDATE

Sonoran Desert Conservation Plan

Re: **Groundwater Level Changes in the Tanque Verde Valley**

Groundwater Level Changes in the Tanque Verde Valley
November, 2001
by Elizabeth Hill and Julia Fonseca

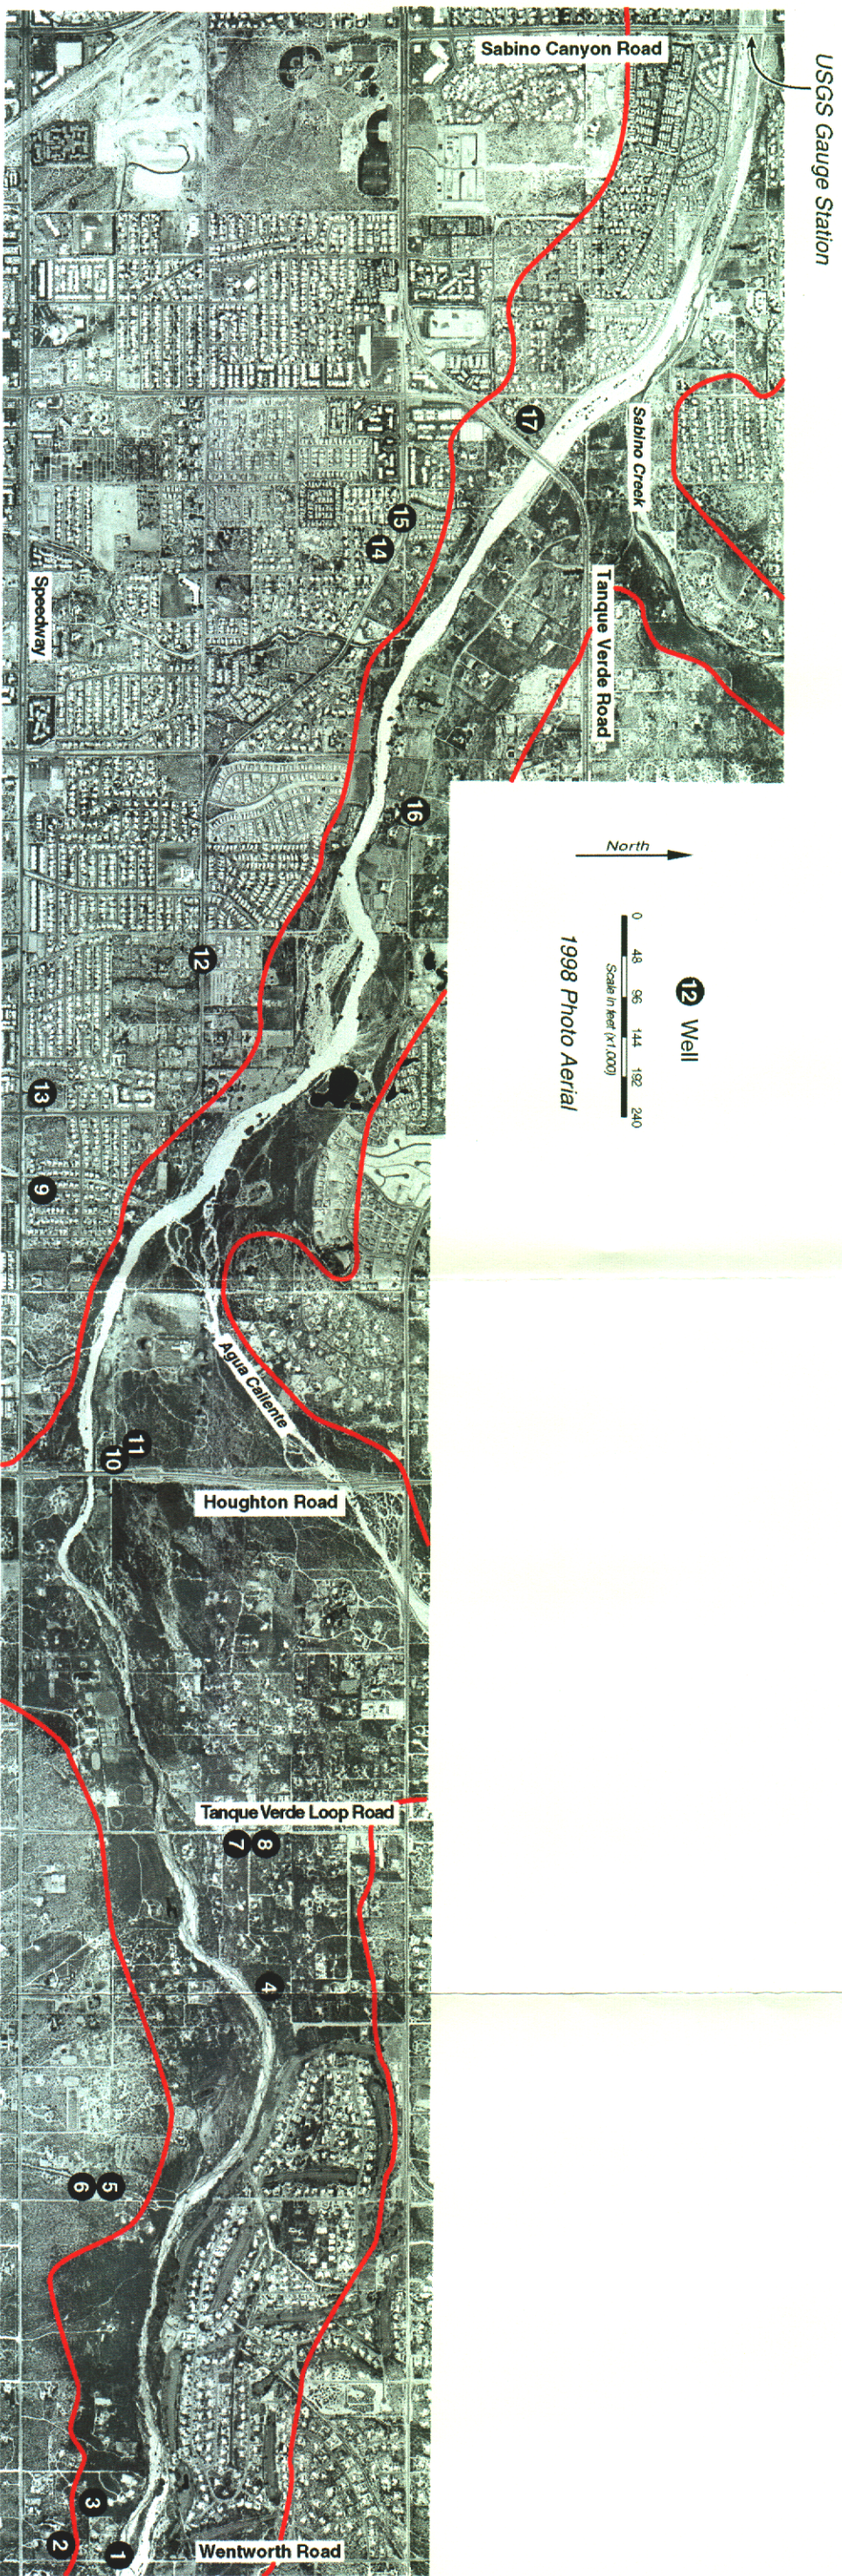
Figure 2. Location of wells used in this study

Approximate boundary of riparian corridor as inferred from 1941 aerial photography.

Figure 2 shows an aerial photo of the study area (1998). Tanque Verde Creek has natural earthen banks upstream of Houghton Road, except for a few isolated locations where bank stabilization has been constructed by individual property owners. Hydro-mesoriparian habitat has been mapped across much of the floodplain from Wentworth Road to Houghton Road. The presence of a significant stand of continuous riparian vegetation is one of Tanque Verde Creek's most distinguishing characteristics (Pima County Flood Control, 2001).

The 17 well locations are shown on Figure 2 and the wells are described in Appendix B. For ease of reference, Tucson Water well names have been numbered simply from 1 to 17, beginning at Wentworth Road and proceeding downstream. Water surface elevations in wells located upstream of Houghton Road are generally higher; the direction of groundwater movement is generally westerly.

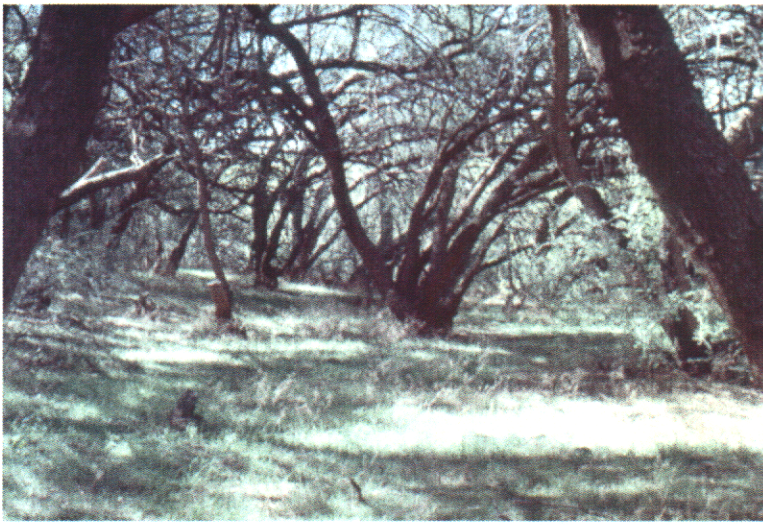
Figure 3. Decline of Mesquite Bosques

Healthy mesquite bosque, Cienega Creek (groundwater level at approximately 20 feet).

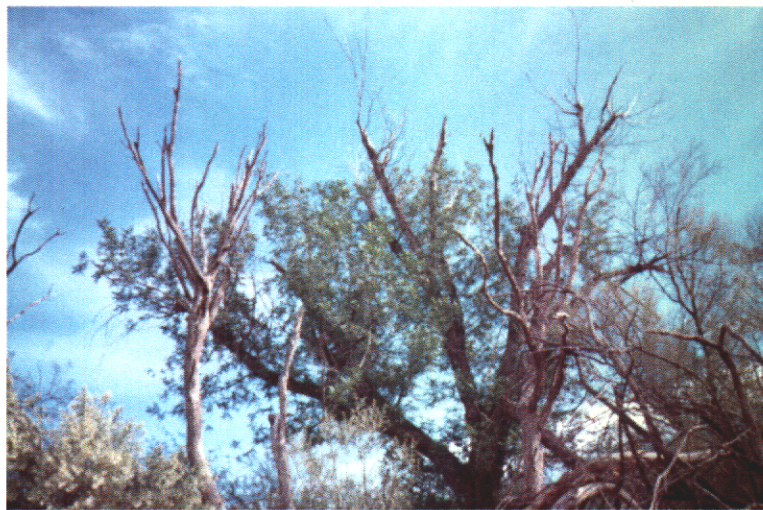
Canopy dieback, Tanque Verde Creek at Pantano Wash
November 1999 (groundwater level at approximately 50 feet).

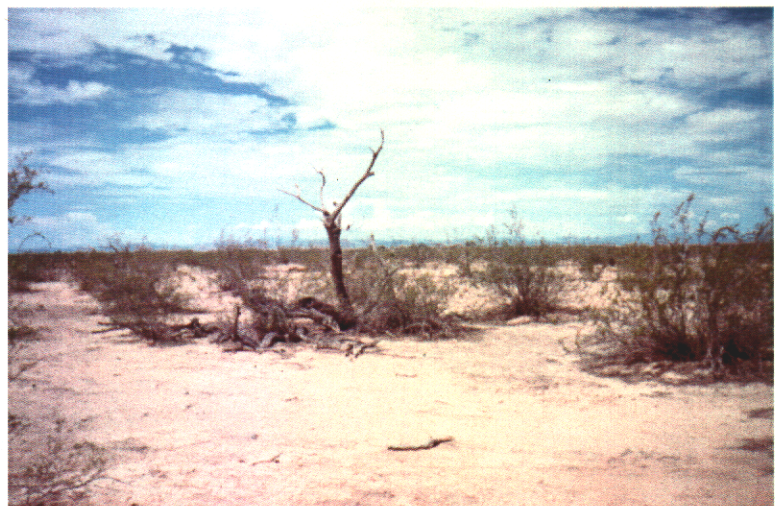
Former mesquite bosque, Casa Grande (groundwater level at approximately 100 feet).

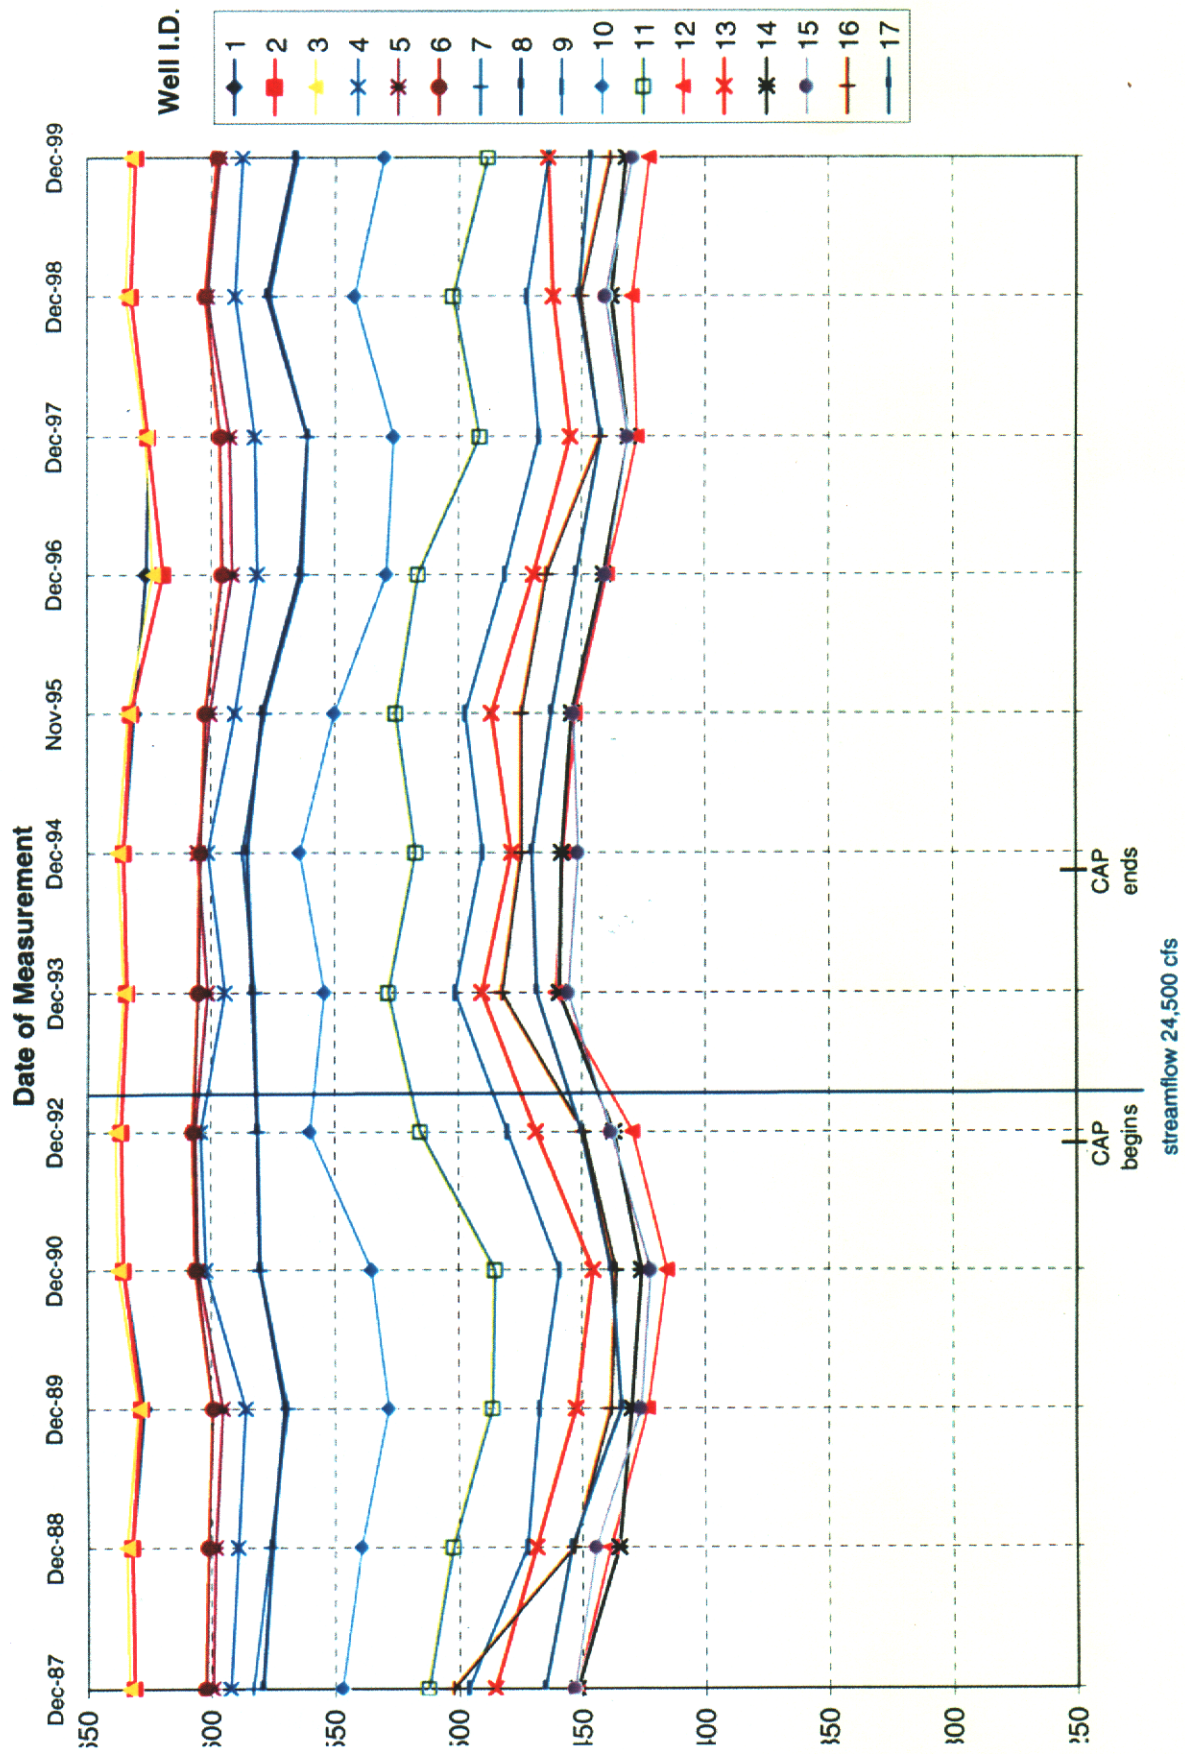
Figure 4. Water surface elevations

Groundwater profiles in Figure 4 show the water surface elevations generated for the 12 year period. Groundwater profiles in Figure 5 show the depth-to-water below land surface. The depth-to-water ranges from 6 to 161 feet. According to the Stromberg study, mesquites are stressed when water depths are between 16 and 59 feet, while near-lethal and lethal stress occurs in mesquites at water levels greater than 59 feet. As shown on Figure 5, only water levels in wells 1-3 are

Two significant dates of Central Arizona Project (CAP) water delivery are noted on Figures 4 and 5, with delivery beginning in November 1992, and phasing out approximately two years later in October 1994. As CAP water was introduced to the potable water delivery system, Tucson Water began taking water supply wells out of production, notably in their Central Wellfield.

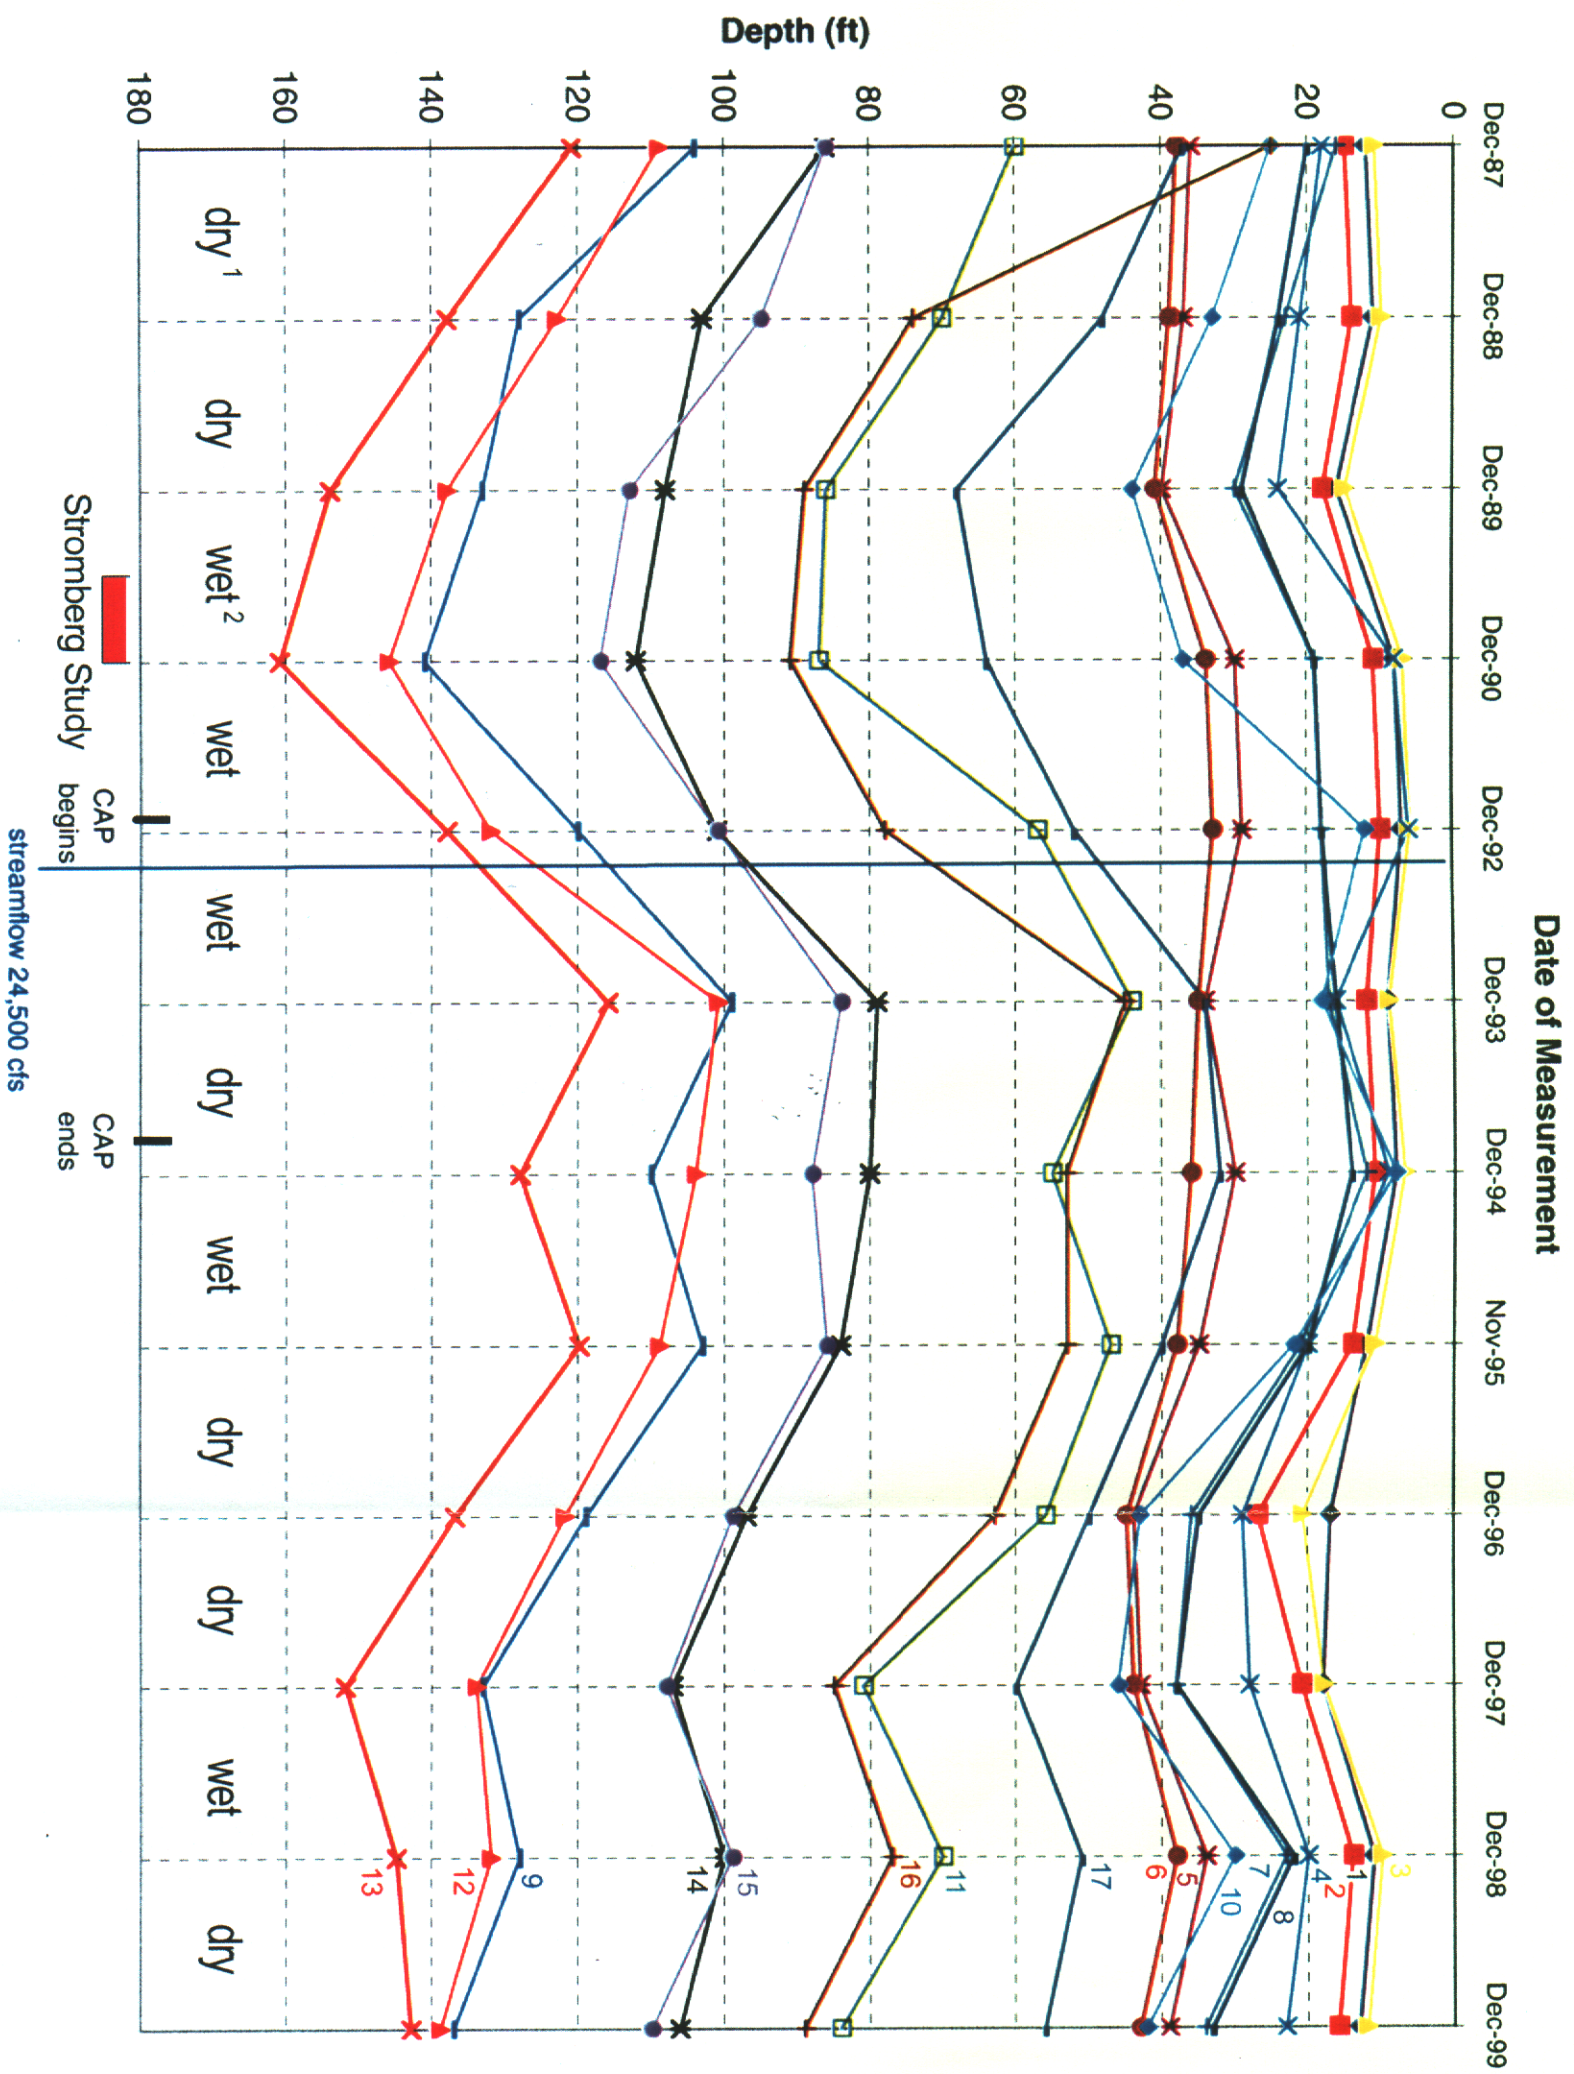
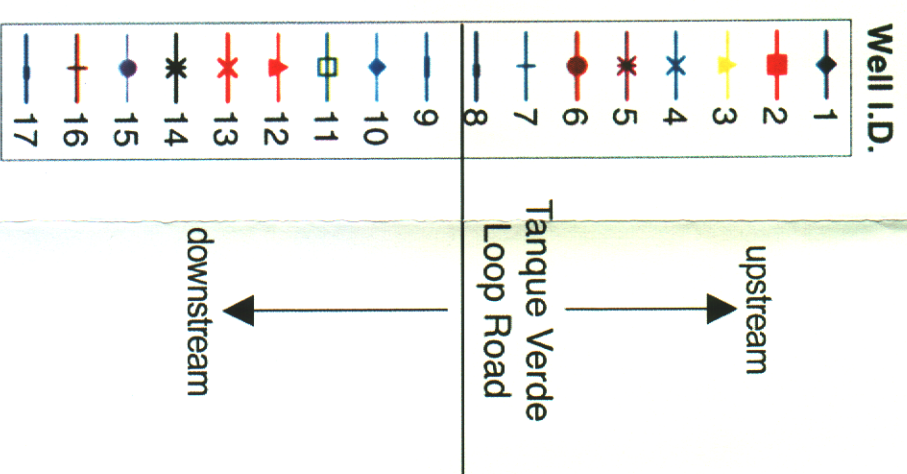
Figure 5. Depth - to - Water below land surface

generally less than 16 feet; in wells 4-10, levels are between 16 and 59 feet; and in wells 11-17, levels are generally greater than 59 feet. Wells 1,3,4,7,8,10,11,16 and 17 are at or close to the elevation of the mesquite bosque. Areas of former mesquite bosque were interpreted from 1941 aerial photographs.

dry¹ year < 18,000 AF / annual stream flow

wet² year > 18,000 AF / annual stream flow

"Wet" and "dry" years are labeled on Figure 5 and refer to an average annual discharge of approximately 18,000 AF (calculated from the 18 year period of record at the gauging station). A "dry" year thus refers to less than 18,000 AF average annual runoff. A multi-year drought was occurring prior to and during the beginning years of the graph, 1987 to 1990. Water years 1994, 1996 and 1997 were also extremely dry.

In order to visually describe the effect of runoff on aquifer recharge, "wet" and "dry" years can be compared to the fluctuating depth-to-water profiles on Figure 5. Very generally, there appears to be a decline in water levels following "dry" water years such as 1994, 1996 and 1997, and a rise in water levels following "wet" water years such as 1993 and 1995, suggesting that streambed recharge affects groundwater levels along the Creek. All of the wells do not exhibit this rise-and-fall

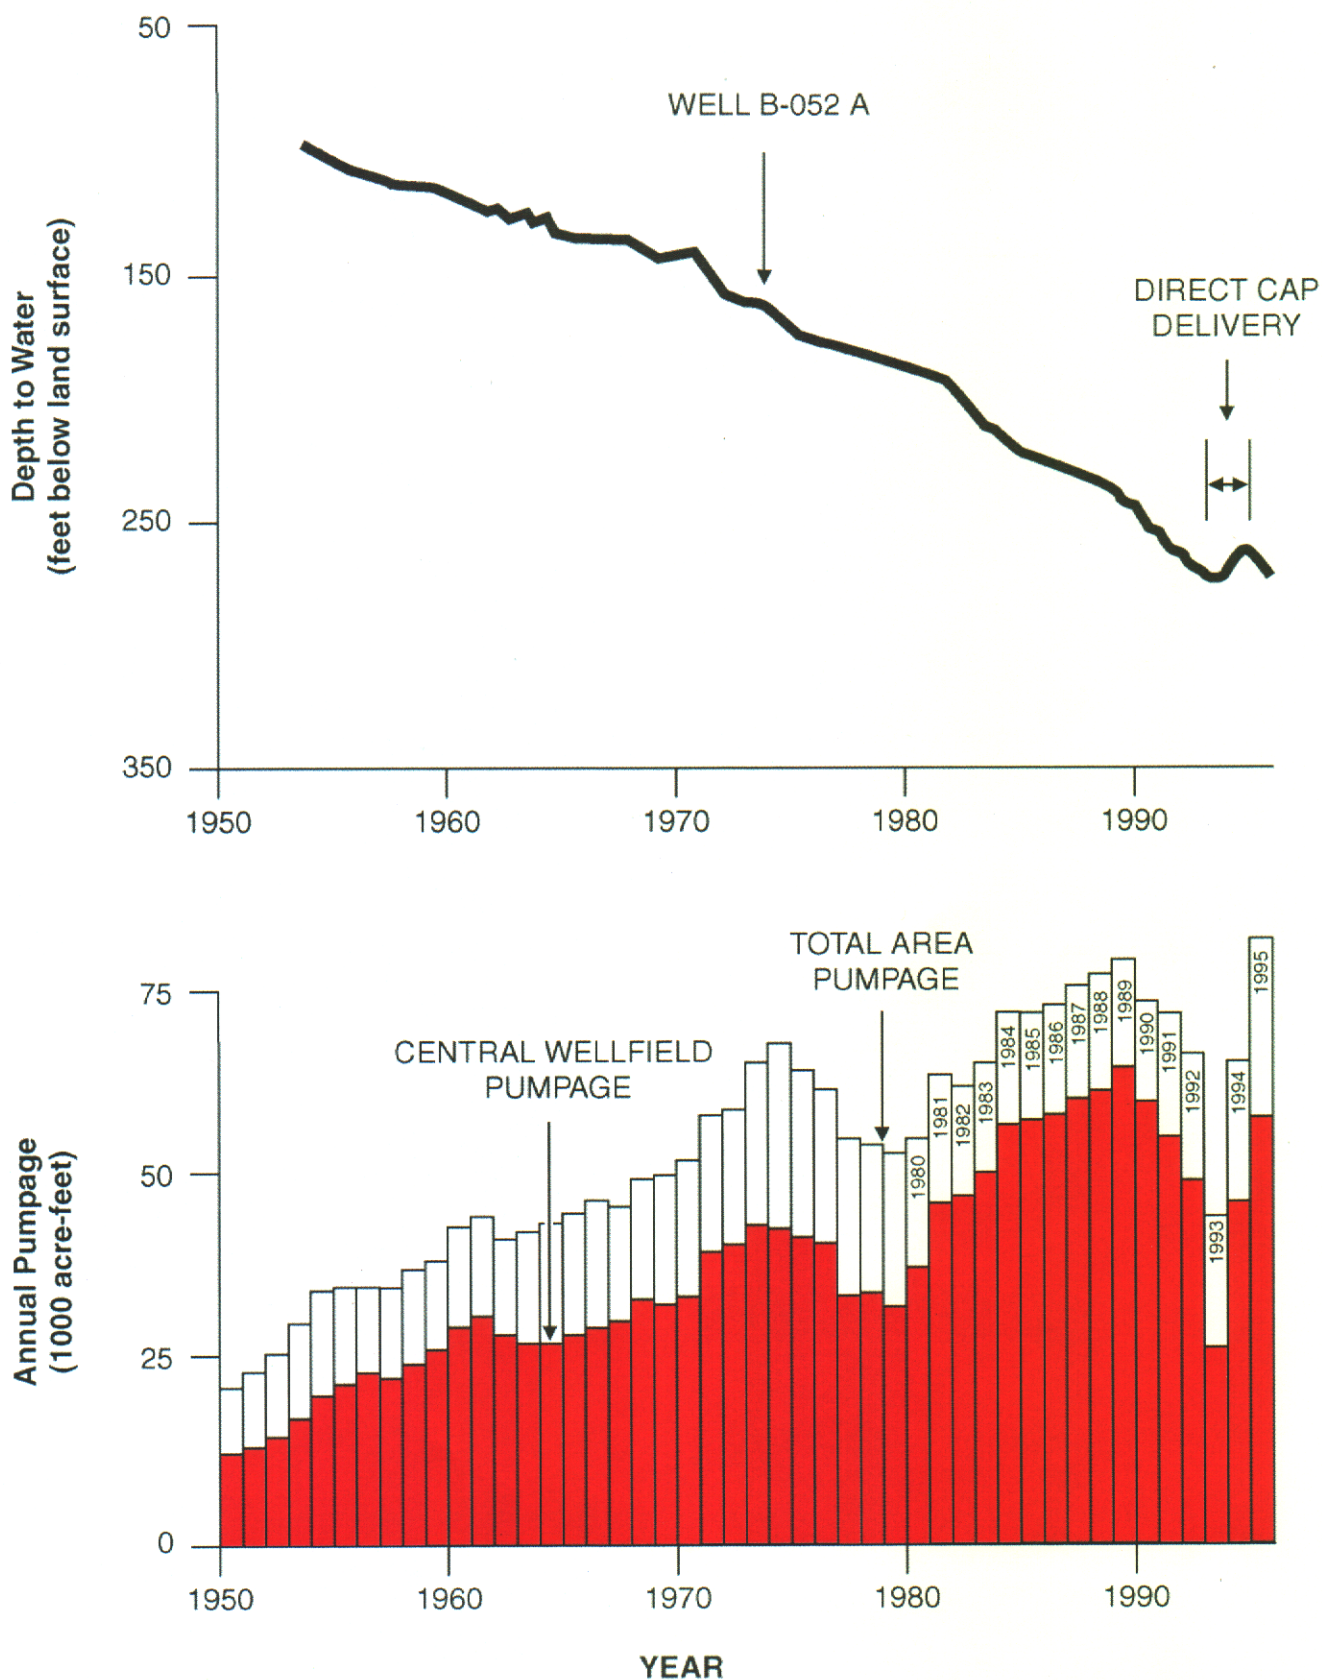
Figure 7. Tucson Water Central Wellfield Pumpage and Hydrographs of Well B-052 A

The graphs in Figure 7, extracted from a City of Tucson report (1996), illustrates the general effect CAP water delivery had on pumping in the Central Wellfield, and on total area pumping. A continuous hydrograph of Well B-052A, located in the Central Wellfield near Grant/Craycroft, shows a rise in water surface elevation during CAP delivery and supply well shutdown. In 1993, with CAP water supplementing the delivery system, there was a significant decrease in total area pumping, when compared to previous years. Inspection of Figure 5 Depth-to-Water in 1993 shows that the reduction in pumping coupled with a very wet year resulted in rising water surface levels in the deeper wells. However, in the dry year of 1994 when consumer demand increased (Figure 7) and CAP was being phased out, water levels declined in the deeper wells. (Figure 5). Shallow wells did not show consistent water level fluctuations for those years.

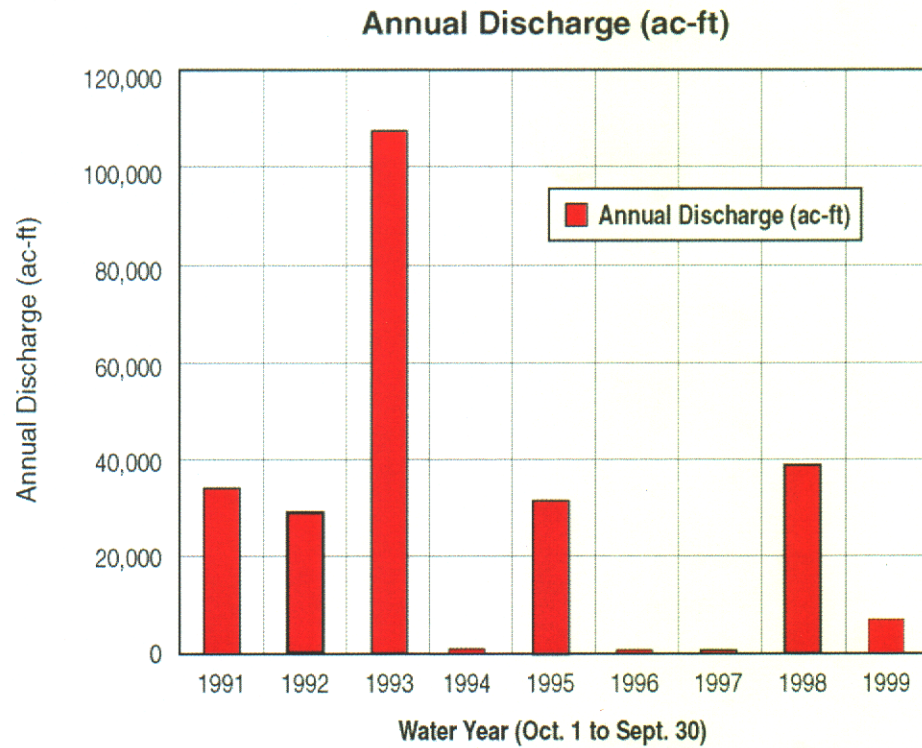
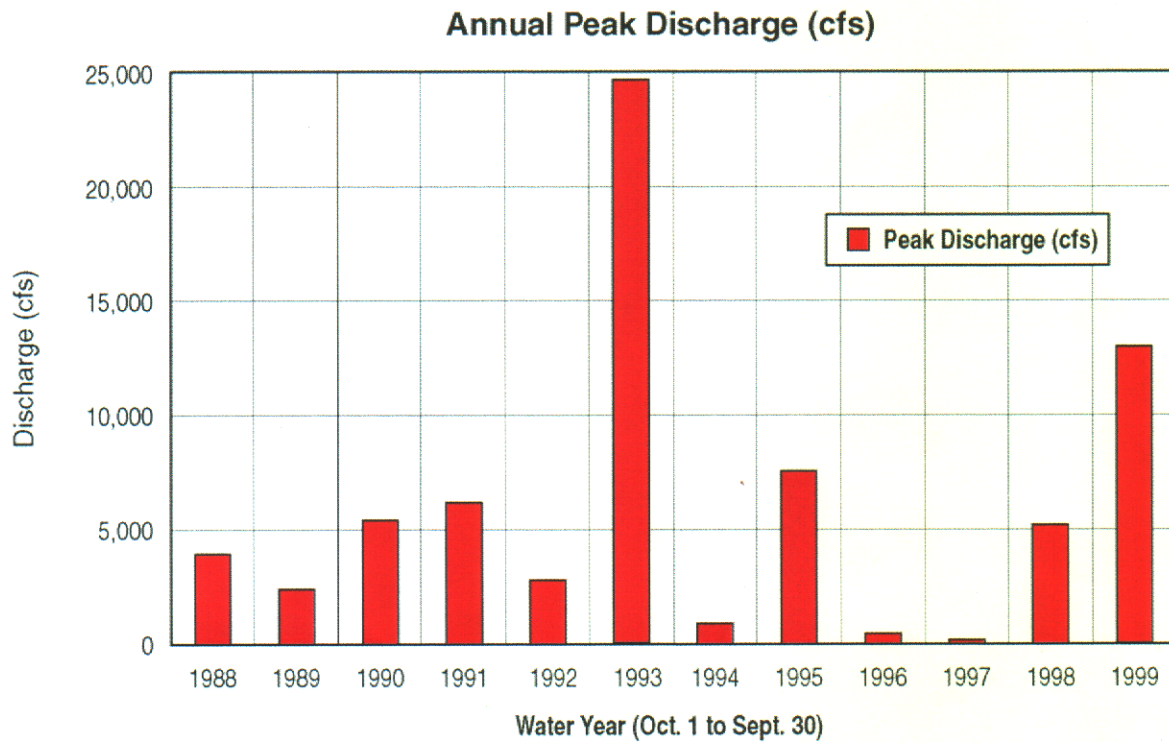
Figure 8. Tanque Verde Creek USGS Gauge #984500

The United States Geological Survey operates a gauging station at Site #09484500 located at the intersection of Sabino Canyon Road and Tanque Verde Creek (Figure 2). The Tanque Verde Creek streamflow data shown in Figure 8 are for Water Years (October 1 to September 30).

Total annual streamflow in acre-feet (AF) was available for eight years, 1991 to 1999 (Figure 8, top). Water Year 1993 was significant with over 100,000 AF.

Annual peak streamflow in cubic feet per second (cfs) was available for the 12 year study period (Figure 8, bottom). Water Year 1993 was significant with a peak flow of 24,500 cfs, while the peaks in the previous years are much less than the 100 year event for the gauging station.
