SUBJECT: **Cienega Creek Natural Preserve Surface Water and Groundwater Monitoring  
Annual Report for the 2009-2010 Fiscal Year**

# Pima County's Cienega Creek Natural Preserve

Surface Water and Groundwater Monitoring Project – PAG Annual Report

Fiscal Year 2009 - 2010

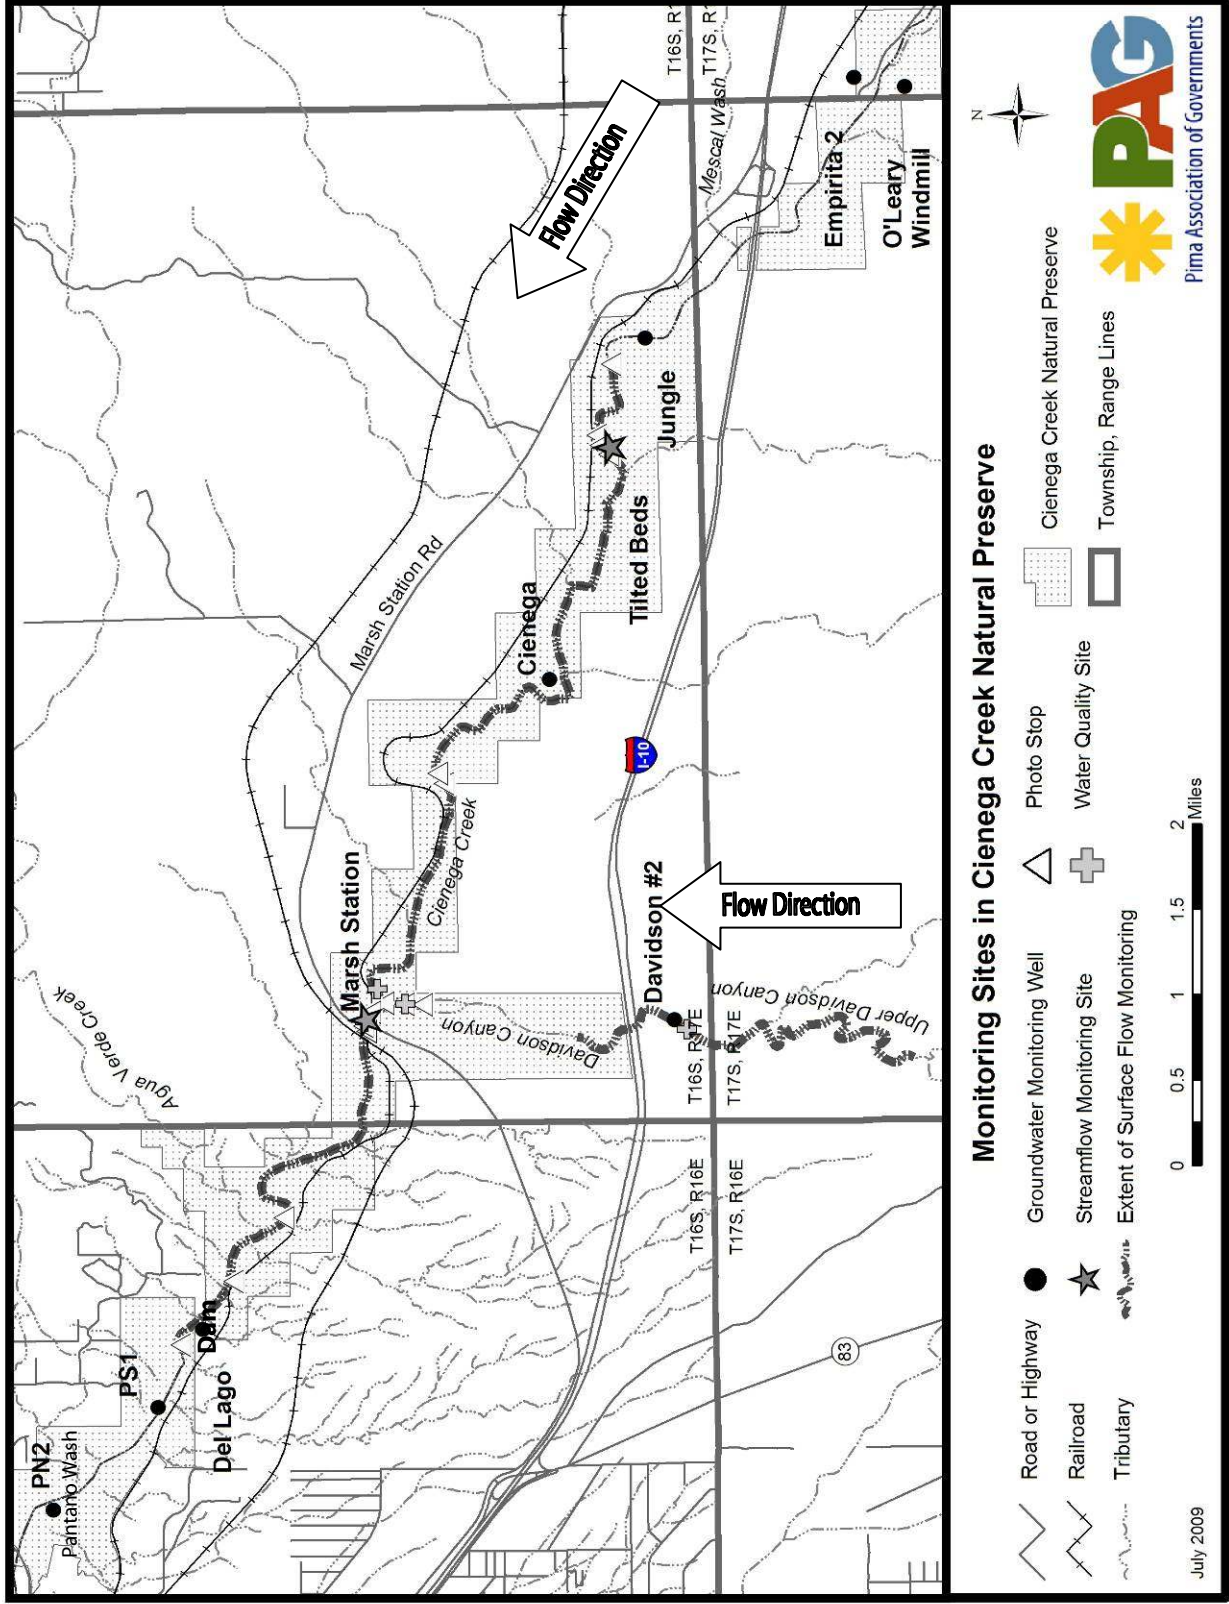
Figure 1A. PAG Monitoring Site Locations in the Cienega Creek Watershed

The locations of all of the monitoring sites are shown in Figures 1A and 1B. During FY 09-10, monitoring methods and locations remained essentially the same as in past years, with any exceptions for this year explained in this report. The specific methodology for each aspect of monitoring is described within its corresponding section. PAG has further documentation for protocols, forms and metadata available in-house, as well as reports from previous years available in the PAG on-line library.

Depths to groundwater were measured at eight wells with either a Solinst Water Level Meter or with *in situ* transducers. The wells are distributed throughout the preserve length and are named (Figure 1A). On a monthly basis, PAG monitored the Jungle, Cienega, Del Lago 1 and Empirita 2 (when accessible) well sites. Davidson 2 continued to be monitored on a quarterly schedule. The PS-1 and PN-2 wells were monitored four times a day by ADWR transducers. If any monitor dates fell outside of this schedule, it is noted in Table 2. Because the O'Leary well had a pump installed in June 2007, which influenced subsequent water levels, it has been removed from the monitoring program and calculations.

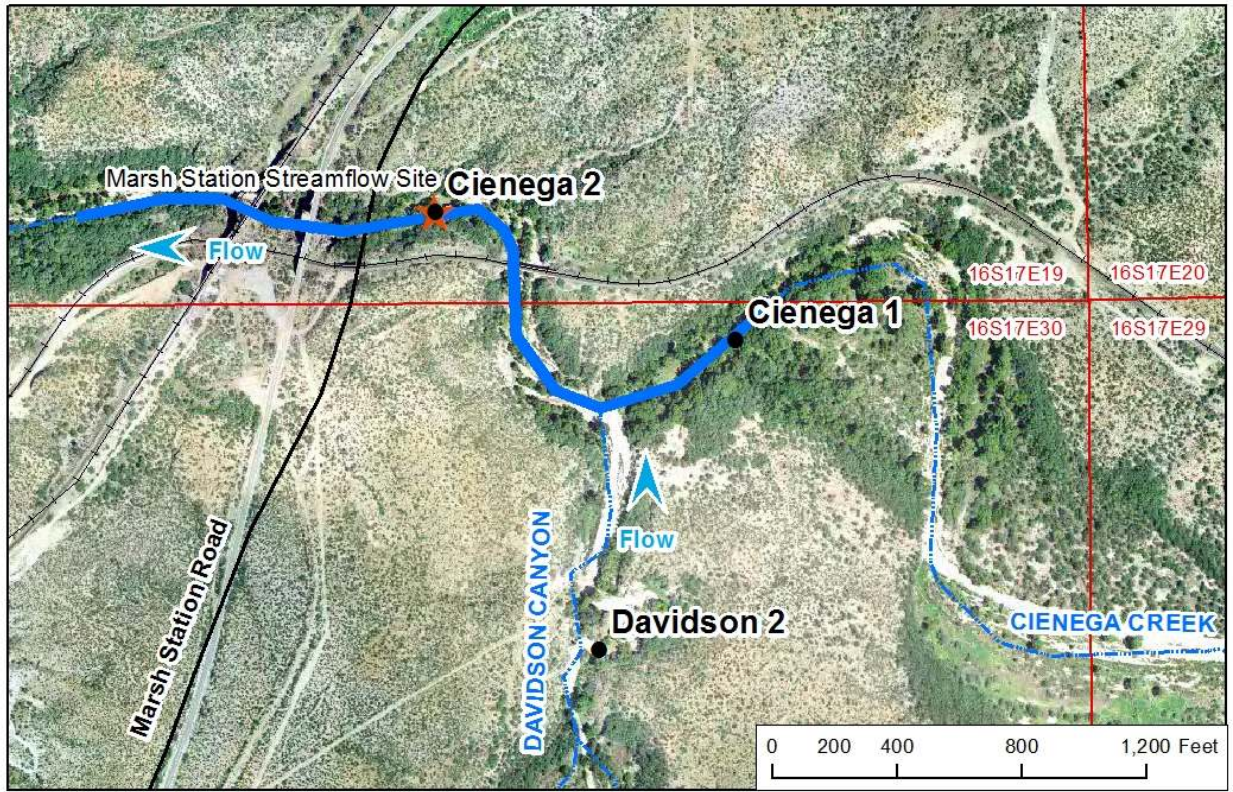
Figure 1B. PAG Water Quality Monitoring Site Locations

The locations of the monitoring sites for water chemistry are displayed in Figure 1B. Current monitoring stations, Davidson 3 and Davidson 2 are both located in Davidson Canyon upstream from its confluence with Cienega Creek, and both exhibit ephemeral flow conditions. Davidson 3 replaced Davidson 1 after it went dry. Cienega 1, located just upstream of the confluence with Davidson Canyon is a perennial site. Cienega 2, located downstream from the confluence at Marsh Station Bridge, is also a perennial streamflow monitoring site. ADEQ has over 10 years of historical water quality data from the Marsh Station monitoring location.

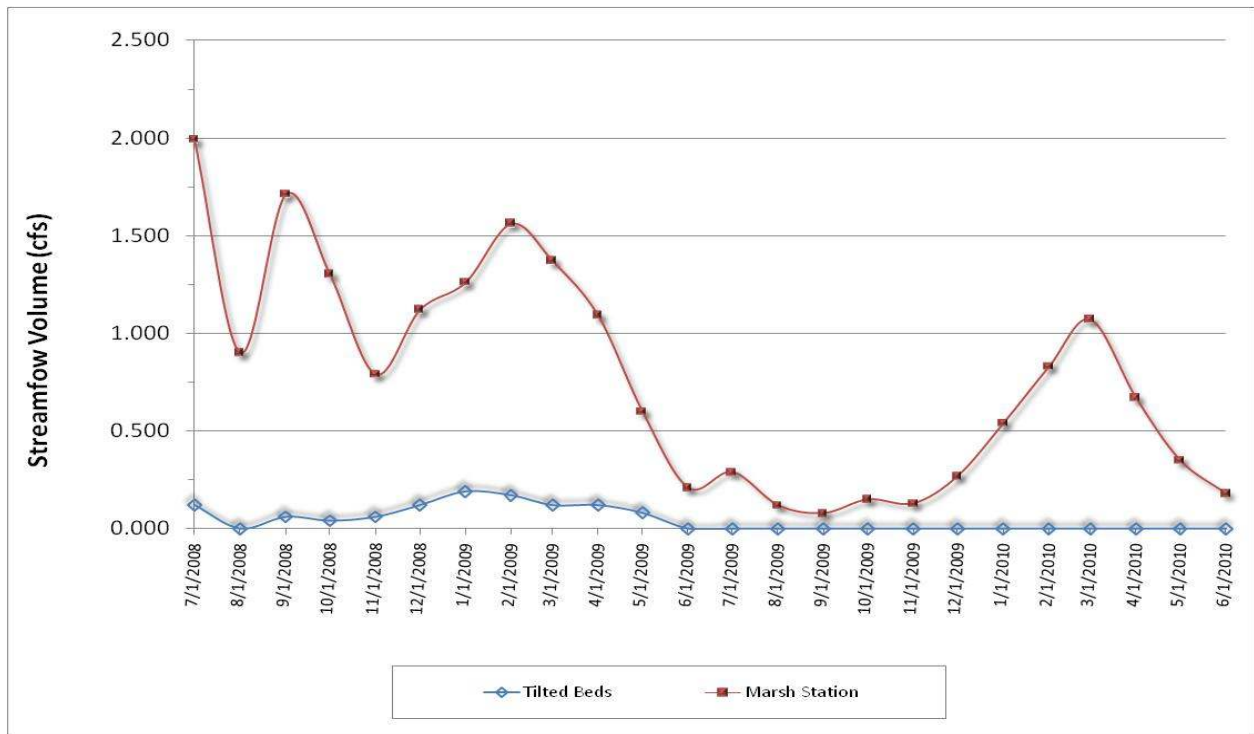
Figure 2. Monthly Streamflow Volume at Tilted Beds and Marsh Station Sites (July 2008 - June 2010)

Tilted Beds was dry during FY 09-10, with the exception of January 2010, when isolated patches of water with immeasurable movement were observed (Table 1). Tilted Beds has a pattern of ephemeral flow for 2-3 years, followed by absence of flow for 2-3 years (Figure 3). The site flows generally during the winter months. However, from 2007 to 2009, Tilted Beds exhibited nearly consistent flow throughout the year. This site's flow may be ephemeral because it is more impacted by sedimentation and erosion processes than the Marsh Station site.

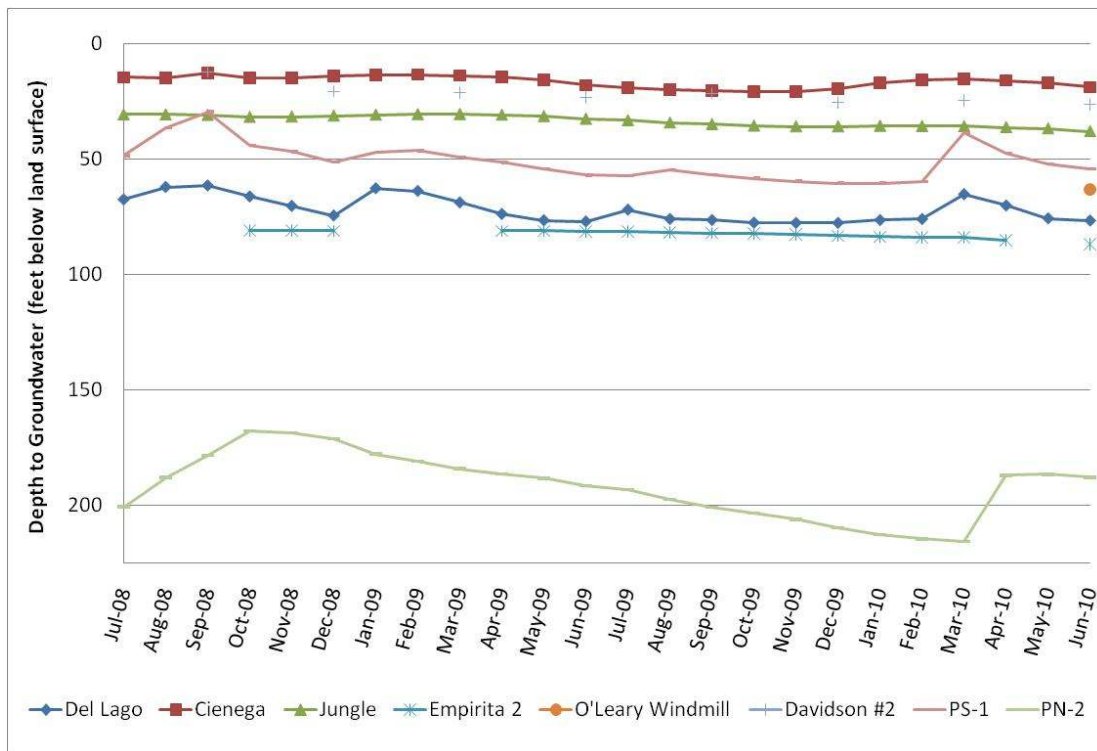
Figure 7. Cienega Creek Natural Preserve Monthly Depth to Groundwater (July 2008 - June 2010)

Data are not available for some months due to inaccessibility.

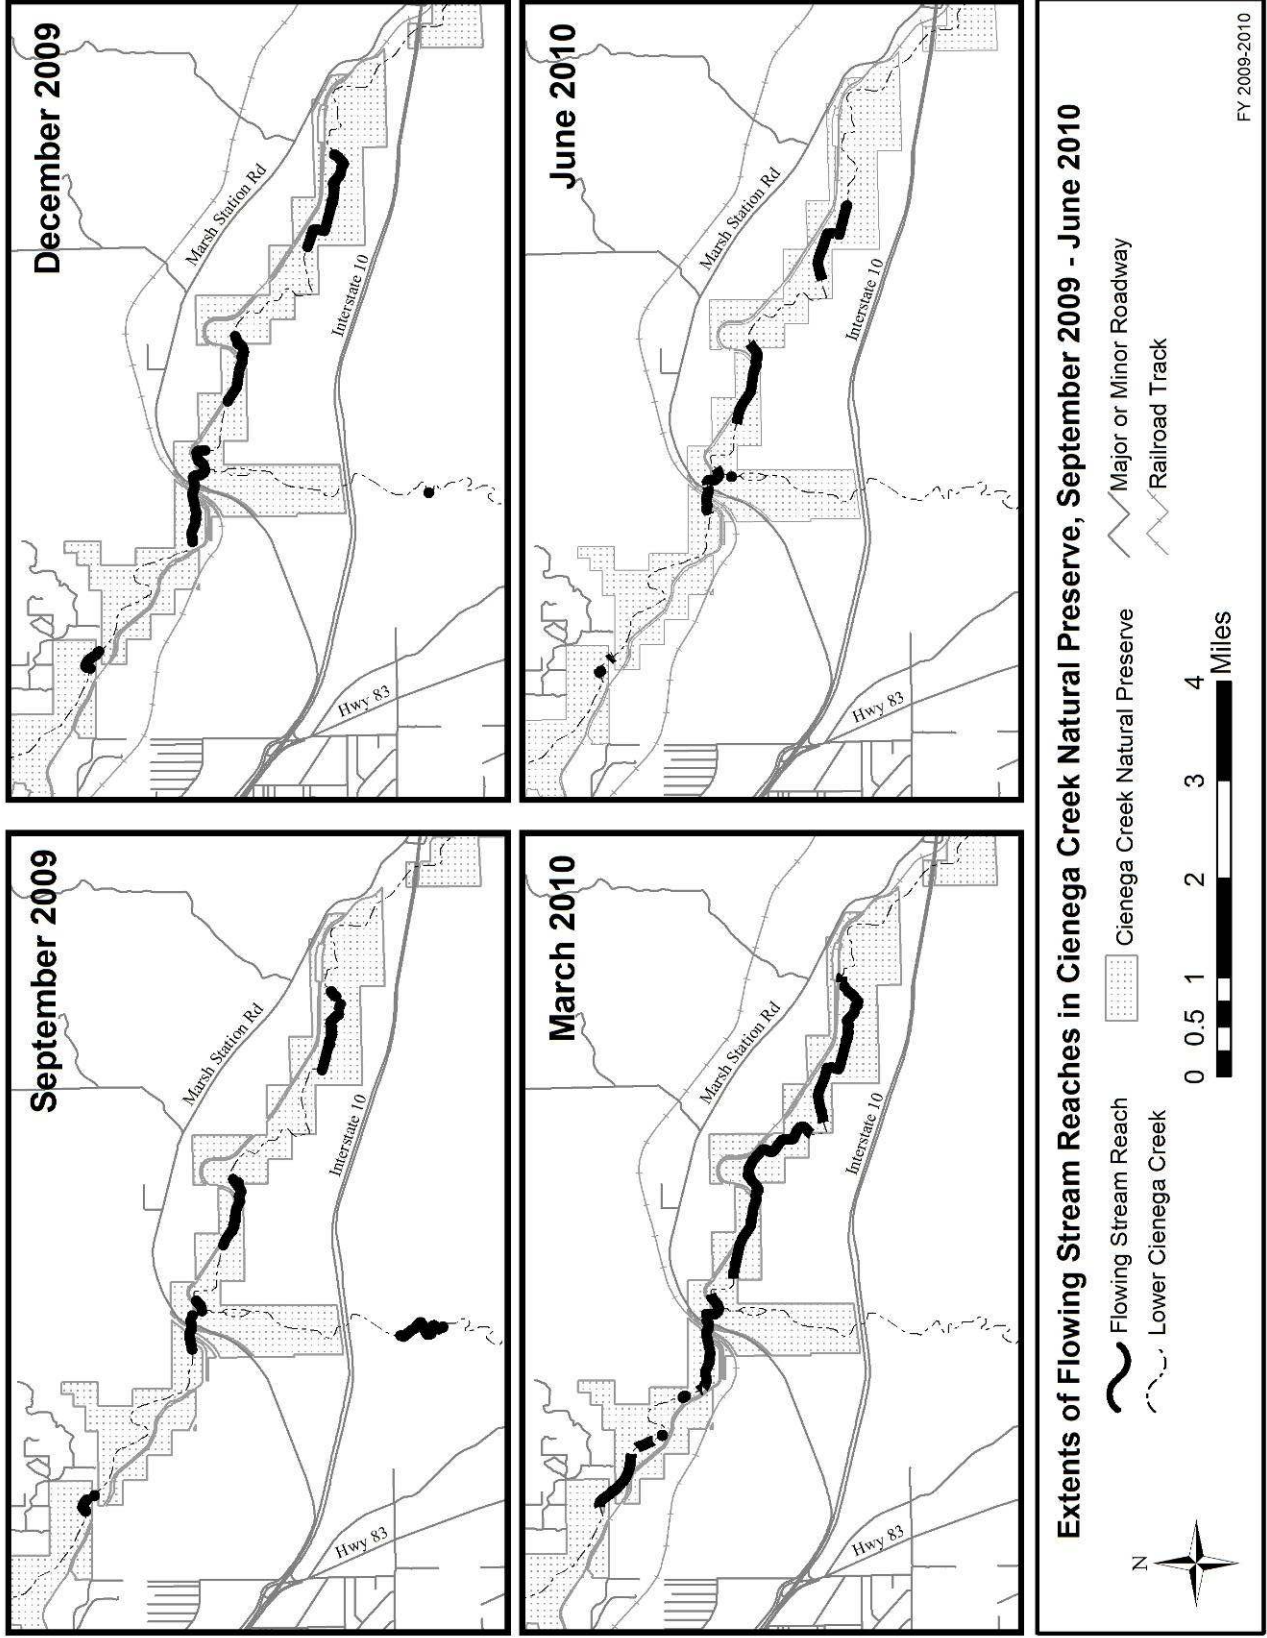
Figure 8. Maps of Cienega Creek and Davidson Canyon, Quarterly Flow Extent (Sep. 2009 - June 2010)

The flowing reaches of upper Davidson Canyon are located at a spring next to a bedrock outcrop south of the I-10 crossing (as seen on the map in Figure 8). This is the fifth year that these surface flows were systematically mapped, but the streamflows along this reach were also noted during earlier PAG studies. Pools of considerable size, between one to three feet deep, remain along this channel, but no fish have been sighted since the summer of 2005. The only flowing quarter in Davidson Canyon in FY 09-10 was in September 2009 when it flowed for 0.58 miles (Table 4). Since monitoring began in Upper Davidson Canyon, September has been the peak flow extent, followed by progressively lower flows each quarter through the monitoring year. In FY 09-10, PAG observed the lowest September flow on our short record, followed by the first observation of consecutive quarters of no flow. June 2008 was the only other quarter where no flow was seen since monitoring began on this reach in September 2005.

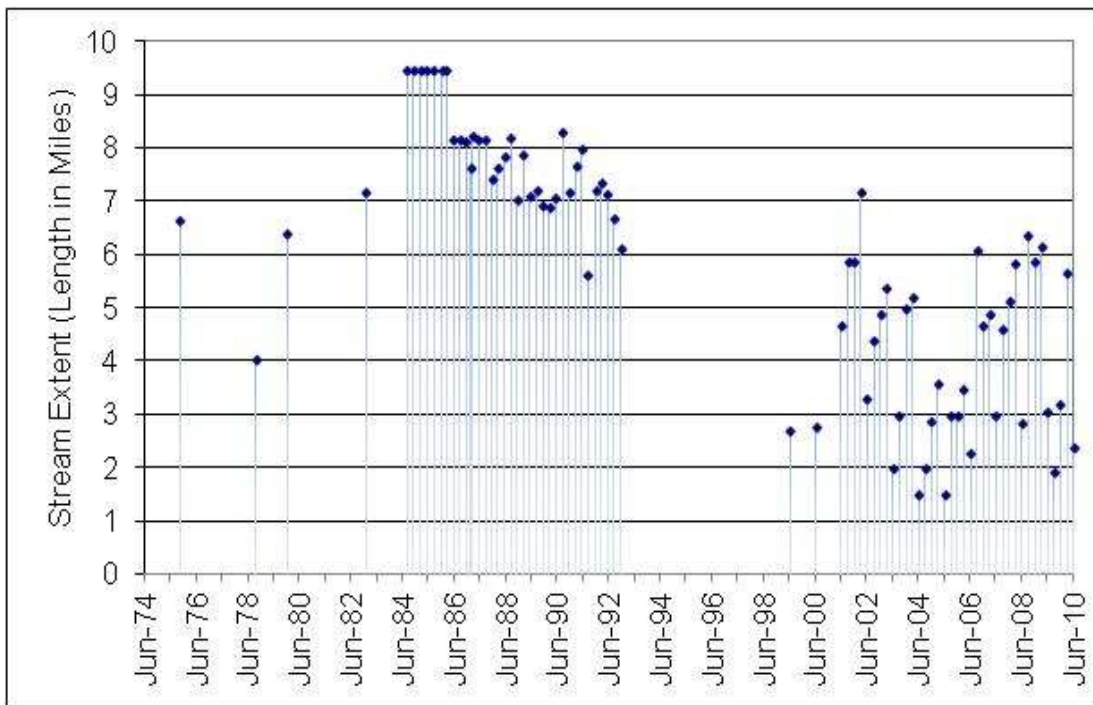
Figure 10. Cienega Creek Flow Extent, 1975 to 2010

Data prior to 1993 is from Errol L. Montgomery & Associates, (Montgomery & Associates 1993). Prior to 1984, and between 1999-2000, flow extent was measured was not consistently. Extent length was measured in October 1974, September 1978, December of 1979 and 1982, and June of 1999 and 2000, typically drier months. Length was not measured from 1993-1998. Akko other measurements were taken quarterly.

The documentation of seasonal variation helps to identify ephemeral and perennial reaches. Seasonal variation is evaluated for each year by taking the difference between the quarters with the longest and shortest total flow extents. The largest change in flow extent generally occurs as a decline between the months of March and June, which coincides with the time period when evapo-transpiration rates increase, precipitation is minimal and recharge rates decrease (Figure 8 and Table 4). With drought, increased seasonal variation of surface flow length was observed (Figure 10). The

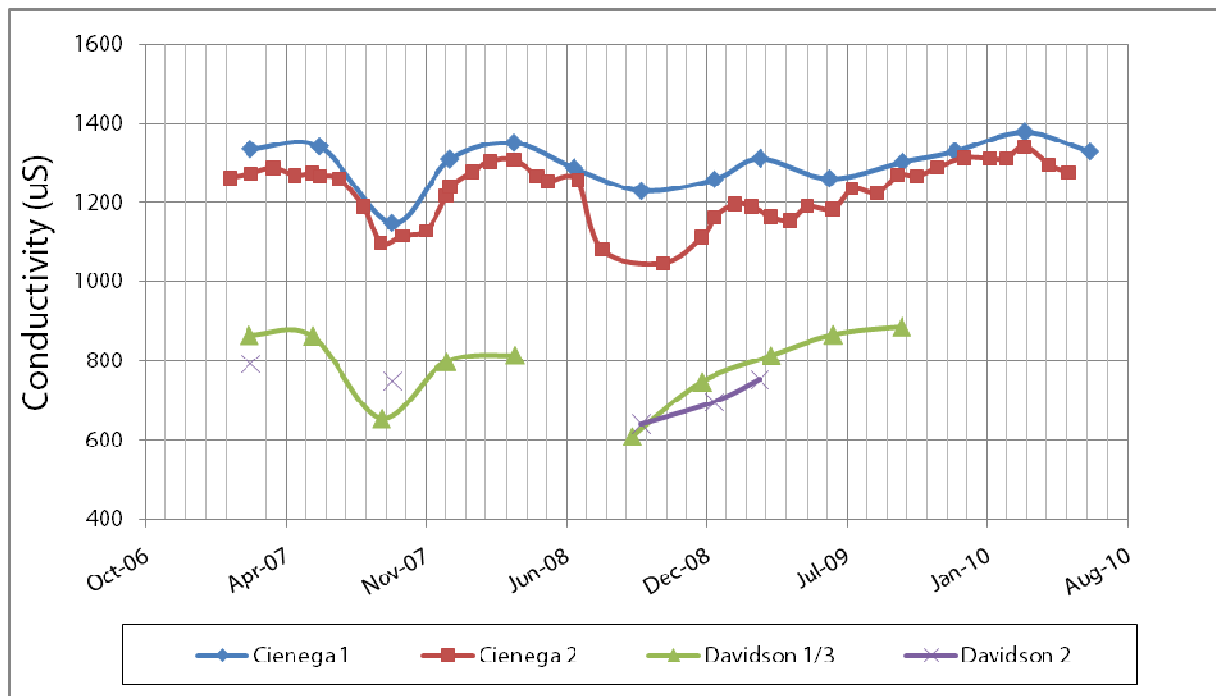
Figure 13. Cienega Watershed – Seasonal Conductivity Fluctuation (January 2007 - June 2010)

Note: Davidson 3 serves as a replacement for the Davidson 1 site since March 2007. Depending on the site, readings were measured every 1-3 months, when sites had available flow. No data was collected from 2004-2006.

Our data shows seasonal and geographic variations in water chemistry, but does not indicate any significant long-term trends. Seasonally, conductivity and total dissolved solids drops in the fall. Conductivity fluctuates by about 200  $\mu\text{S}$  within a year (Figure 13). This trend was not observed in 2009, possibly due to abnormally low precipitation. The average conductivity of the Davidson Canyon sites is lower than the Cienega sites. The contribution of Davidson Canyon to baseflows in Cienega Creek may lower the conductivity at the Cienega Creek downstream from the Davidson confluence (Cienega 2). The long-term trend (Figure 14) shows that over the last nine years, conductivity increased slightly at all sites, except for a slight decrease at Davidson 2. The pH was highest at Davidson 1/Davidson 3 and at Cienega 2 (Figure 15). The temperature was lowest at Cienega 1 (Figure 16).

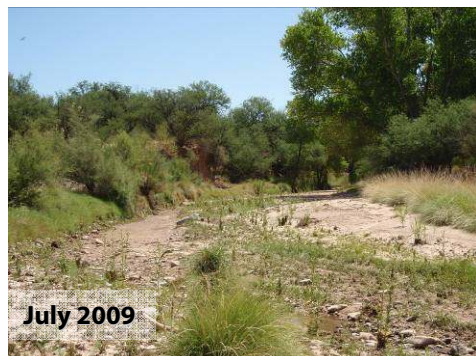
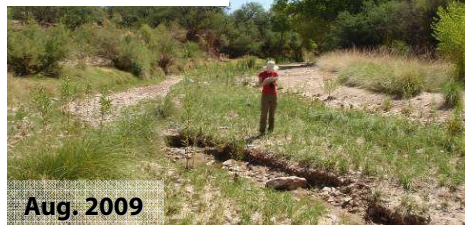
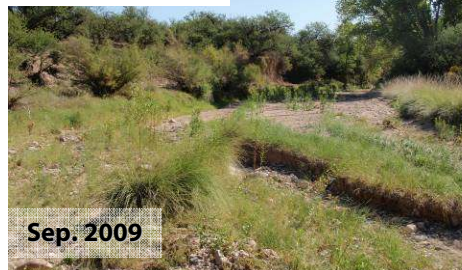
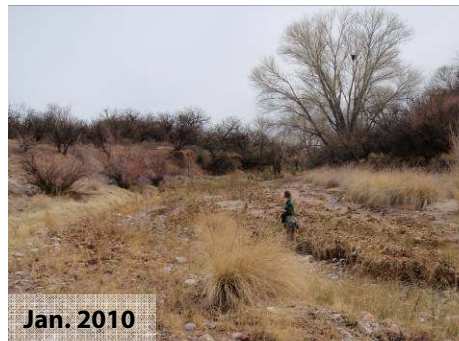
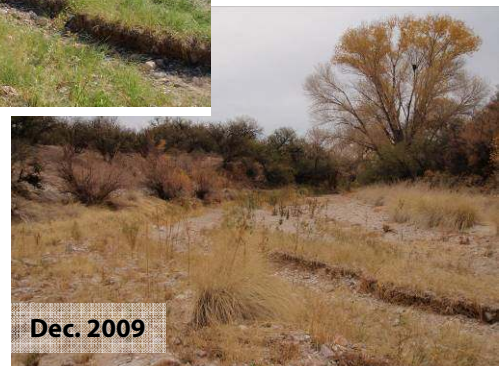
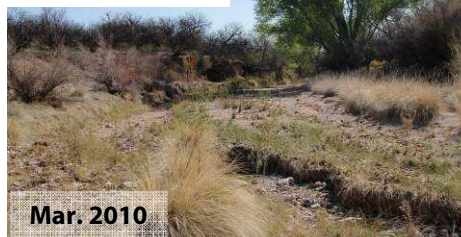
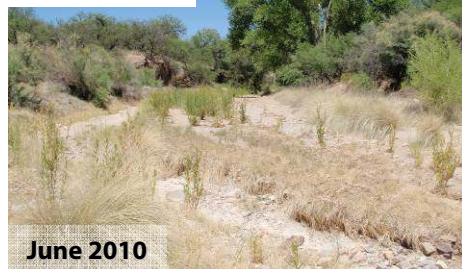
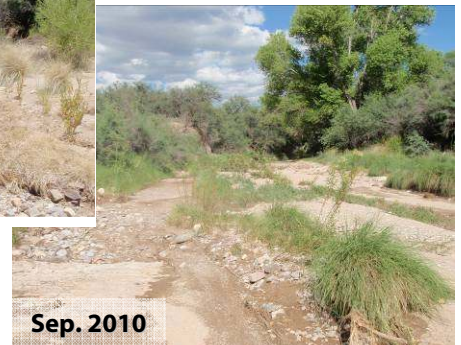
Figure 17. Photo Documentation of Erosion at Tilted Beds, Cienega Creek

This series of photographs shows repeat photography at photo site #5, upstream from Tilted Beds, facing upstream. This sequence shows how the creek experiences alternating scouring and sedimentation over time, as well different scour patterns. For example, the Sep. 2009 photograph shows an incised streambed, but by June 2010 that sediment had accumulated and eliminated the downcut channel bed.

During the time period shown here, some water was observed on the streambed surface, but there was never sufficient water to create measurable baseflow. Along this reach, occasional flood events scoured the surface, forming pools. Scour events tended to form after dry periods, as shown here.

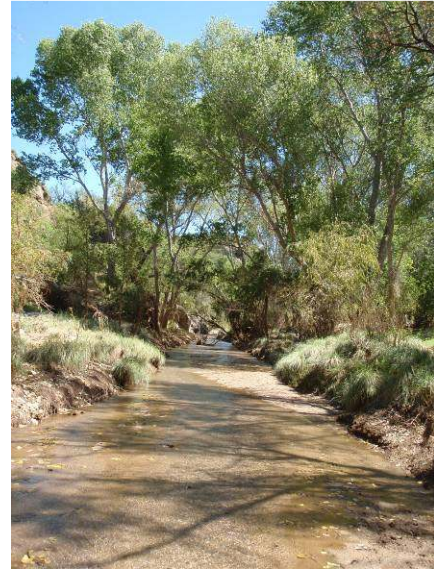
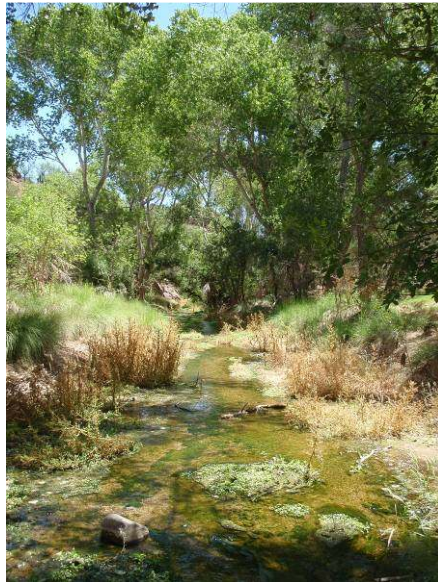
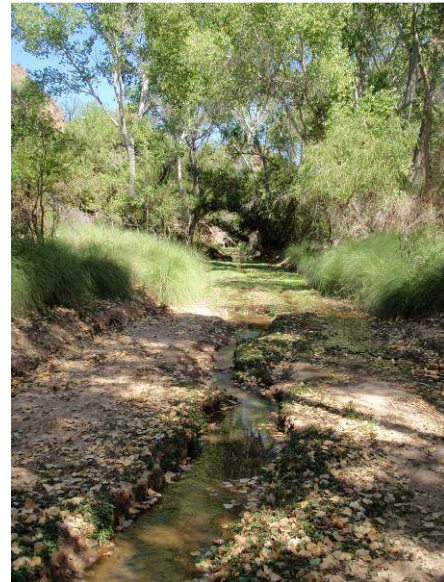
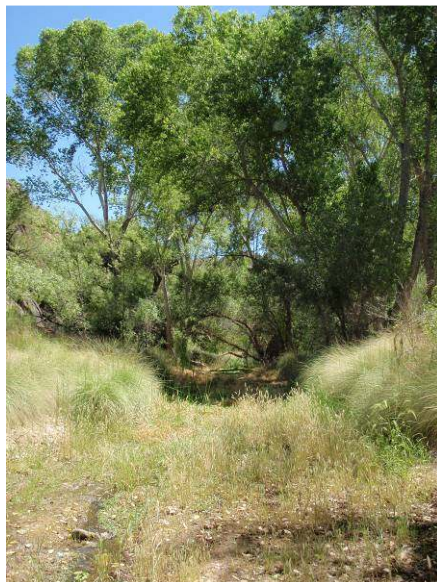
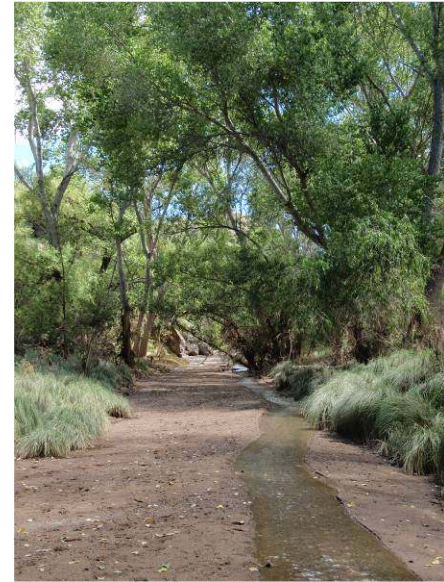
Figure 18. Photo Documentation of Streamflow Volume Changes at Marsh Station, Cienega Creek

These photos are taken at the Marsh Station site, looking upstream to the streamflow measuring location. They highlight the dramatic reduction of flow in September 2009, which was the driest September since the drought began in 2003. In general, September streamflow volumes are higher than those documented in June because of monsoon rainfall, however, Sep. flows were smaller than June flows in 2009. The photos also illustrate that ranges of streamflow volume of flow can each take many forms.

**Sep. 2008 (1.71 cfs)**

**June 2009 (0.21 cfs)**

**Sep. 2009 (0.08 cfs)**

**June 2010 (0.18 cfs)**

**Sep. 2010 (0.34 cfs)**

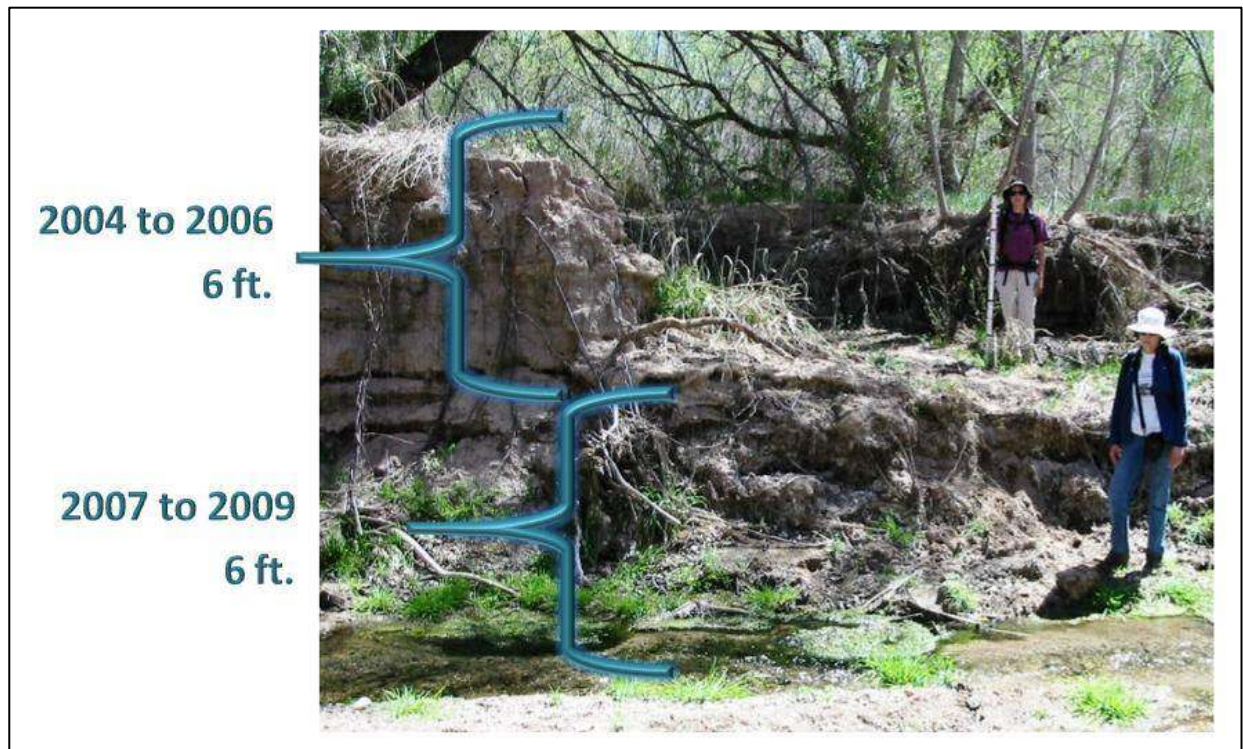
Figure 19. Photo of Depth of Erosion in Active Headcutting Study Area

This photo features the headcut at the "Railroad Horseshoe turn" where a second channel (behind the person on the upper level) branches of the main channel (person in the foreground).

Depending on the value attributed to trade-offs for certain habitat types, changes in the creek habitat may be viewed as either positive or negative. The immediate results show that streamflow is restored in the headcut region and may last until (and if) the area experiences another wave of sediment accumulation. The trade-off for increased surface flow is loss of local shallow aquifer storage and possibly faster movement of flow out of the system. Loss of vegetation increases temperature and evaporation, decreases infiltration and speeds flood flows. When looking at the long-term, the current older growth tree-fall is reducing vegetative overstory, which will take 30 years to fill back in by the next generation of trees. In the shorter term, it appears that this erosion process will restore fish habitat in the active headcutting area, which has an approximately 10-year life span in our study area.

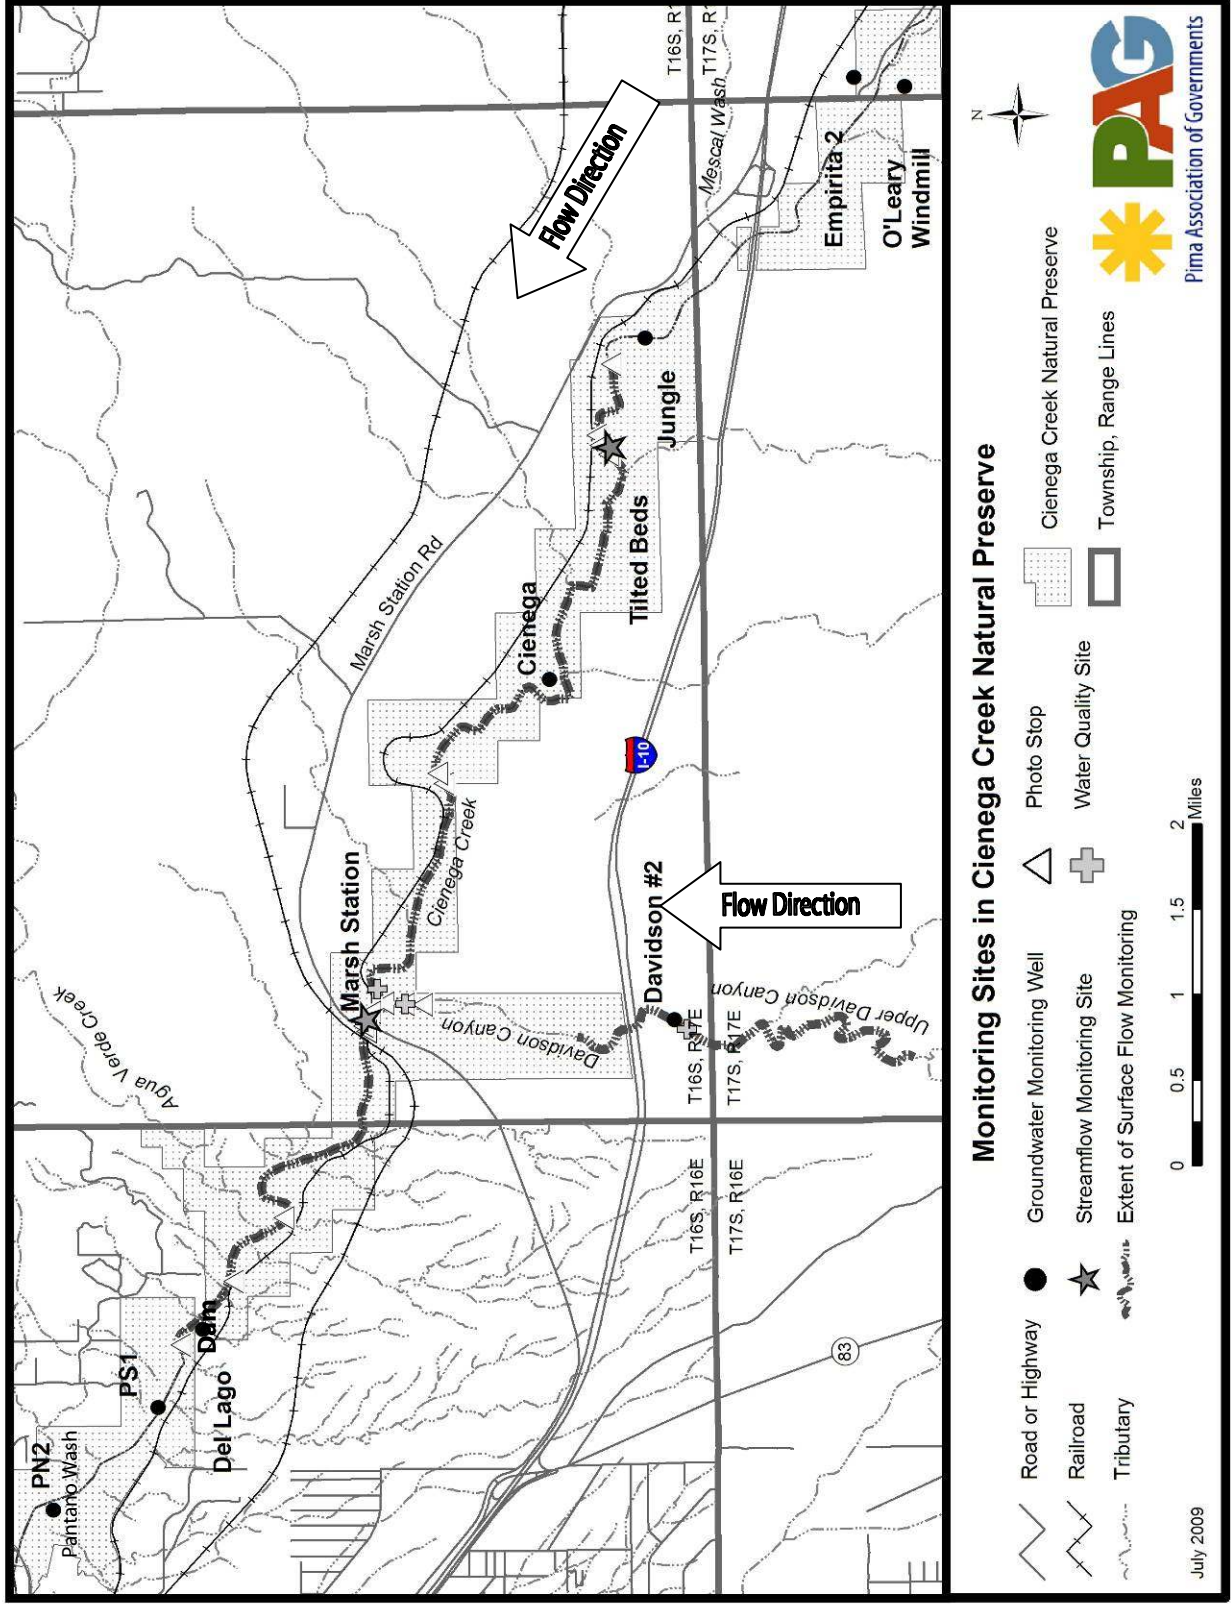
Figure 1A. PAG Monitoring Site Locations in the Cienega Creek Watershed

The locations of all of the monitoring sites are shown in Figures 1A and 1B. During FY 09-10, monitoring methods and locations remained essentially the same as in past years, with any exceptions for this year explained in this report. The specific methodology for each aspect of monitoring is described within its corresponding section. PAG has further documentation for protocols, forms and metadata available in-house, as well as reports from previous years available in the PAG on-line library.

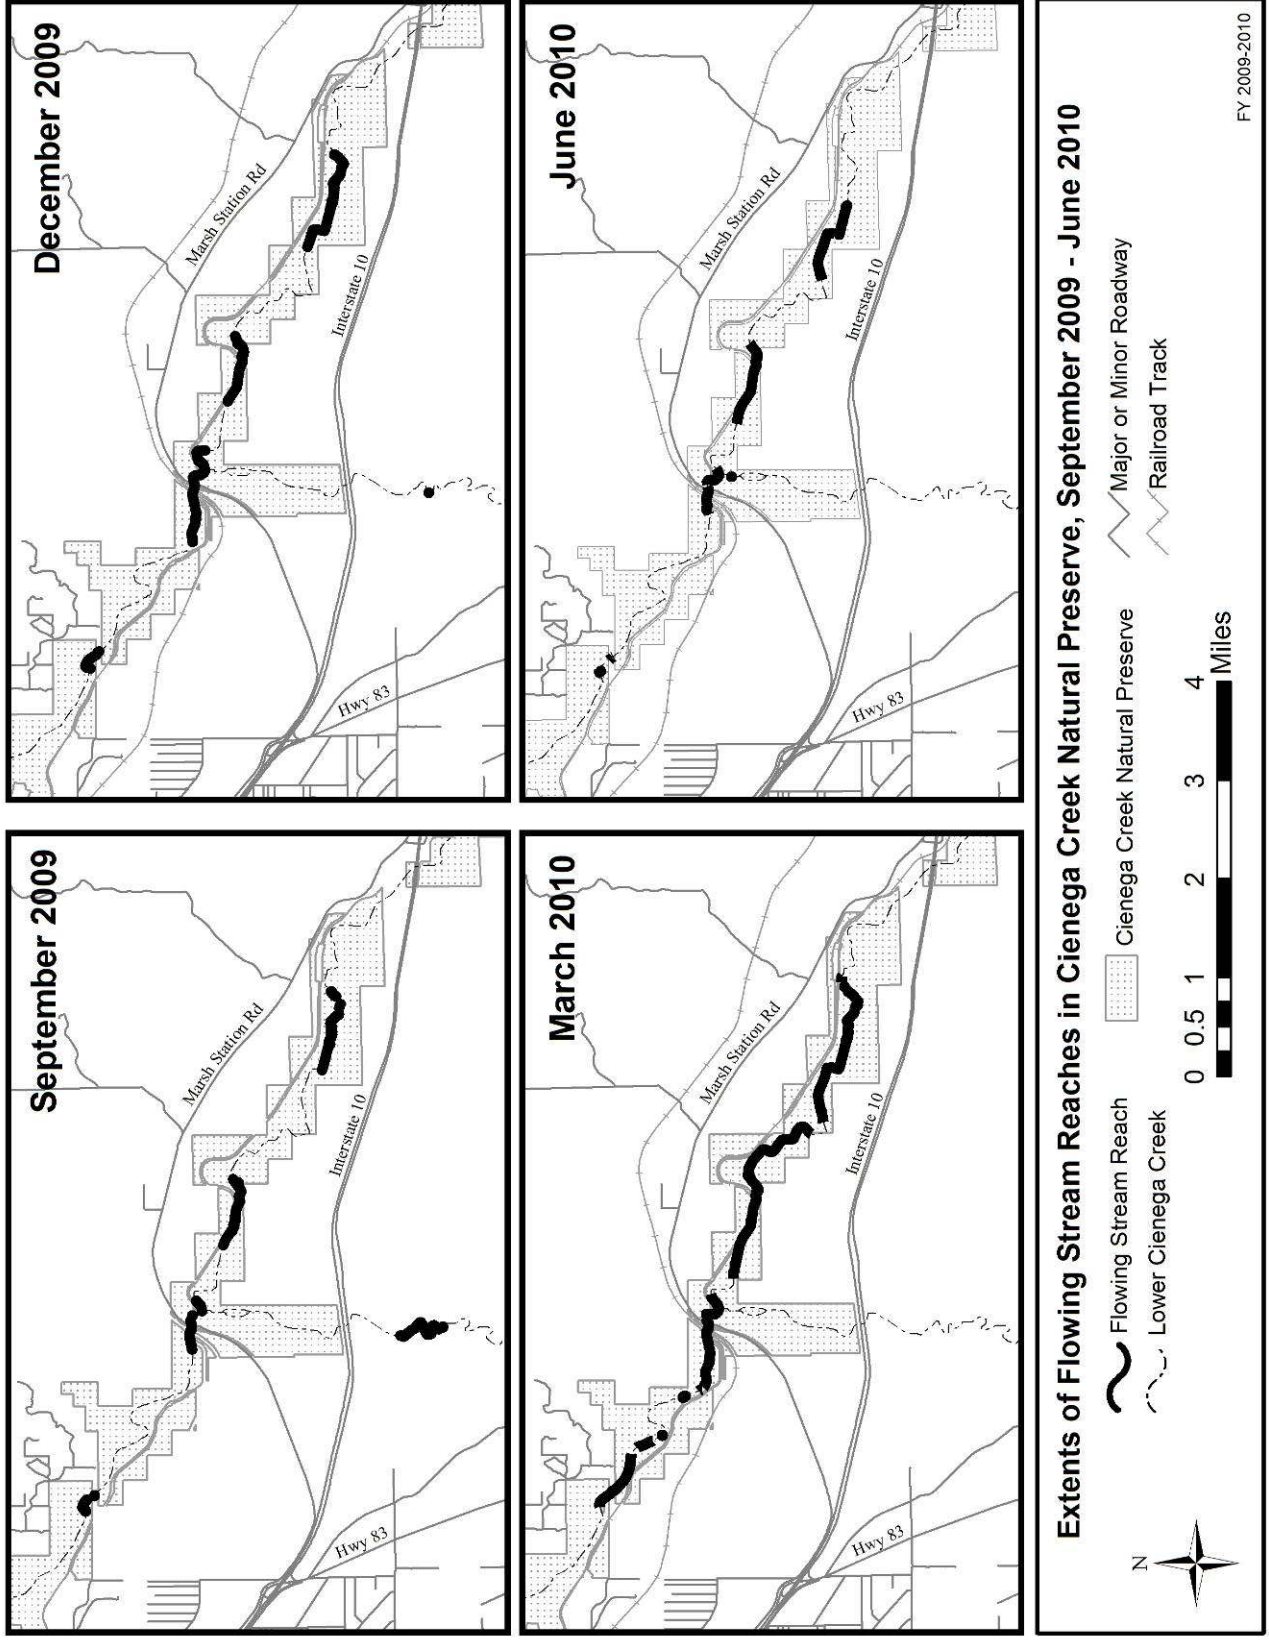
Figure 8. Maps of Cienega Creek and Davidson Canyon, Quarterly Flow Extent (Sep. 2009 - June 2010)

Mapping streamflow during the driest part of the year conservatively identifies the perennial reaches in the Preserve. As seen in Figure 8, the total flow extent in the Preserve is consistently lowest pre-monsoon, in June. Summer flow extents have declined substantially since the 1980s (Table 5, Figure 12). In July 1984, the creek flowed continuously from I-10 to the Pantano Dam, a distance of 9.5 miles (Montgomery & Associates 1993). In contrast, the average percentage of wet (i.e. flowing) creek length in the same area in June since 1999 has been 28 percent. Since 1999, the summers of 2004 and 2005 were a low point followed by a rise in flow in 2007, 2008 and 2009 (Figure 9). With a decrease in summer flow this June 2010, the creek flowed for 2.38 miles in total, composing 25 percent of the monitored preserve length (Figure 11). This was 0.3 miles less than the average since 1999. In addition to shorter total flow extent, drier years and drier seasons also generally have shorter length stream reaches, as seen in Figure 8 and Table 4.

The mapped extent of streamflow is processed using GIS. From 1999 to 2008, wet/dry mapping was completed on hardcopy aerial photography maps in the field and was subsequently hand digitized in GIS (ArcMap) to clip a creek shapefile line into corresponding flowing segments. In FY 07-08, PAG began using a GPS (Trimble) Unit to mark points at the beginning and end of intermittent flow. PAG continues to use GIS to clip the same Cienega streamflow shapefile line, which follows the general incision of the creek, but does not necessarily follow the small meanders, since the particular stream course changes over time. This shapefile template is from the Pima County Land Information System and was created at a 1:200,000 scale. The mapping results are shown in Figure 8 and Figure 11.

Mapping streamflow during the driest part of the year conservatively identifies the perennial reaches in the Preserve. As seen in Figure 8, the total flow extent in the Preserve is consistently lowest pre-monsoon, in June. Summer flow extents have declined substantially since the 1980s (Table 5, Figure 12). In July 1984, the creek flowed continuously from I-10 to the Pantano Dam, a distance of 9.5 miles (Montgomery & Associates 1993). In contrast, the average percentage of wet (i.e. flowing) creek length in the same area in June since 1999 has been 28 percent. Since 1999, the summers of 2004 and 2005 were a low point followed by a rise in flow in 2007, 2008 and 2009 (Figure 9). With a decrease in summer flow this June 2010, the creek flowed for 2.38 miles in total, composing 25 percent of the monitored preserve length (Figure 11). This was 0.3 miles less than the average since 1999. In addition to shorter total flow extent, drier years and drier seasons also generally have shorter length stream reaches, as seen in Figure 8 and Table 4.

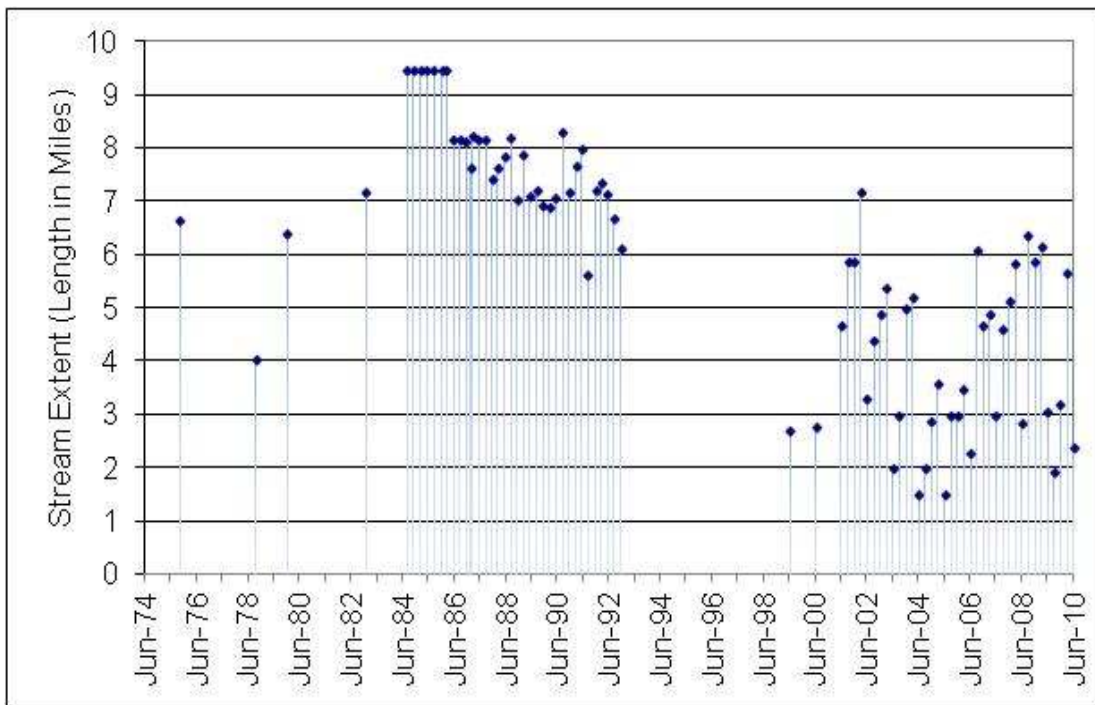
Figure 10. Cienega Creek Flow Extent, 1975 to 2010

The annual average total distance of surface flow extent in the Cienega Creek Preserve since 1975 has decreased over time (Figure 10). It decreased from 7.7 miles, the average flow length from 1975 to 1992, to 4.1 miles on average since 2001. Using this flow extent data plus groundwater levels, streamflow volume and precipitation data, PAG considers the time period since 2001 to be a drought period. In the short term (Figure 9), the annual average flow extent was 3.3 miles in length during FY 09-10, a decrease of 61% from last year.

Data prior to 1993 is from Errol L. Montgomery & Associates, (Montgomery & Associates 1993). Prior to 1984, and between 1999-2000, flow extent was measured was not consistently. Extent length was measured in October 1974, September 1978, December of 1979 and 1982, and June of 1999 and 2000, typically drier months. Length was not measured from 1993-1998. Akko other measurements were taken quarterly.

The annual average total distance of surface flow extent in the Cienega Creek Preserve since 1975 has decreased over time (Figure 10). It decreased from 7.7 miles, the average flow length from 1975 to 1992, to 4.1 miles on average since 2001. Using this flow extent data plus groundwater levels, streamflow volume and precipitation data, PAG considers the time period since 2001 to be a drought period. In the short term (Figure 9), the annual average flow extent was 3.3 miles in length during FY 09-10, a decrease of 61% from last year.

The documentation of seasonal variation helps to identify ephemeral and perennial reaches. Seasonal variation is evaluated for each year by taking the difference between the quarters with the longest and shortest total flow extents. The largest change in flow extent generally occurs as a decline between the months of March and June, which coincides with the time period when evapo-transpiration rates increase, precipitation is minimal and recharge rates decrease (Figure 8 and Table 4). With drought, increased seasonal variation of surface flow length was observed (Figure 10). The

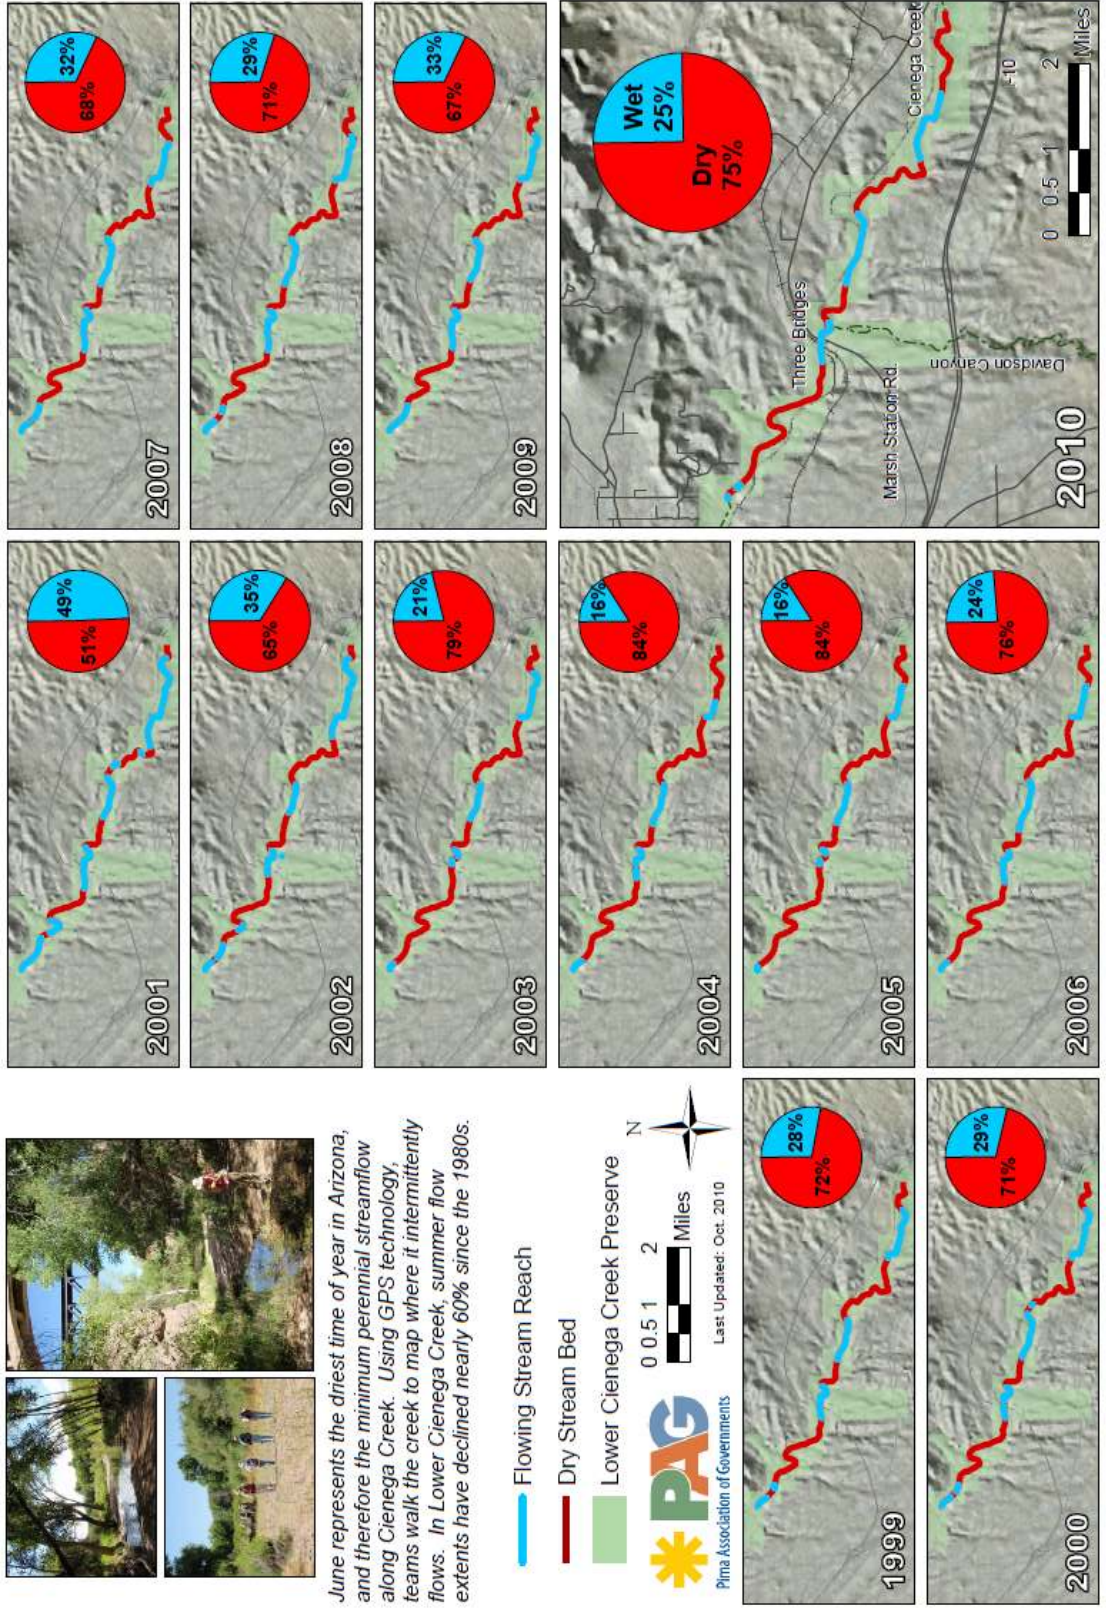
Figure 11. Map of Cienega Creek's June Flowing Reaches with Wet/Dry Pie Charts, 1999 to 2010

# Cienega Creek Annual Wet/Dry Status in June
