SUBJECT: **Cienega Creek Natural Preserve Surface Water and Groundwater Monitoring  
Annual Report for the 2009-2010 Fiscal Year**

# Pima County's Cienega Creek Natural Preserve

Surface Water and Groundwater Monitoring Project – PAG Annual Report

Fiscal Year 2009 - 2010

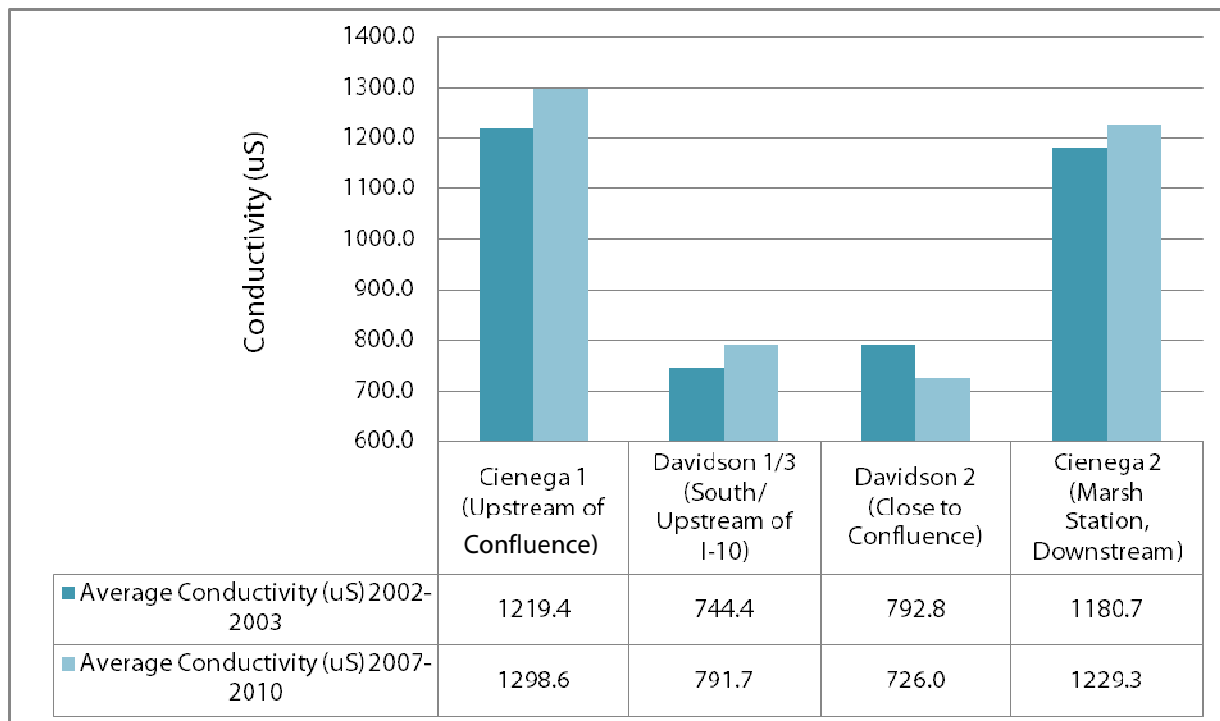
Figure 14. Cienega Watershed – Change in Average Conductivity per Site (2002 – 2010)

Note: Davidson 3 serves as a replacement for the Davidson 1 site since March 2007. Depending on the site, readings were measured every 1-3 months, when sites had available flow. No data was collected from 2004-2006.

Our data shows seasonal and geographic variations in water chemistry, but does not indicate any significant long-term trends. Seasonally, conductivity and total dissolved solids drops in the fall. Conductivity fluctuates by about 200  $\mu\text{S}$  within a year (Figure 13). This trend was not observed in 2009, possibly due to abnormally low precipitation. The average conductivity of the Davidson Canyon sites is lower than the Cienega sites. The contribution of Davidson Canyon to baseflows in Cienega Creek may lower the conductivity at the Cienega Creek downstream from the Davidson confluence (Cienega 2). The long-term trend (Figure 14) shows that over the last nine years, conductivity increased slightly at all sites, except for a slight decrease at Davidson 2. The pH was highest at Davidson 1/Davidson 3 and at Cienega 2 (Figure 15). The temperature was lowest at Cienega 1 (Figure 16).

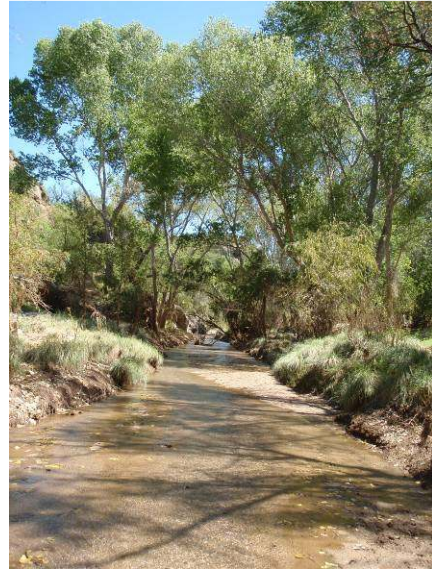
1

These photos are taken at the Marsh Station site, looking upstream to the streamflow measuring location. They highlight the dramatic reduction of flow in September 2009, which was the driest September since the drought began in 2003. In general, September streamflow volumes are higher than those documented in June because of monsoon rainfall, however, Sep. flows were smaller than June flows in 2009. The photos also illustrate that ranges of streamflow volume of flow can each take many forms.

**Sep. 2008 (1.71 cfs)**

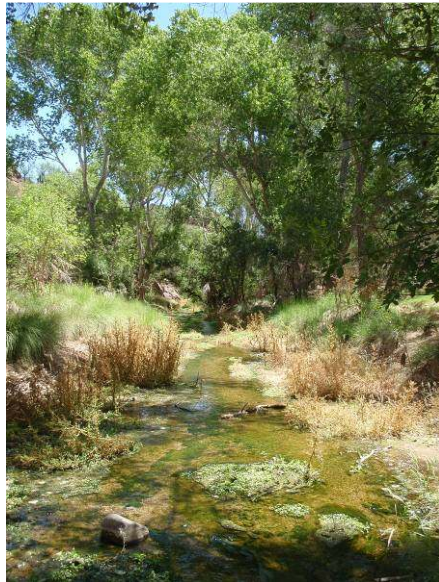
2

**June 2009 (0.21 cfs)**

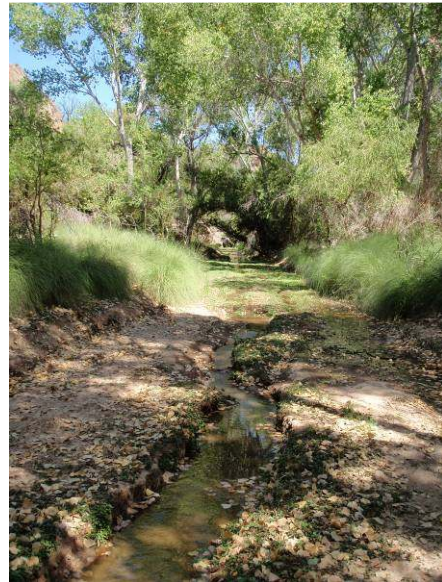
3

**Sep. 2009 (0.08 cfs)**

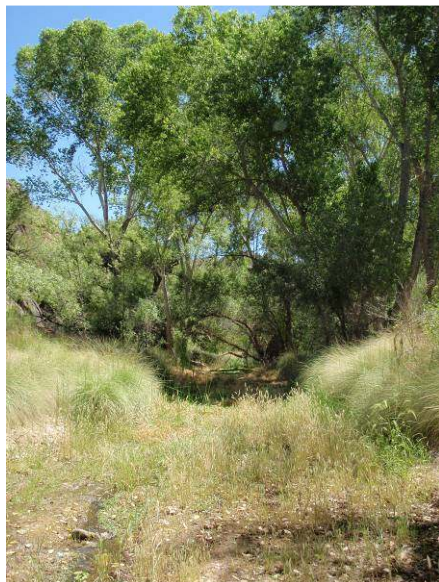
4

**June 2010 (0.18 cfs)**

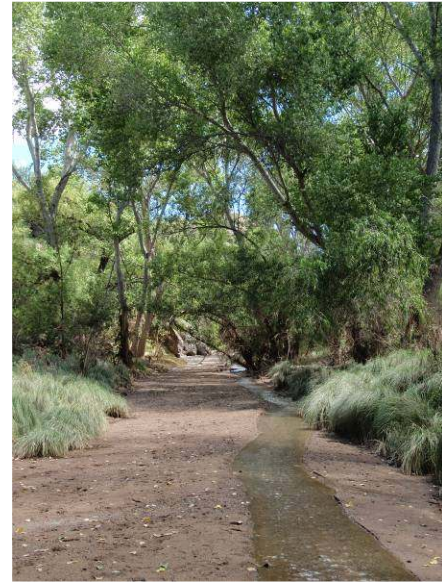
5

**Sep. 2010 (0.34 cfs)**
