SUBJECT: **Cienega Creek Natural Preserve Surface Water and Groundwater Monitoring  
Annual Report for the 2010-2011 Fiscal Year**

# Pima County's Cienega Creek Natural Preserve

## Surface Water and Groundwater Monitoring Project – PAG Annual Report

### Fiscal Year 2010-2011

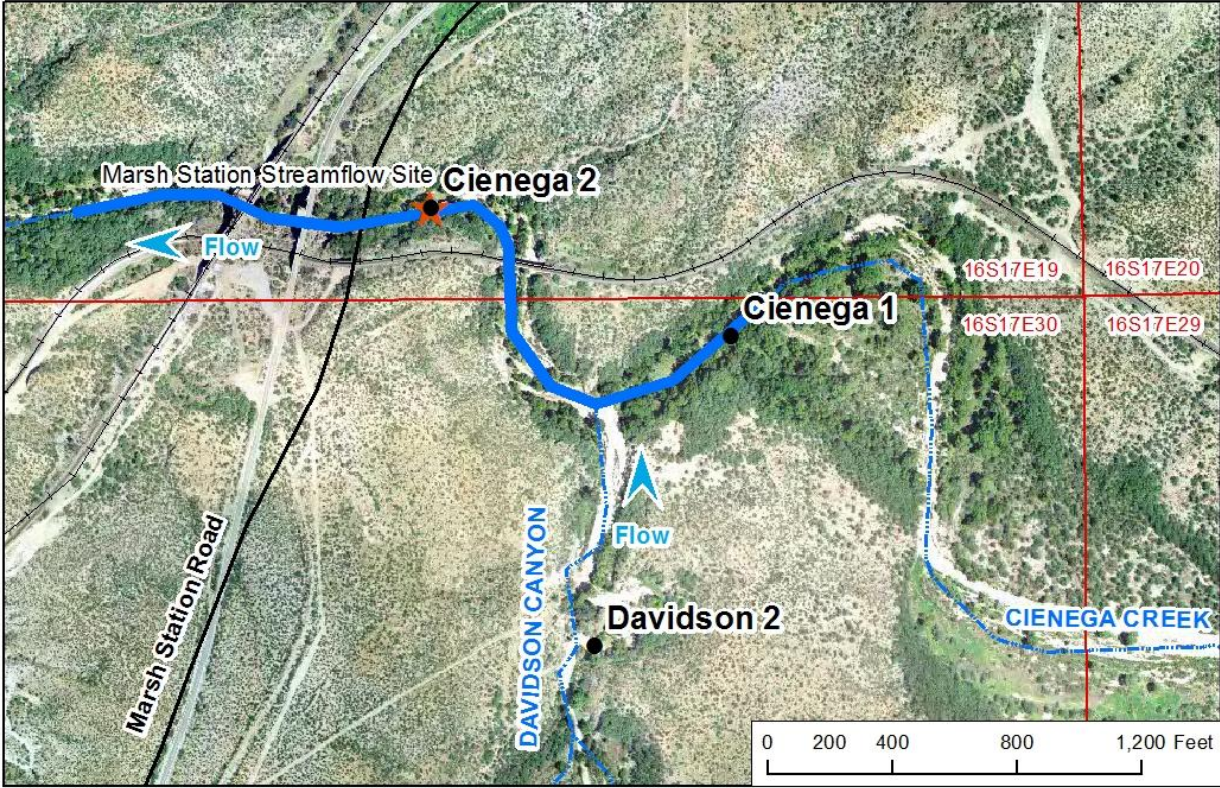
Figure 1B. PAG Water Quality Monitoring Site Locations

The locations of the monitoring sites for water chemistry are displayed in Figure 1B. Current monitoring stations, Davidson 1/3 and Davidson 2 are both located in Davidson Canyon upstream from its confluence with Cienega Creek, and prior to drought both exhibited spatially intermittent baseflow throughout the reach, but now exhibit ephemeral baseflow conditions during this drought. Cienega 1, located just upstream of the confluence with Davidson Canyon is a perennial site. Cienega 2, located downstream from the confluence at Marsh Station Bridge, is also a perennial streamflow monitoring site.

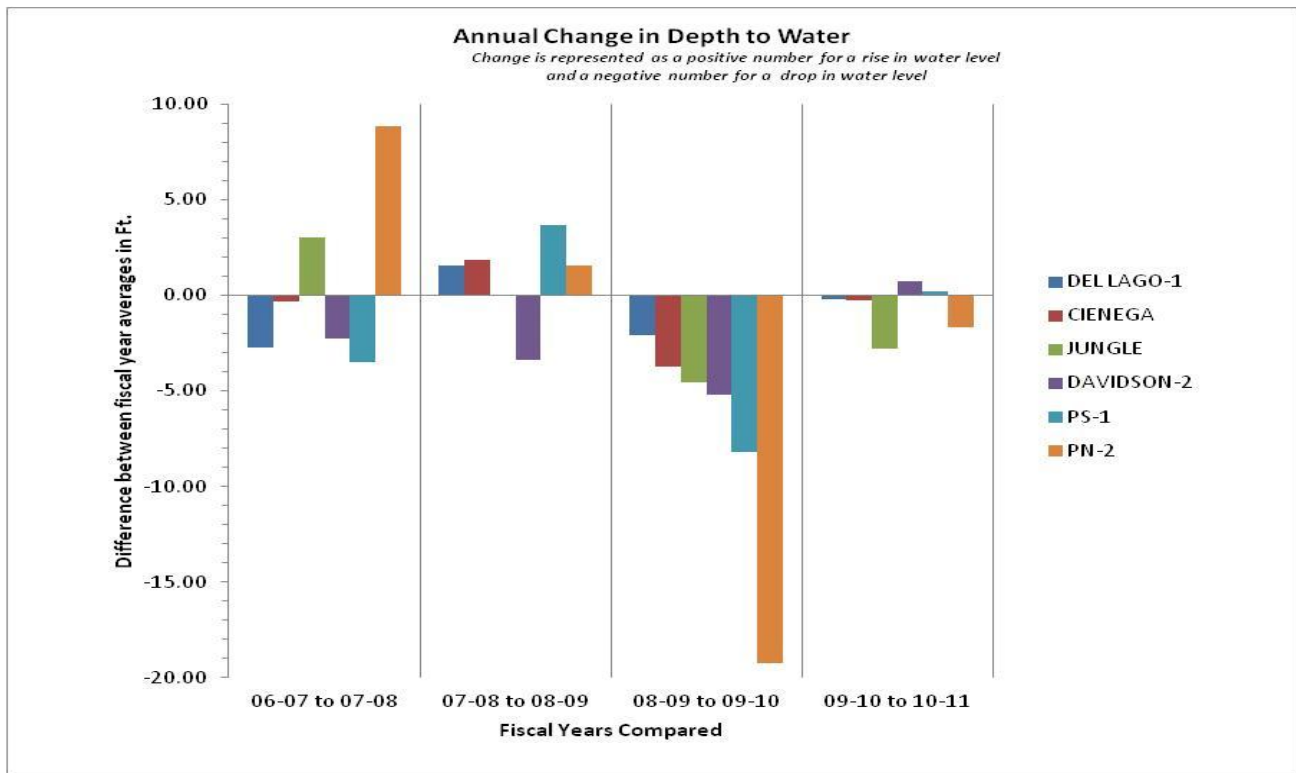
*Figure 5. Annual Change in Average Depth to Water*

Trends in groundwater levels follow trends of streamflow closely. Recent mean annual changes are displayed in Figure 5 and Table 3, while Figure 6A exhibits the long-term trends, showing water level data from 1994 to the present. Figure 6B shows 2005-2011 depth to groundwater for PN-2. In FY 10-11 average depth-to groundwater continued to increase (i.e. dropping water table).

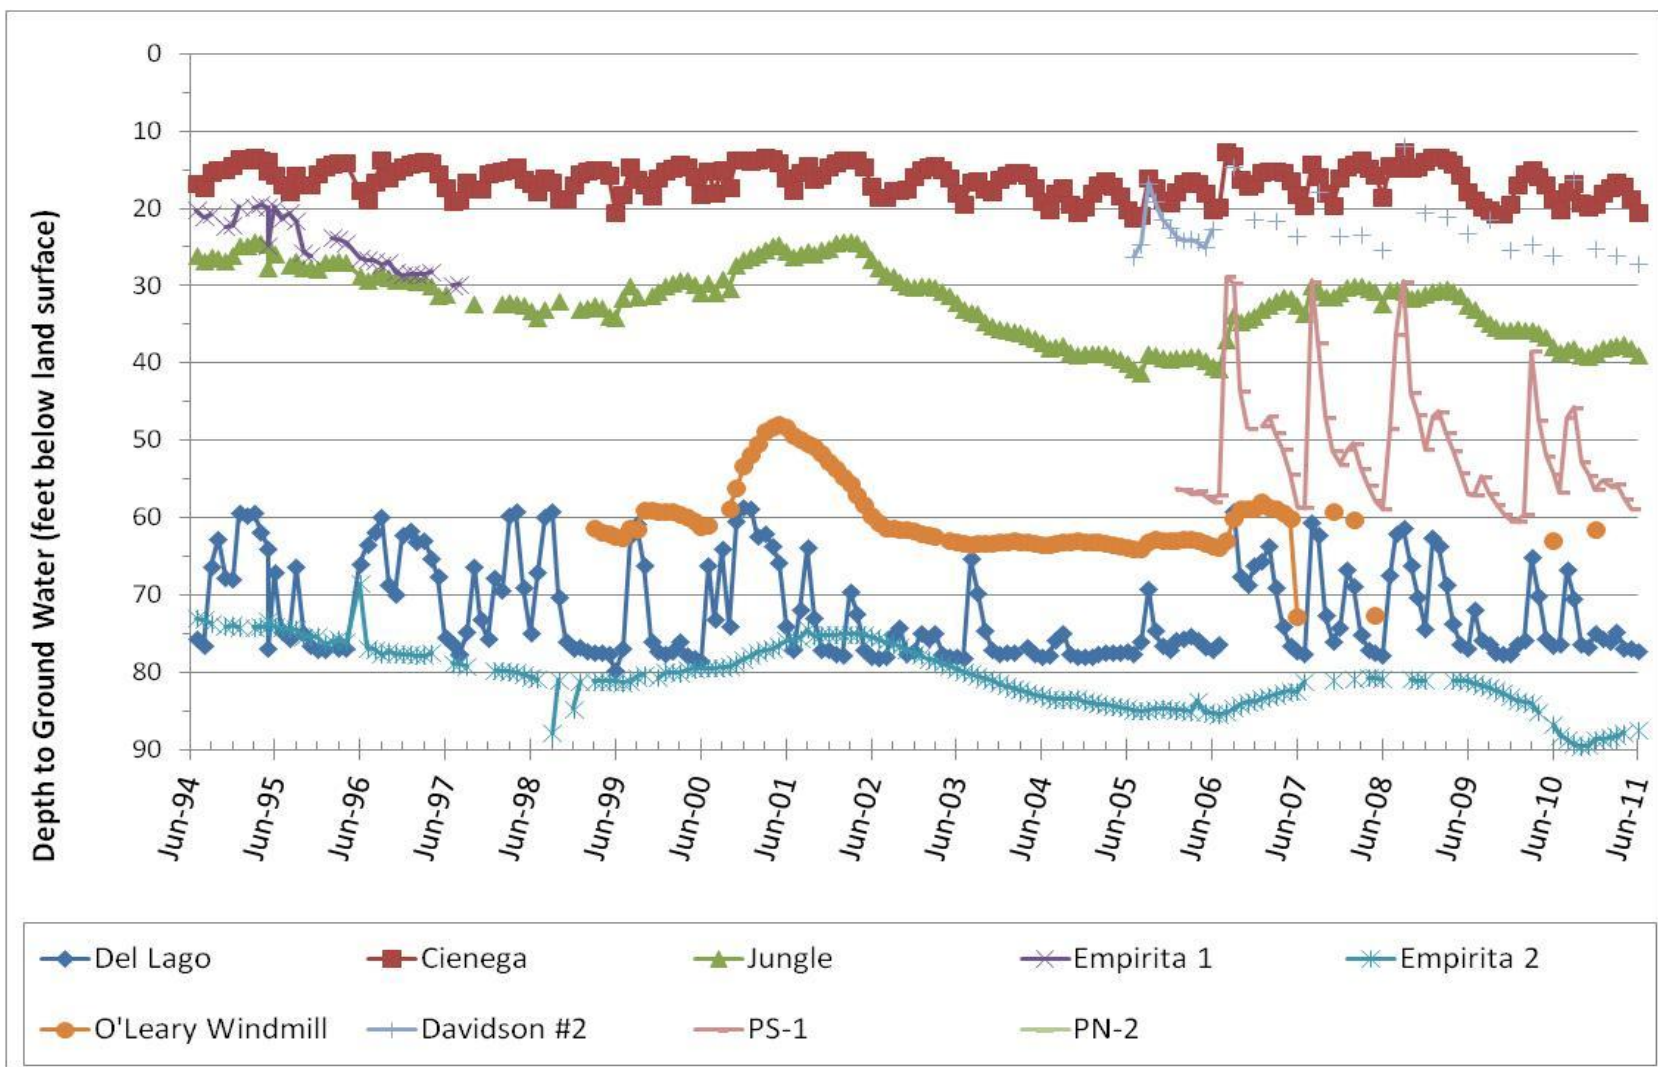
Figure 6A. Cienega Creek Natural Preserve Monthly Depth to Groundwater (June 1994 - June 2011)

Yearly declines in groundwater levels have been exhibited since 1994, with the exception of a brief rise in 2001 and a more prolonged rise from June 2006 to June 2009.. In 2002, drought began to appreciably impact the Cienega Creek Natural Preserve with wells never averaging above pre-drought levels. In FY 09-10, annual mean water levels dropped appreciably at all wells, reaching one of the most severe drought stages on our records because of the lack of summer monsoons. The average change for the 6 wells listed in Table 3 (selected for their consistently available data) was 7.17 feet lower in depth to groundwater (Table 3). In FY 10-11 groundwater levels decreased in most wells, but less drastically than the prior year, averaging 0.66 feet lower (Figure 4).

See Figure 6B to see PN-2, which fell below the scale of this graph.

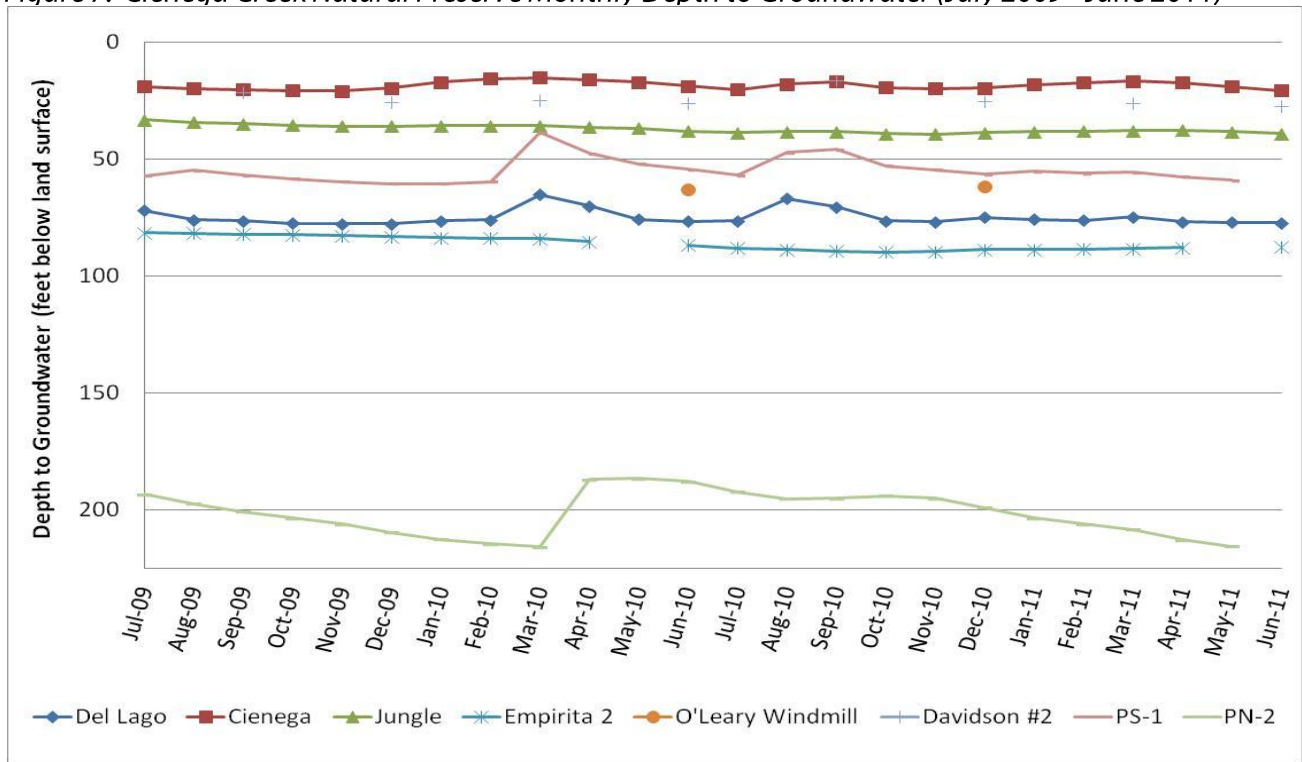
Figure 7. Cienega Creek Natural Preserve Monthly Depth to Groundwater (July 2009 - June 2011)

Data are not available for some months due to inaccessibility.

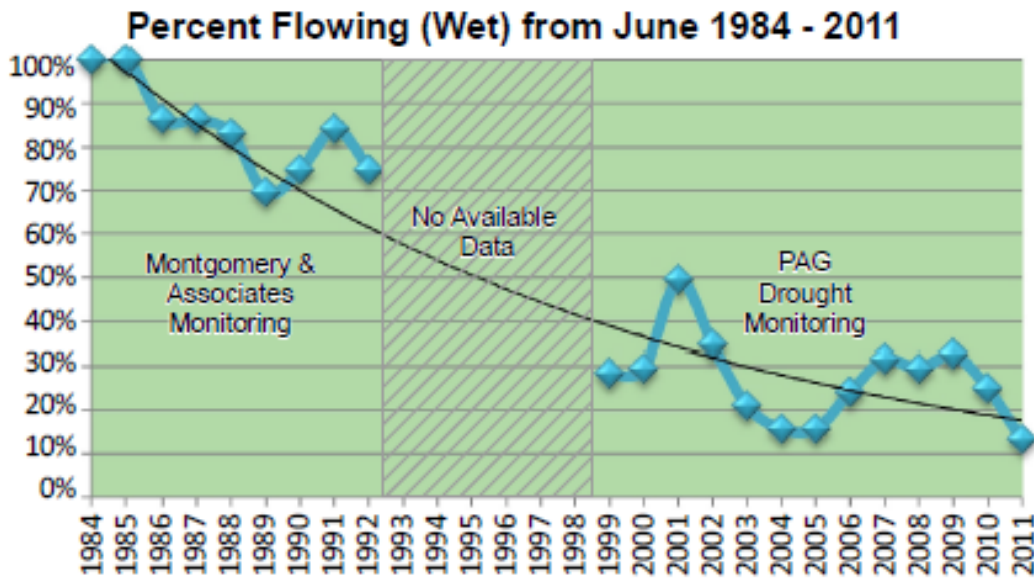
Figure 12. Graph of Percent of Creek Length Flowing in June: Perennial Flow

100% flow refers to the 9.5 miles of creek flow that were present in the wet years of the mid 1980's. This 9.5 miles of creek channel starts at the I-10 overpass at the upstream end of the preserve down to the dam and the downstream end of the preserve. Data is available from the 1970s which reveal less than 100% flow, but that monitoring did not take place in June and so is not included in this graph. Since June is typically the driest time of year, but it can be stated regardless that 100% did not flow perennial those years.

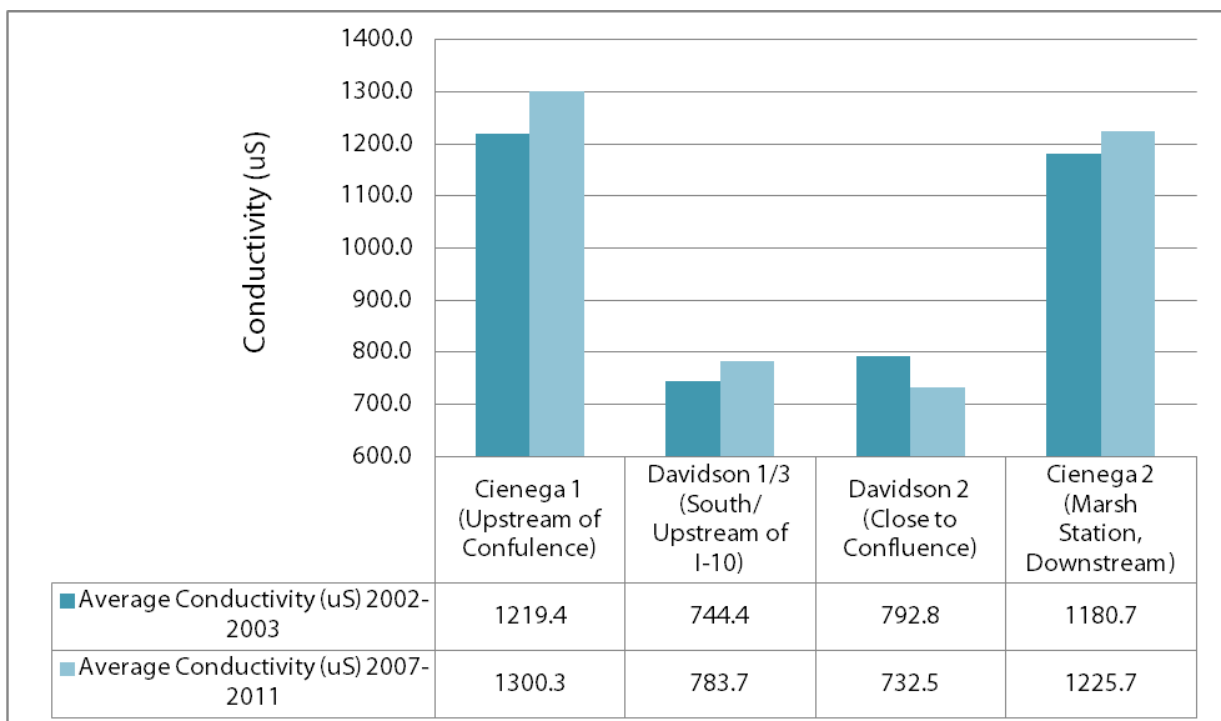
Figure 14. Cienega Watershed – Comparison of Average Conductivity of 2002-2003 to 2007-2011 Time Periods per Site

The average conductivity of the Davidson Canyon sites is lower than the Cienega sites. The contribution of Davidson Canyon to baseflows of Cienega Creek possibly plays a role in creating the lower conductivity found at the Cienega site downstream of the Davidson confluence (Cienega 2) when compared to the site upstream of the confluence (Cienega 1) (Figure 13). The long term trend is illustrated in Figure 14, comparing the last few years' data with 2002-2003 data.

Over the last ten years, we found that average conductivity increased slightly at all sites, except for a slight decrease at Davidson 2 (Figure 14).

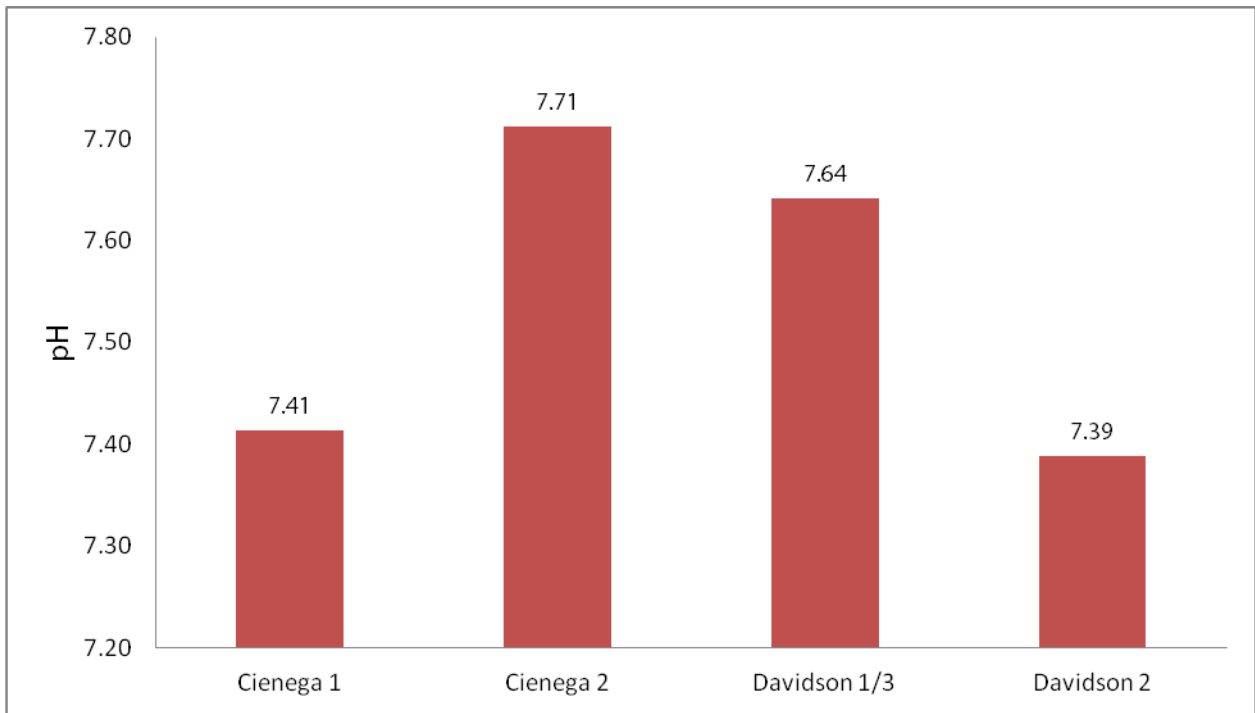
Figure 15. Cienega Watershed – Average pH - 2002 through 2011

The pH was highest at Davidson 1/3 and Cienega 2 (located below the confluence) (Figure 15).

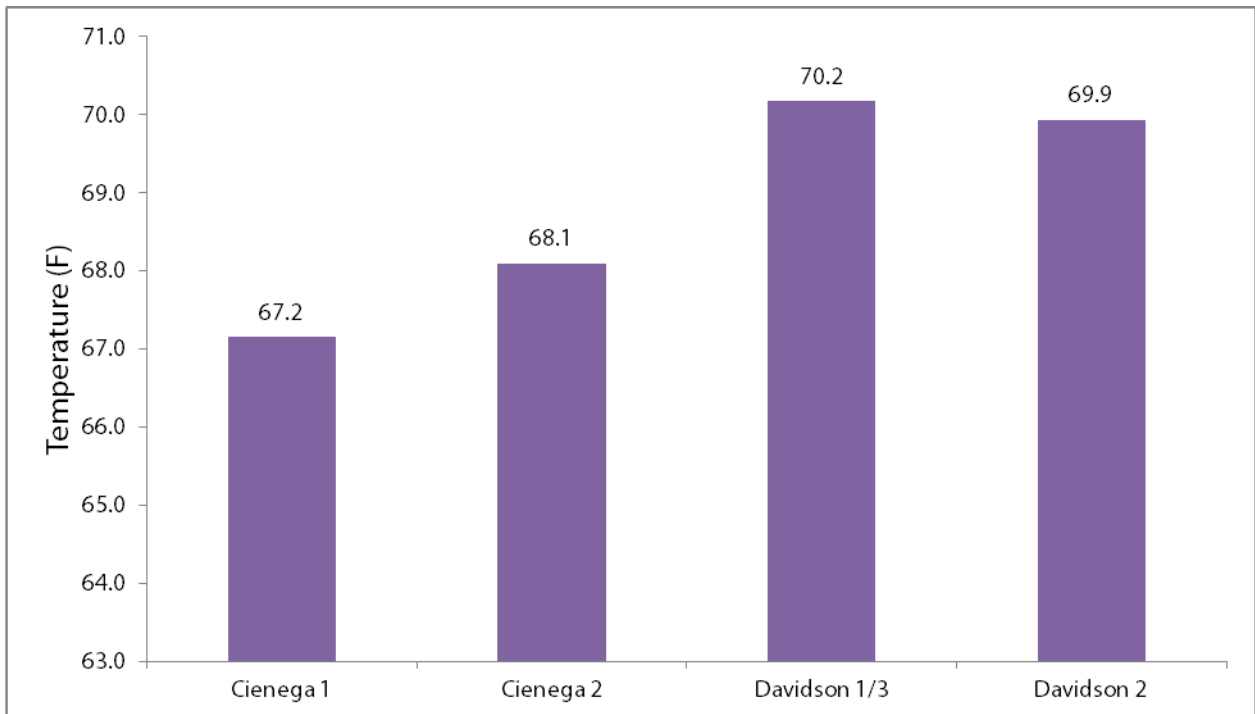
Figure 16. Cienega Watershed – Average Temperature per Site - 2002 through 2011

The temperature was lowest at Cienega 1 (located upstream of the confluence)(Figure 16).

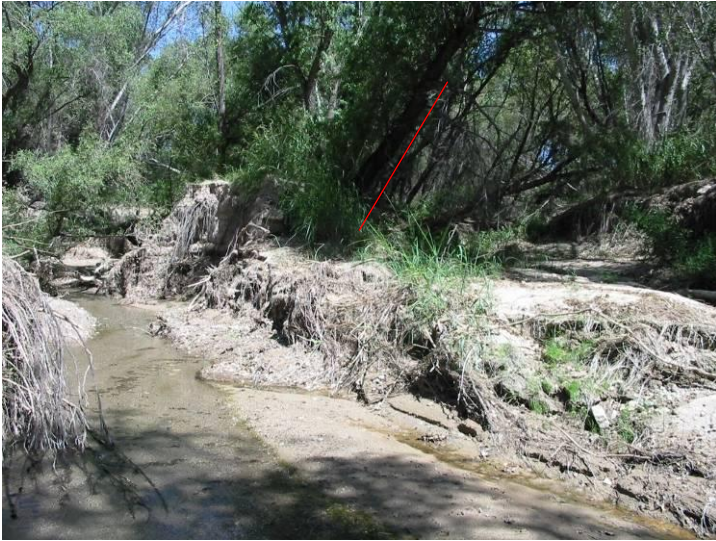
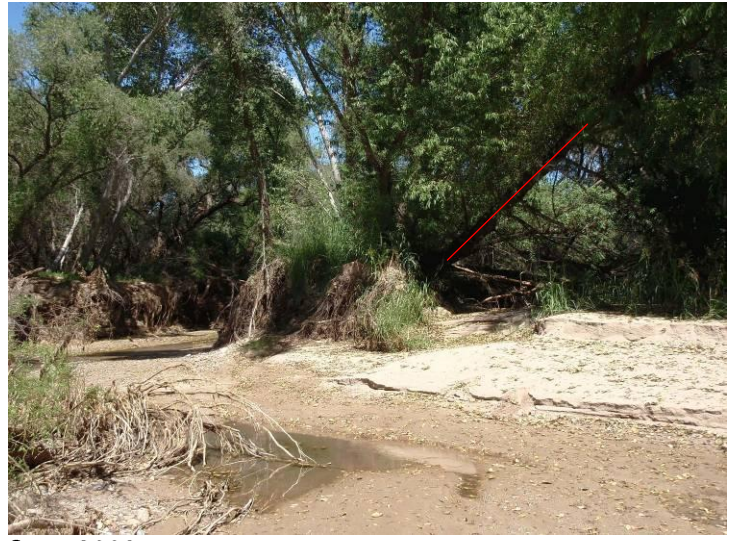
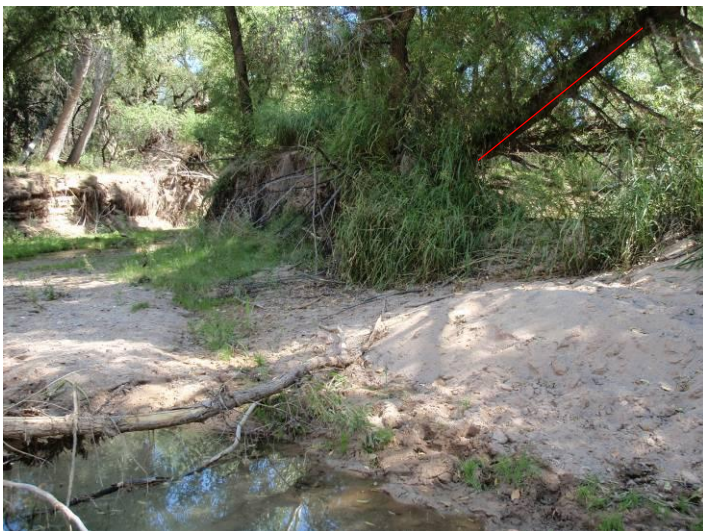
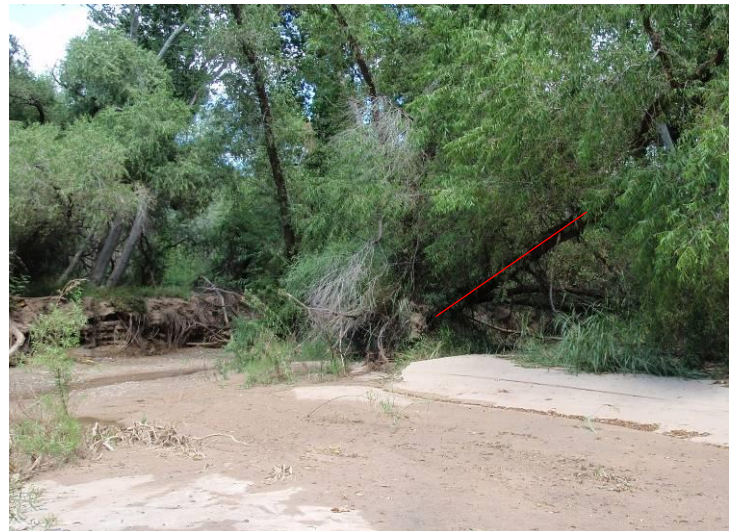
Figure 17. Erosion and sedimentation changes in the headcut  
Repeat photography at site HCb, looking upstream along Cienega Creek. These photographs show the original headcut channel on the left and the second fork on the right, with its entrance hidden by a sand berm.

*Note: The tree is highlighted in red, so that the reader can match the photographs.*

For this FY 10-11 report, we have selected photos from repeat photography sites Headcut A and Headcut B (HCa and HCb), to demonstrate the pronounced erosion and sedimentation changes that have occurred (Figures 17 and 18). In Figure 1A, this location has a triangle symbol near the middle of the preserve where the railroad makes a horseshoe turn around a large wash and wetlands. These two locations are within 30 feet of one another, and are distinguished primarily by the direction they face.

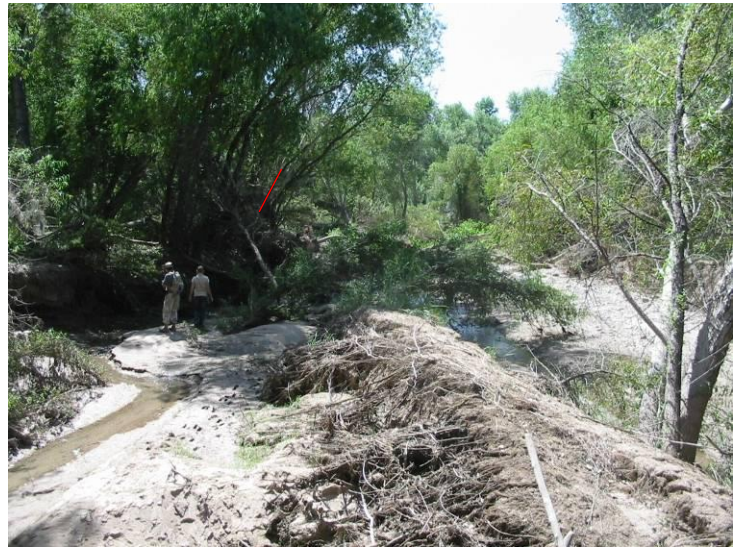
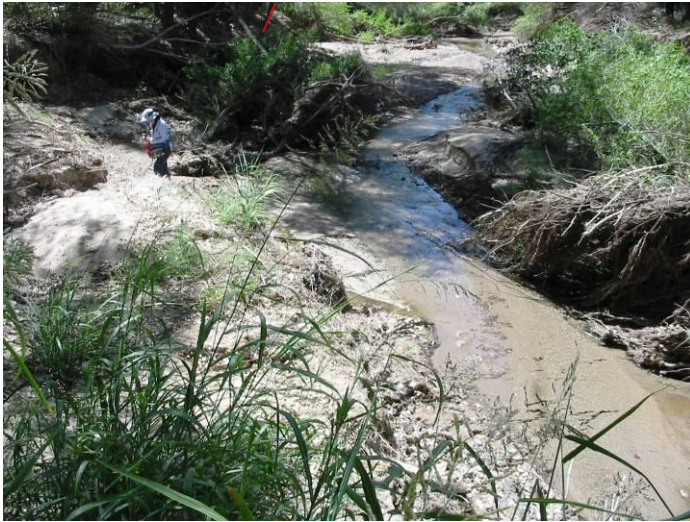
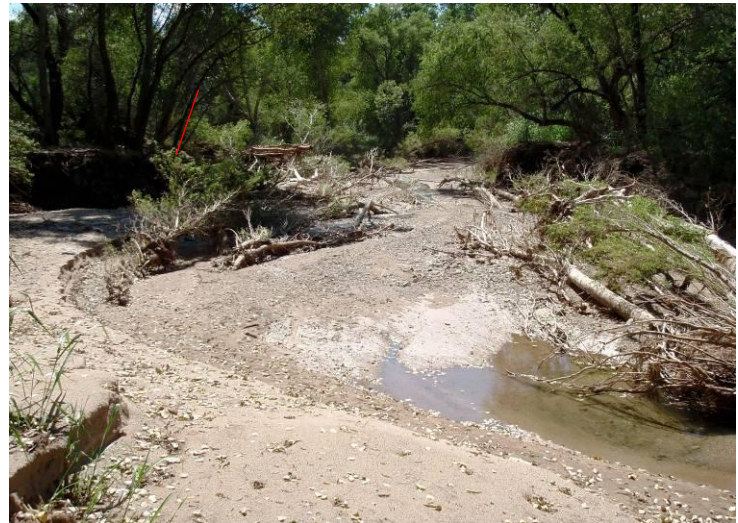
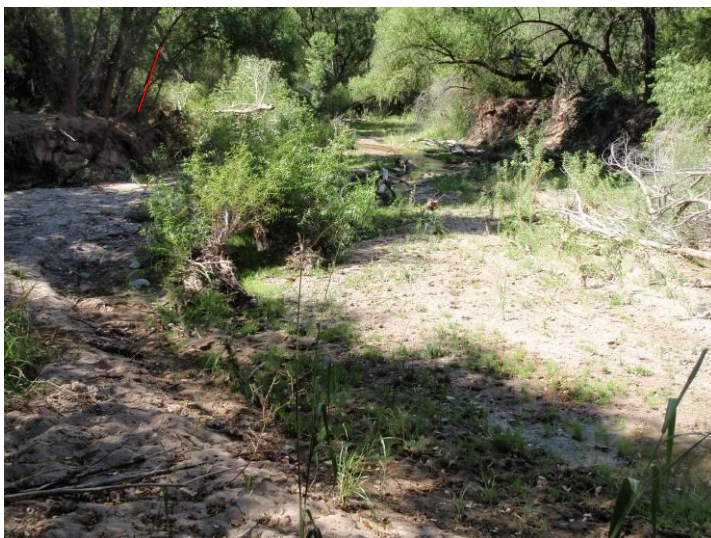
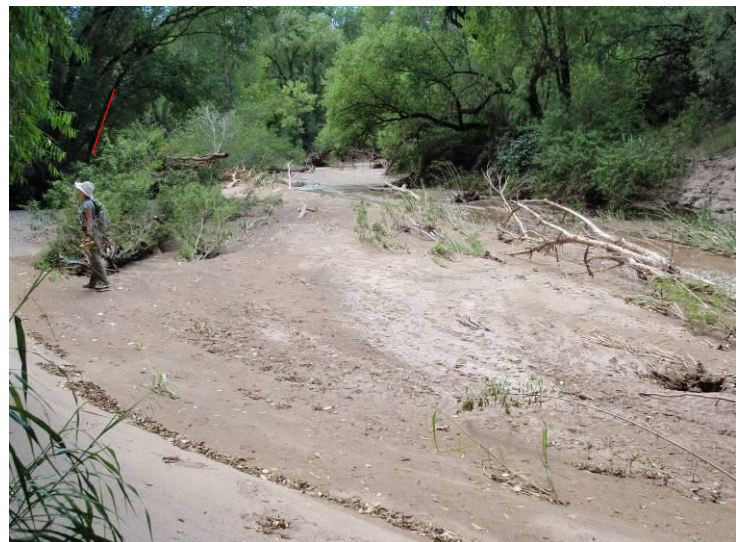
*The tree is highlighted in red, so that the reader can match the photographs.*
