**Tucson Mountain Watercourse Studies:
Technical Data Notebook for Hydrologic and Hydraulic Mapping of the Unnamed 02
and 03 Washes,
Pima County Arizona.**

FEMA FIRM Panel 04019C-1655L

Pima County Regional Flood Control District
97 E Congress Street
Tucson Arizona, 85701

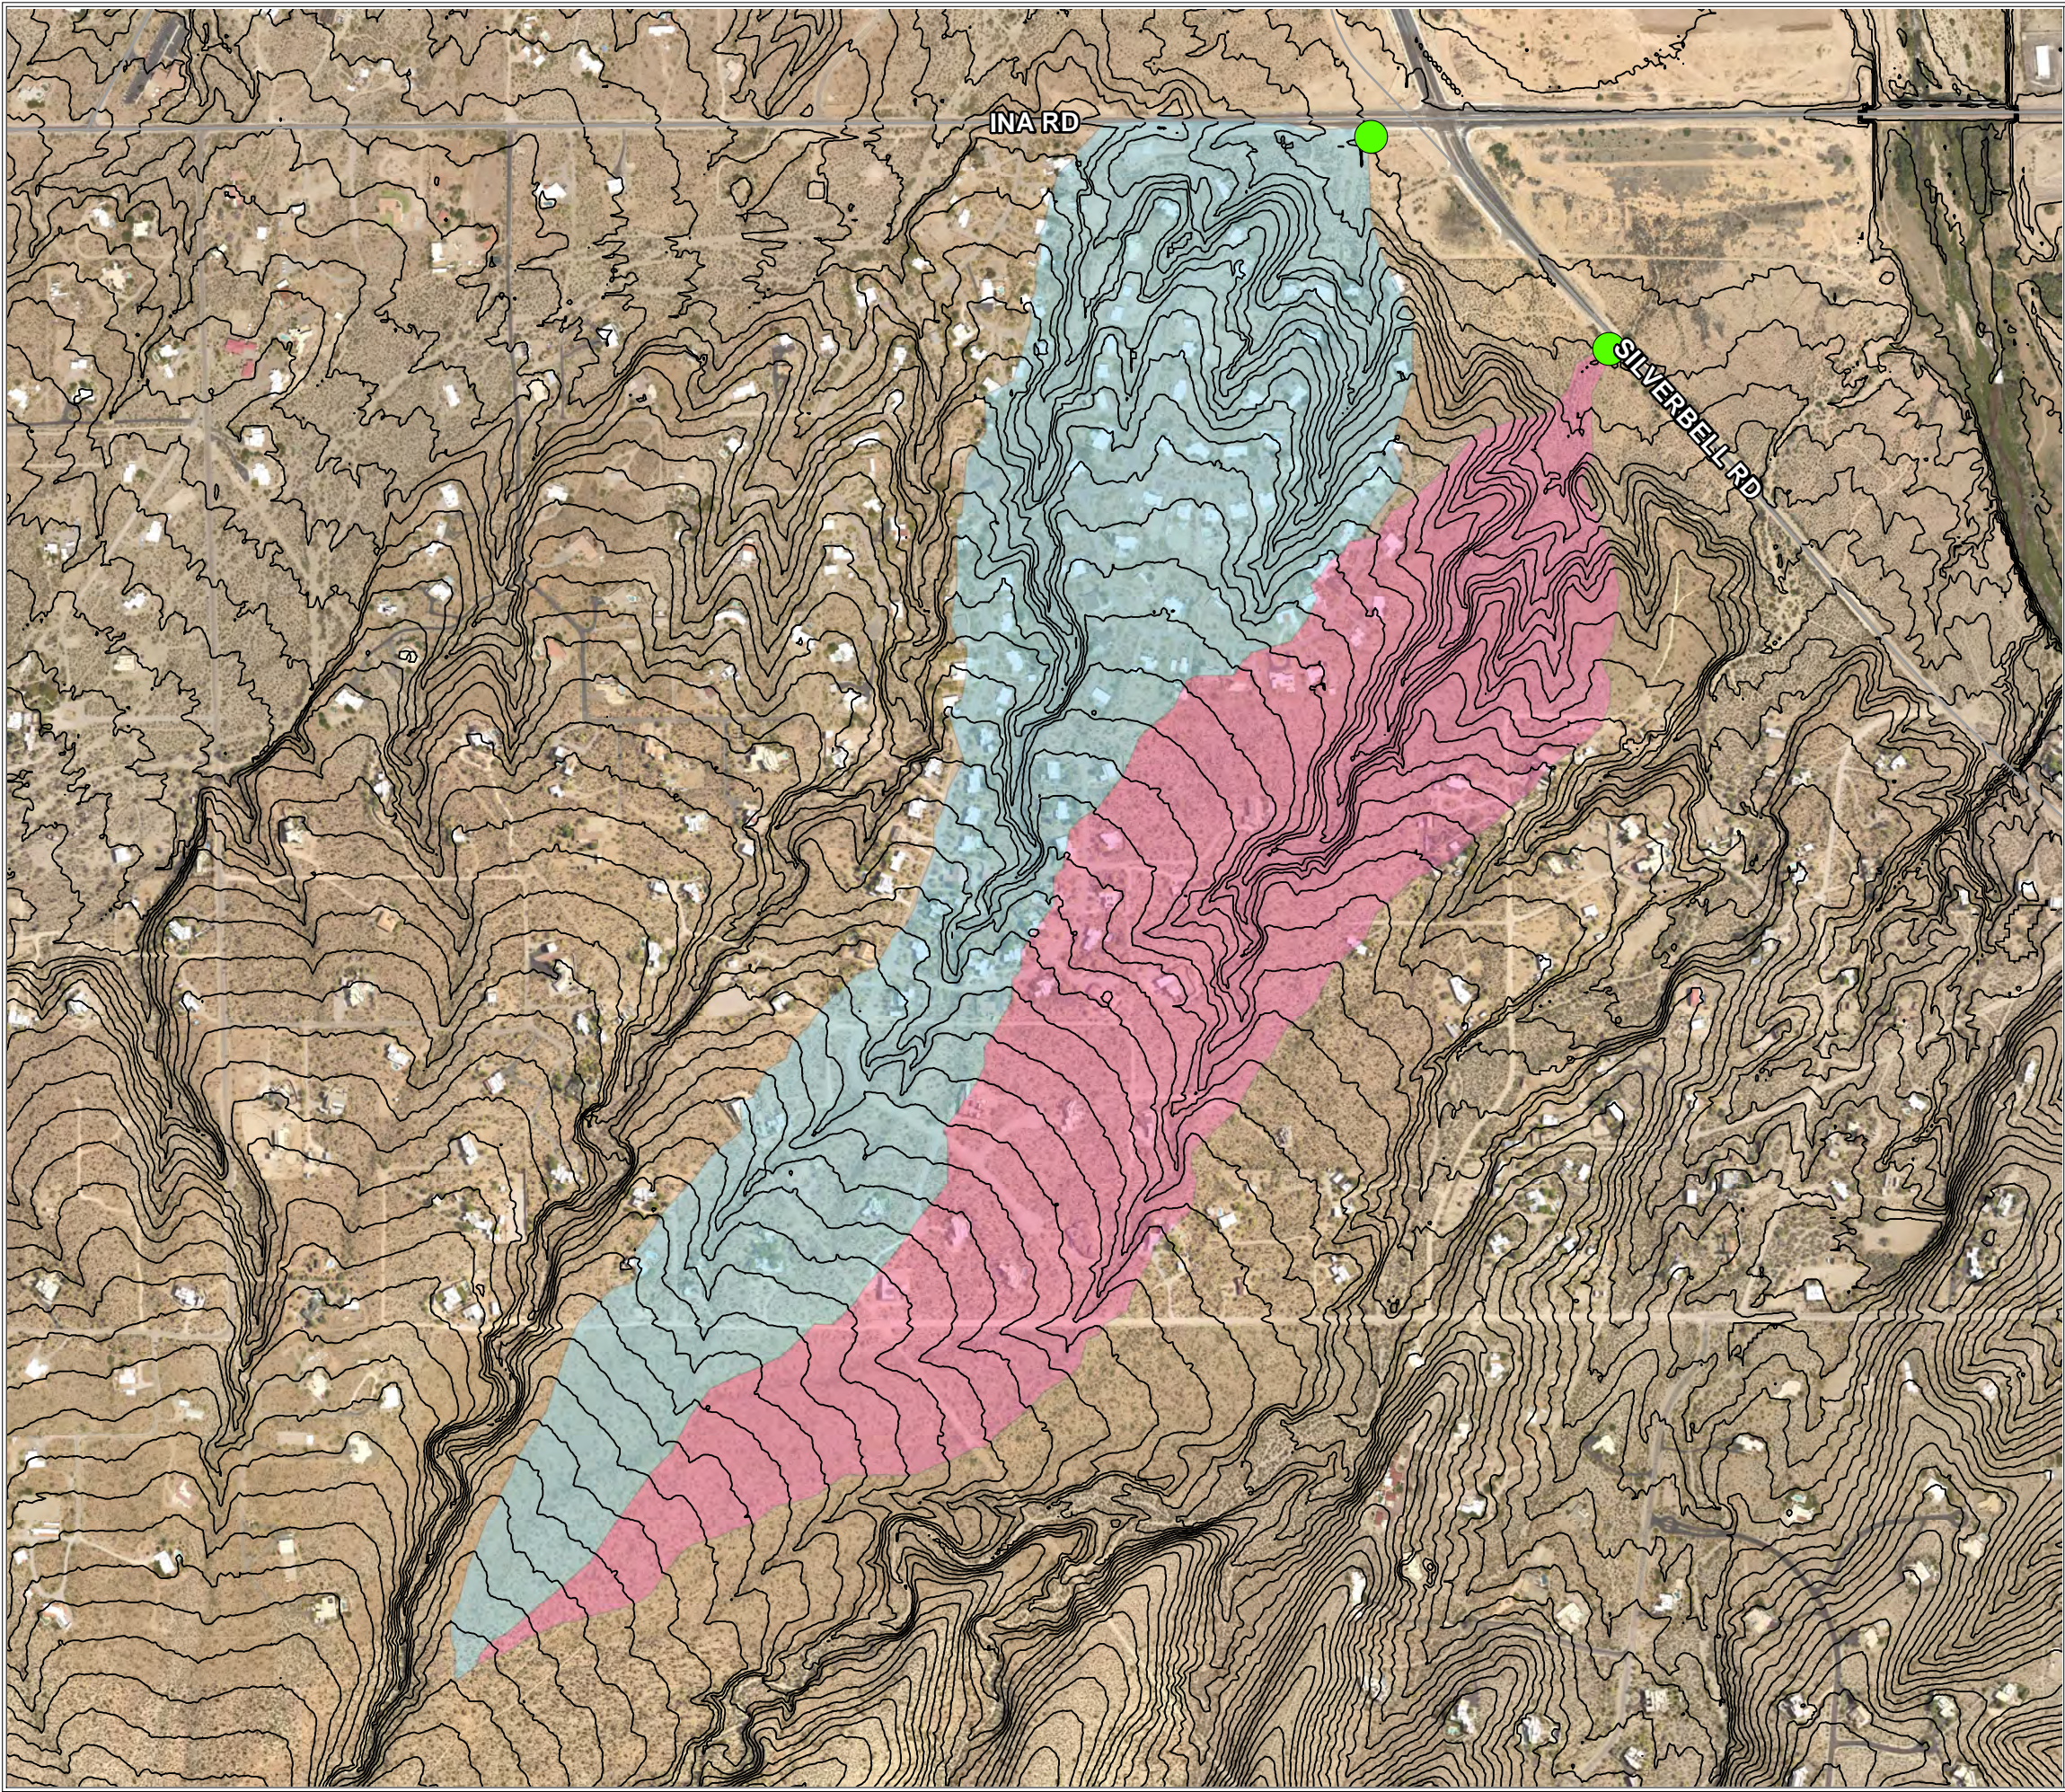
Figure 1.1
Watershed Map
Unnamed 2 Wash
Unnamed 3 Wash

The study area for the Unnamed 02 Wash is from Ina Rd. to Stable TR. (Fig.1.1). The study watershed is 0.25 square miles (Fig.1.2). The study area for the Unnamed 03 Wash

is from Silverbell Rd. to ~700 feet east of Paddock Pl. (Fig.1.1). The study watershed is 0.25 square miles (Fig.1.2).

The Unnamed 02 and 03 Washes watersheds are located within FEMA Zone X. The study area for the Unnamed 02 Wash is from Ina Rd. to Stable TR. (Fig.1.1). The study watershed is 0.25 square miles (Fig.1.2). The study area for the Unnamed 03 Wash is from Silverbell Rd. to ~700 feet east of Paddock Pl. (Fig.1.1). The study watershed is 0.25 square miles (Fig.1.2).

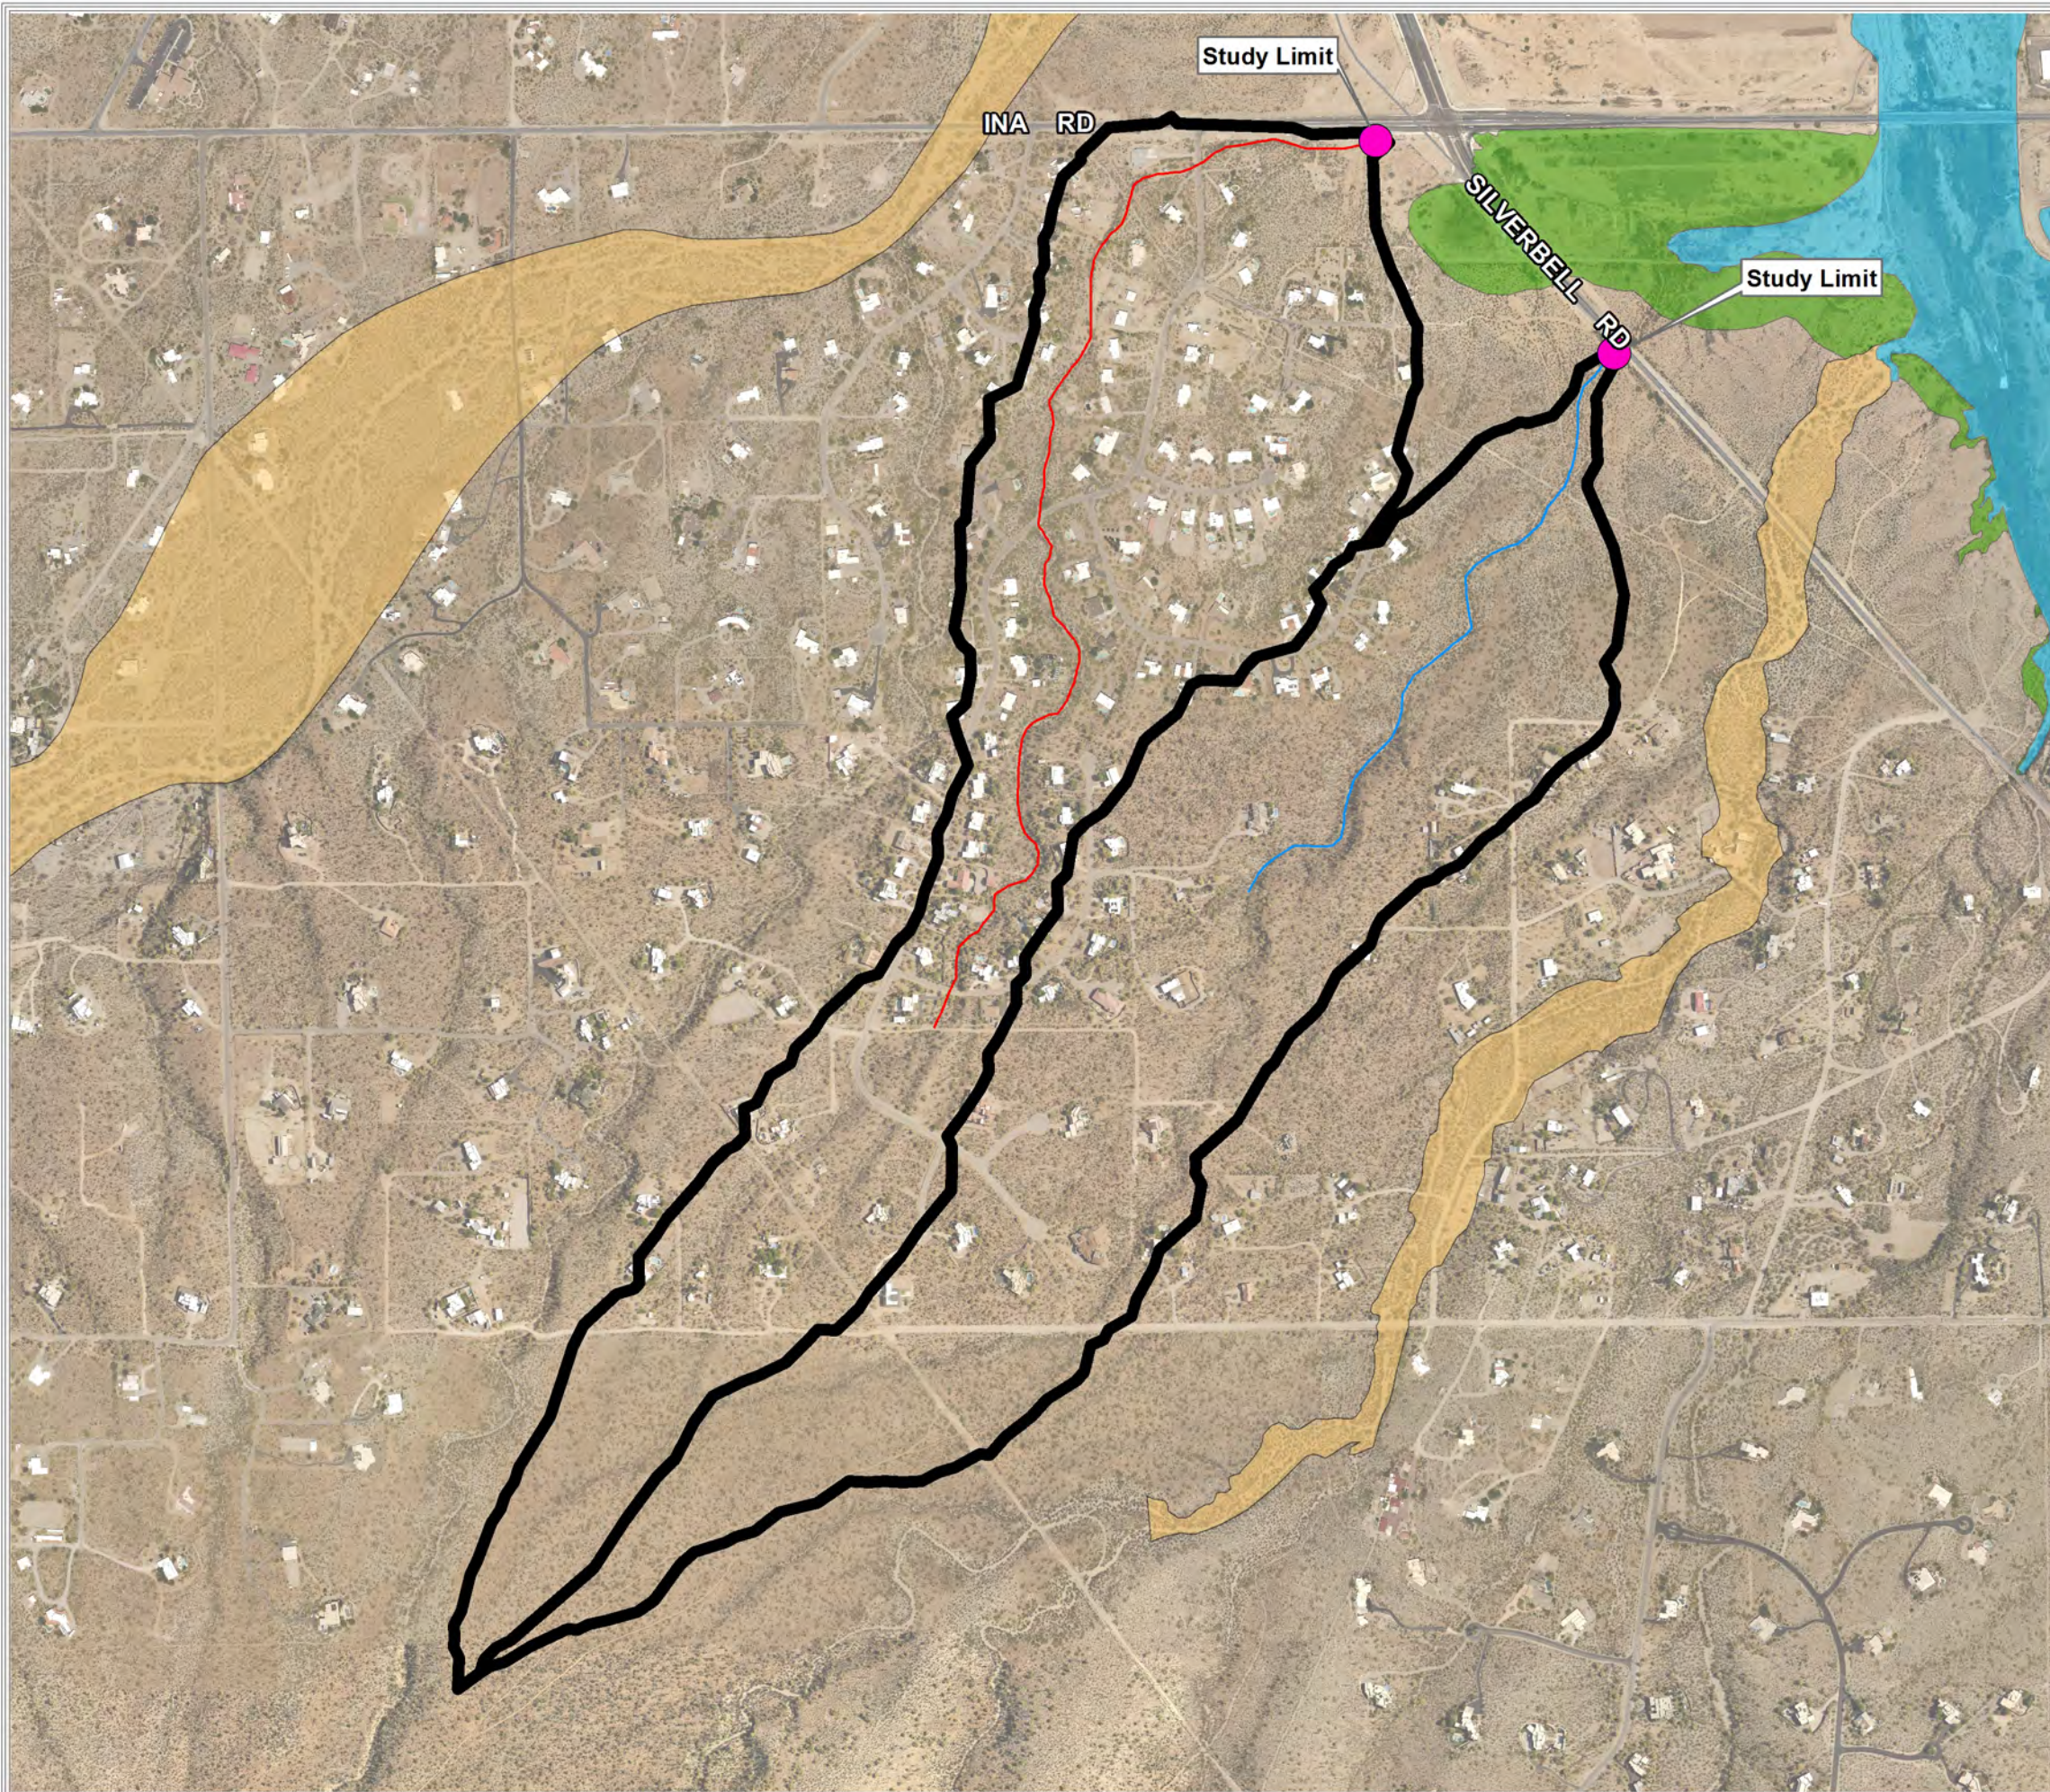
Figure 1.2
Study Limit
Unnamed 2 Wash
Unnamed 3 Wash

The 100-yr discharges were calculated for the Unnamed 02 and 03 Washes. Subbasin boundaries and corresponding CPs are illustrated in Figure 1.2. Hydrologic characteristics for the studied subbasins are presented in Table 2. Calculated discharges are summarized in Table 3. The calculated discharges are compared with the USGS Regional Regression Equation (Table 4). The comparison shows that the peak discharges calculated in this study are reasonable. This study found one home in the Unnamed 02 Wash watershed at risk for flooding during the 100-yr flood.

- Discharge Points
- River Unnamed 2
- River Unnamed 3
- Watersheds
- Existing FEMA Floodplain**
- ZONE A
- ZONE AE
- ZONE X - SHADED

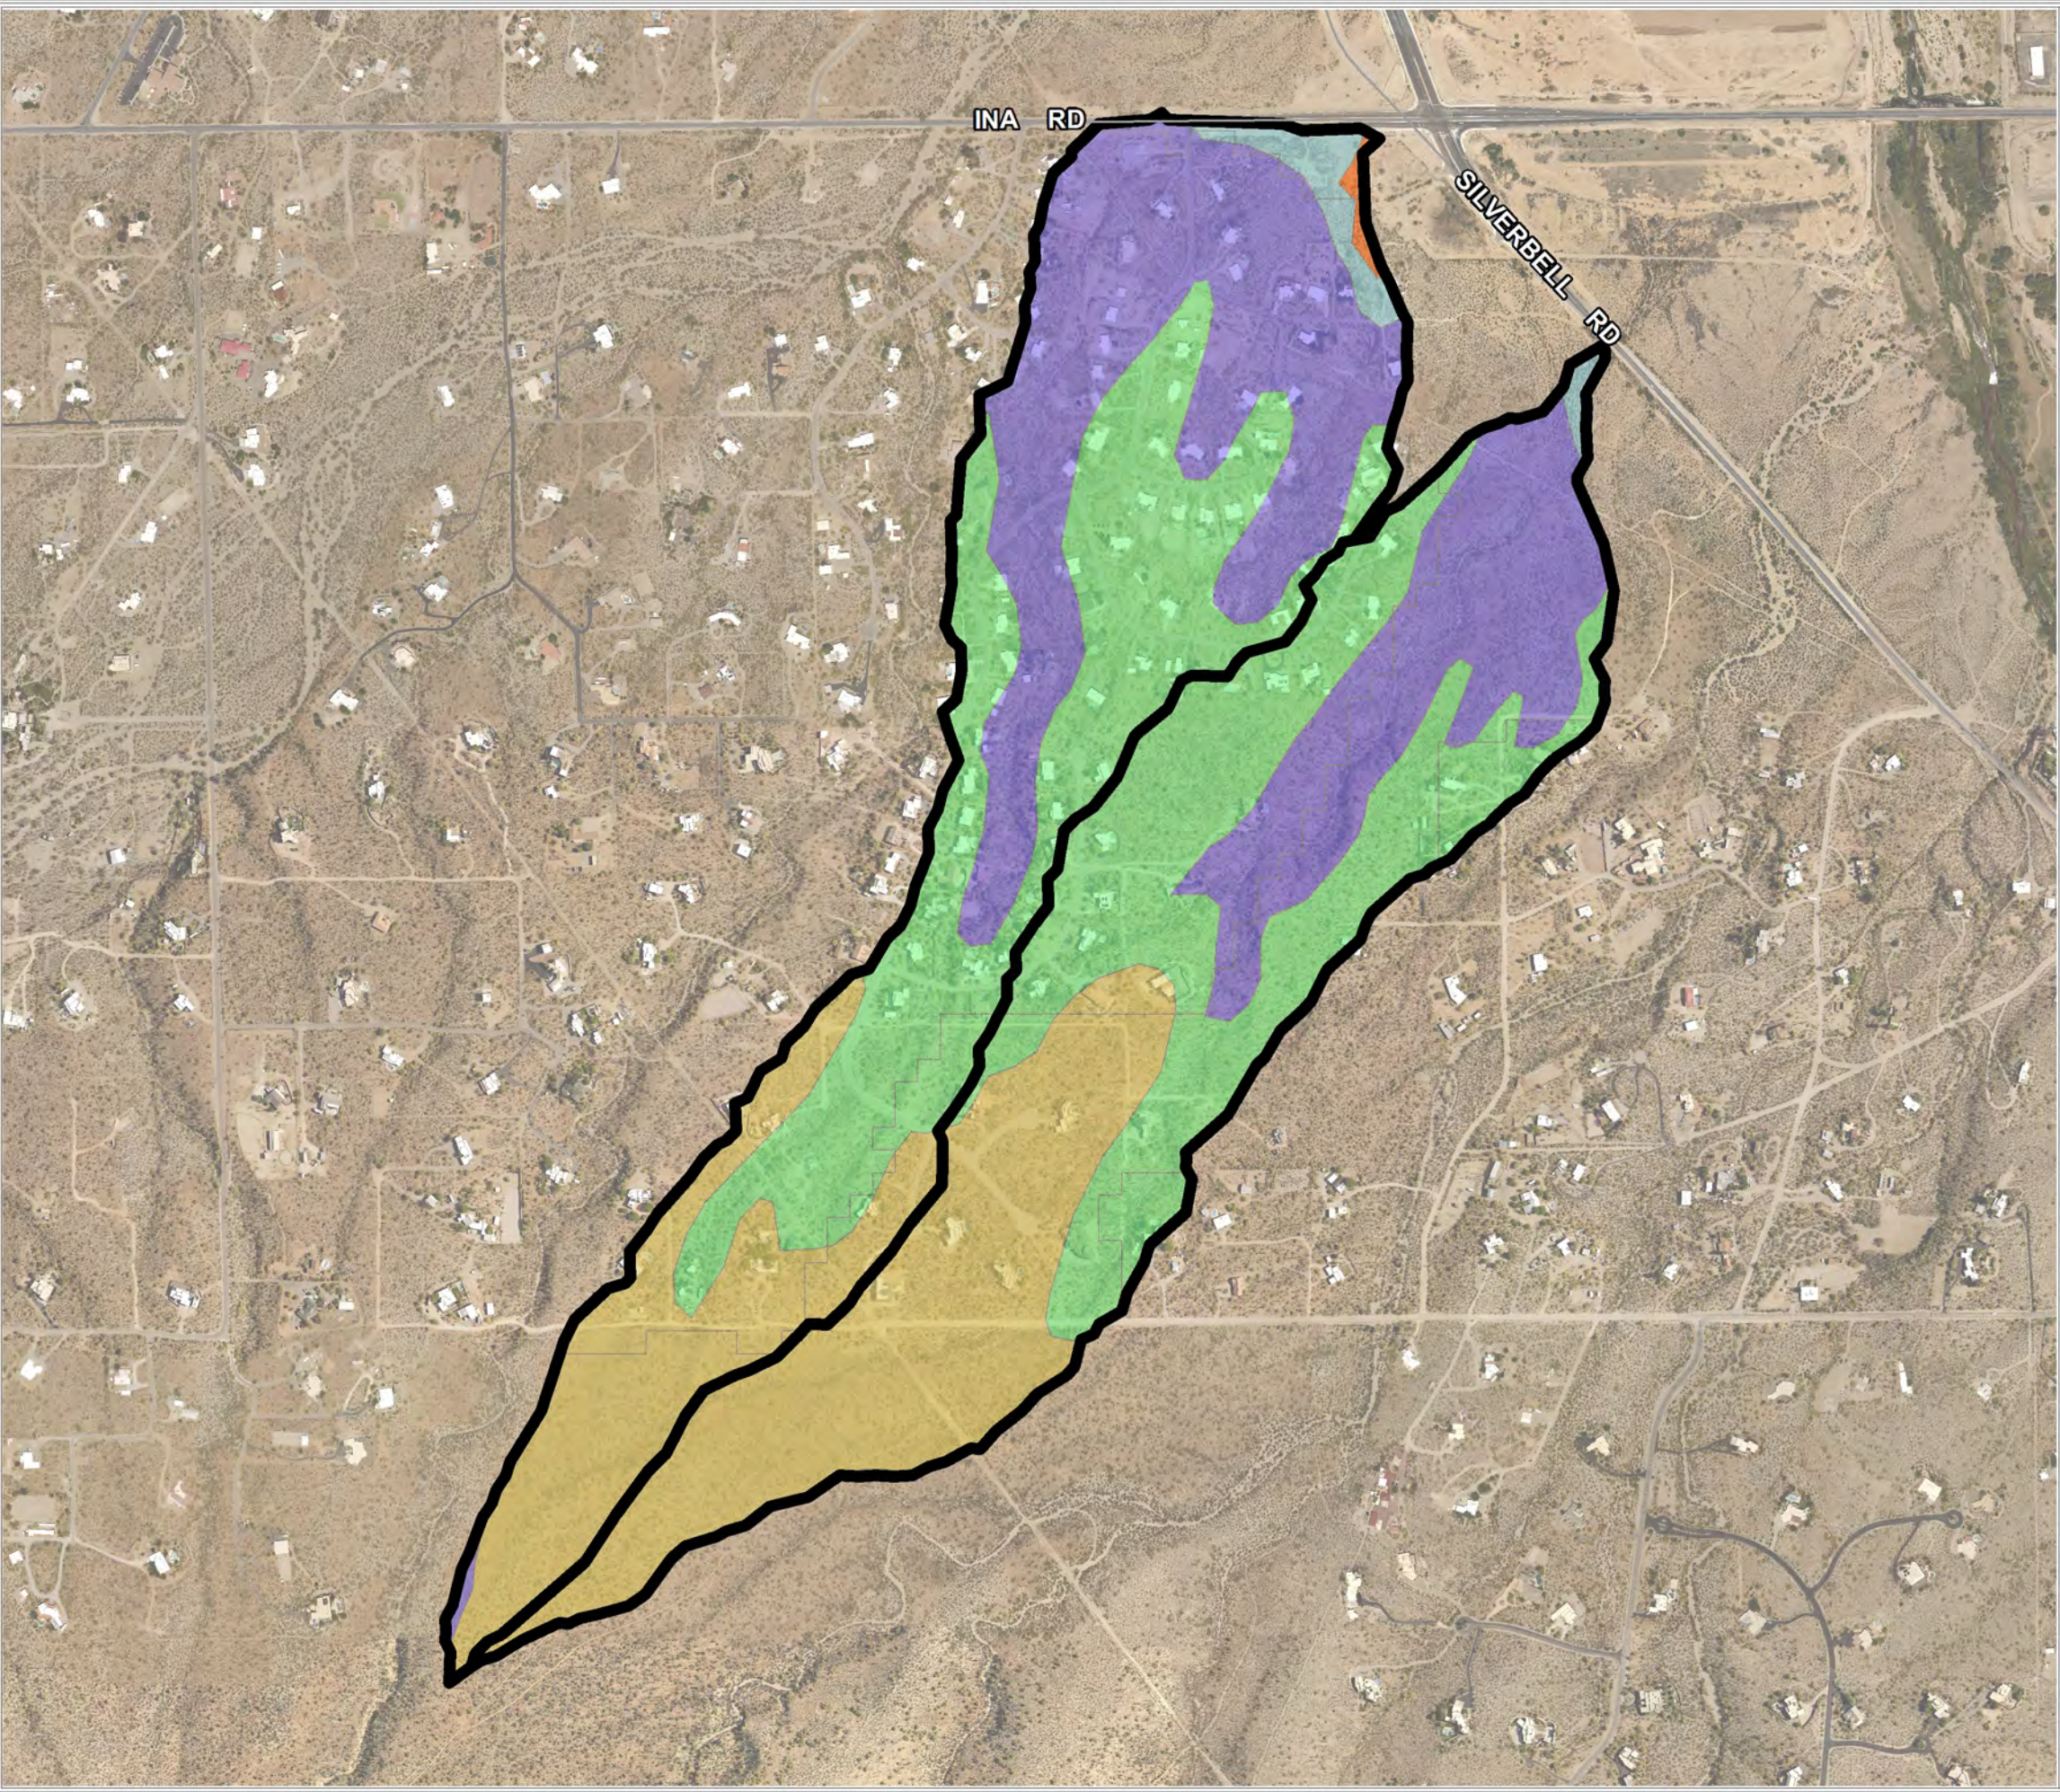
Figure 1.3
Soil Classification
Unnamed 2 Wash
Unnamed 3 wash

Soil Group: B (100%), ANTHONY FINE SANDY LOAM, 0 TO 3 PERCENT SLOPES
-

Soil Group: B (100%), PINALENO VERY COBBLY SANDY LOAM, 1 TO 8 PERCENT SLOPES
-

Soil Group: B (100%), PINALENO-STAGECOACH COMPLEX, 5 TO 16 PERCENT SLOPES
-

Soil Group: B (100%), STAGECOACH-SAHUARITA ASSOCIATION, 1 TO 8 PERCENT SLOPES
-

Soil Group: C (100%), TUBAC GRAVELLY LOAM, 1 TO 8 PERCENT SLOPES
