## **Flood Control District of Maricopa County**

### **Engineering Division, Flood Warning Branch**

# **Storm Report : July 18, 2015 Vicinity of Wickenburg, AZ**

Revision 1 - Sep. 4, 2015

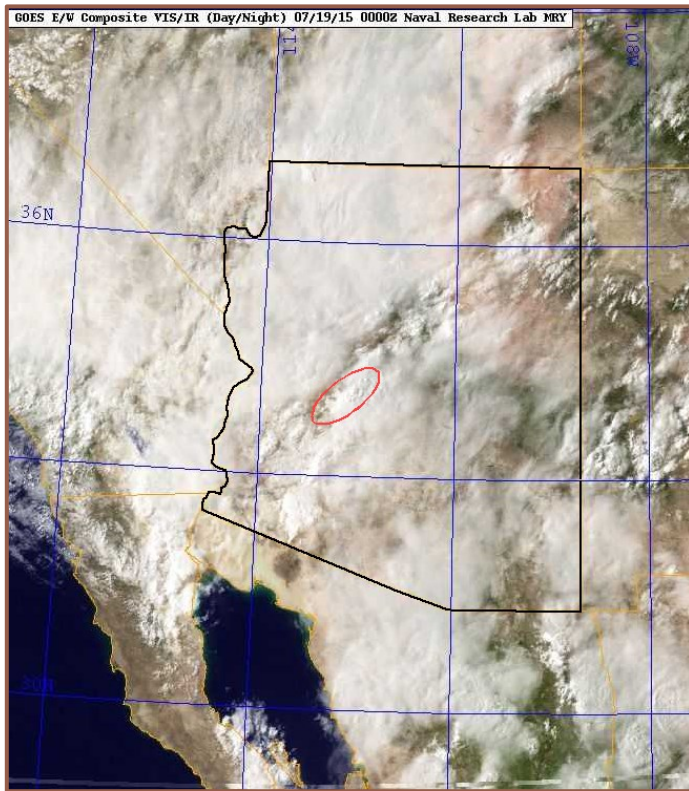
**FIGURE 1**

*True-color visible satellite photo of AZ from GOES West - 5PM MST on July 18th. Red ellipse denotes the location of the Wickenburg storm.*

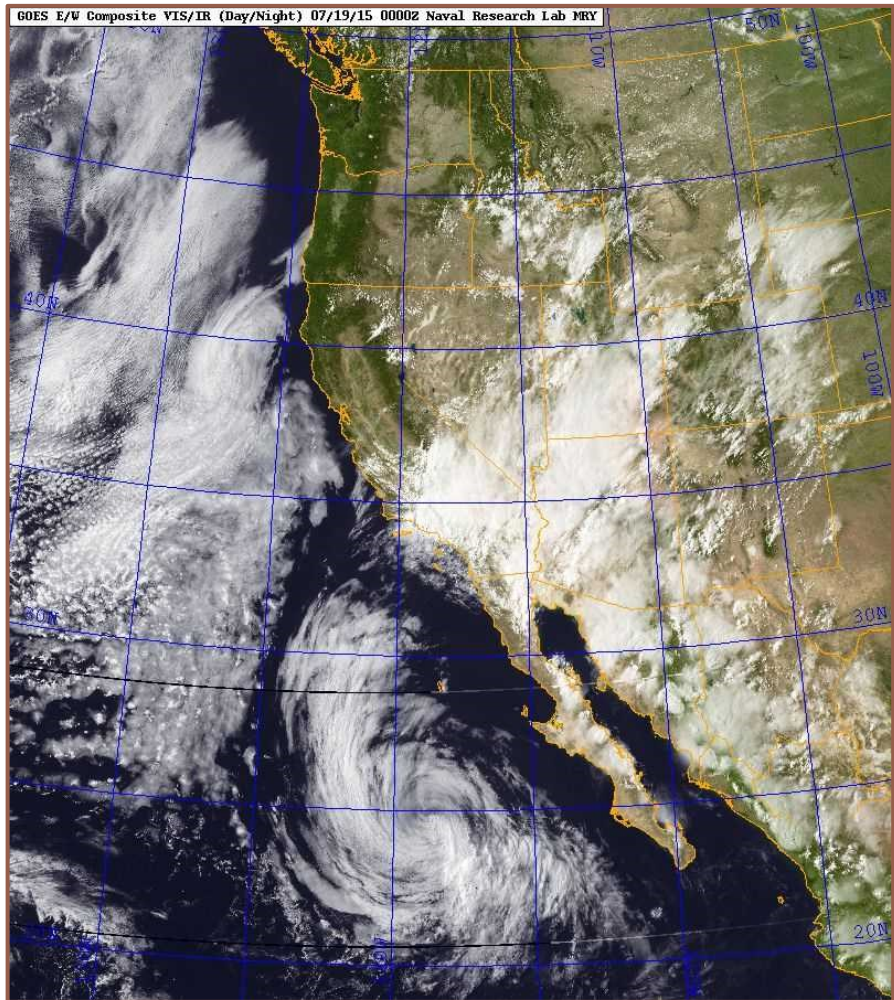
**FIGURE 2**

*True-color visible satellite photo of the eastern Pacific from GOES West - 5PM MST on July 18th. Note position and influence of Hurricane Delores.*

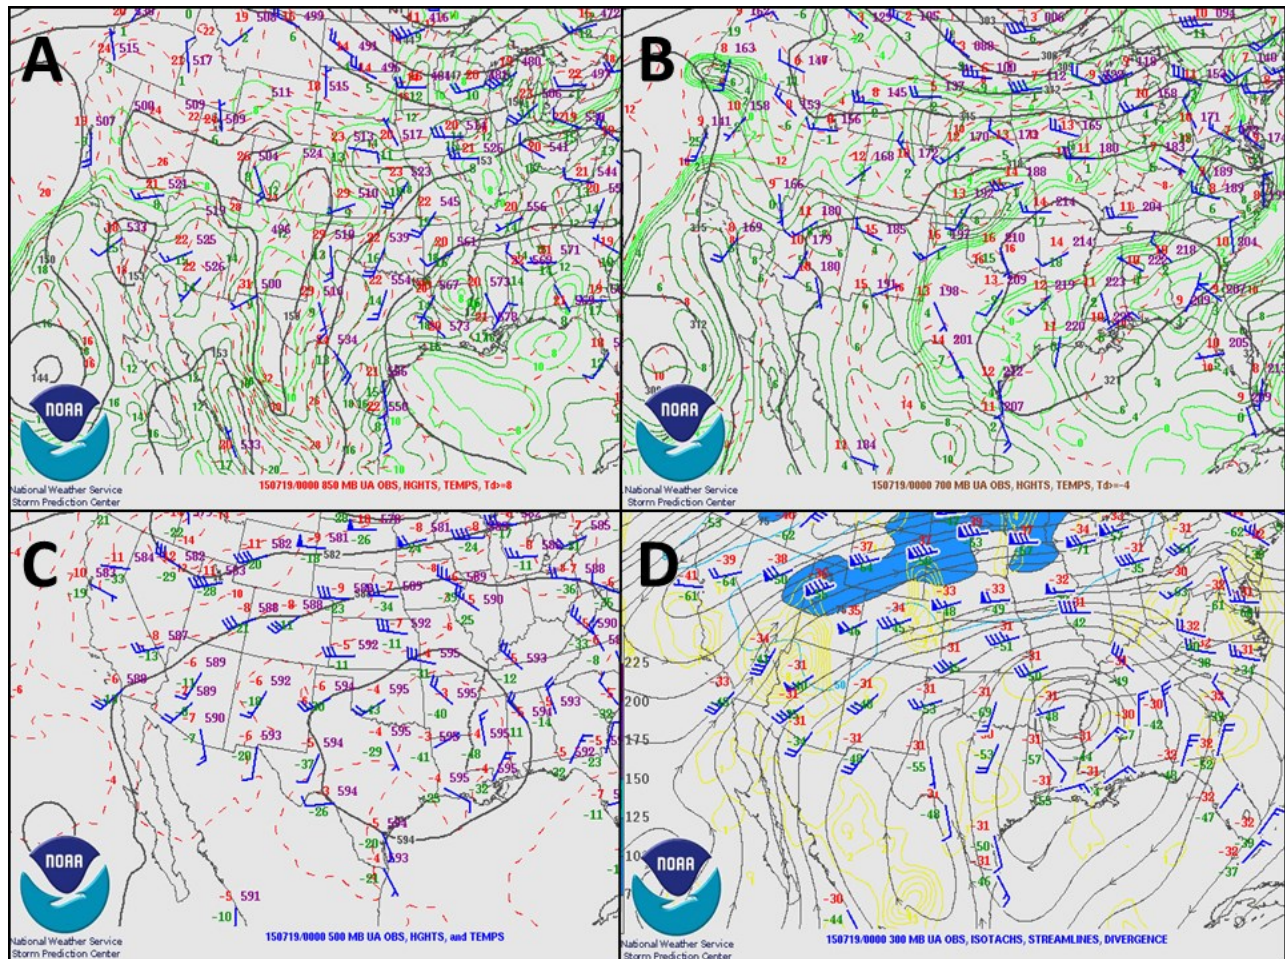
FIGURE 3

**Figure 3** depicts the synoptic setup at 5:00 PM MST on July 18<sup>th</sup> 2015. The images are from the Storm Prediction Center upper air maps archive. **A)** is the 850mb map: the black lines are heights, the red dashed lines are isotherms, the green lines are isodrosotherms, blue barbs are wind speed, and station observations are plotted at each available location. **B)** is the 700mb map: variables colored the same as A. **C)** is the 500mb map: variables colored the same as in A. **D)** is the 300mb map: the black lines are stream lines, the yellow lines are divergence, and station observations are plotted at each available location.

The synoptic setup on the evening of the event is shown in Figure 3 (page 6). The upper level images (C and D) depict the Monsoon ridge suppressed across southeastern TX and a large scale trough off the western coast of CA; meanwhile the remnants of Dolores are seen off the west coast of BC in each of the four images. It's worth noting that this persistent upper-level pattern was evident days before the event and was one of the main drivers helping to draw the tropical system and subsequent moisture north. Looking at the mid-levels, moist south/southwesterly flow was evident in both the 700mb and 850mb maps. Surface moisture values were rather high with area dewpoints running in the mid to upper 60s across much of west central AZ, [image](#) (courtesy of NWS Storm Prediction Center at 00Z, 5:00pm MST). Precipitable water values were measured throughout the day as the deep surge of tropical moisture moved north into southern AZ/CA. A value of 1.73" was observed on the 00Z, 5:00pm MST, KPSR sounding (Figure 2, below) which according to the Storm Prediction Sounding Climatology page (can be viewed [here](#)) was a period of record daily max.

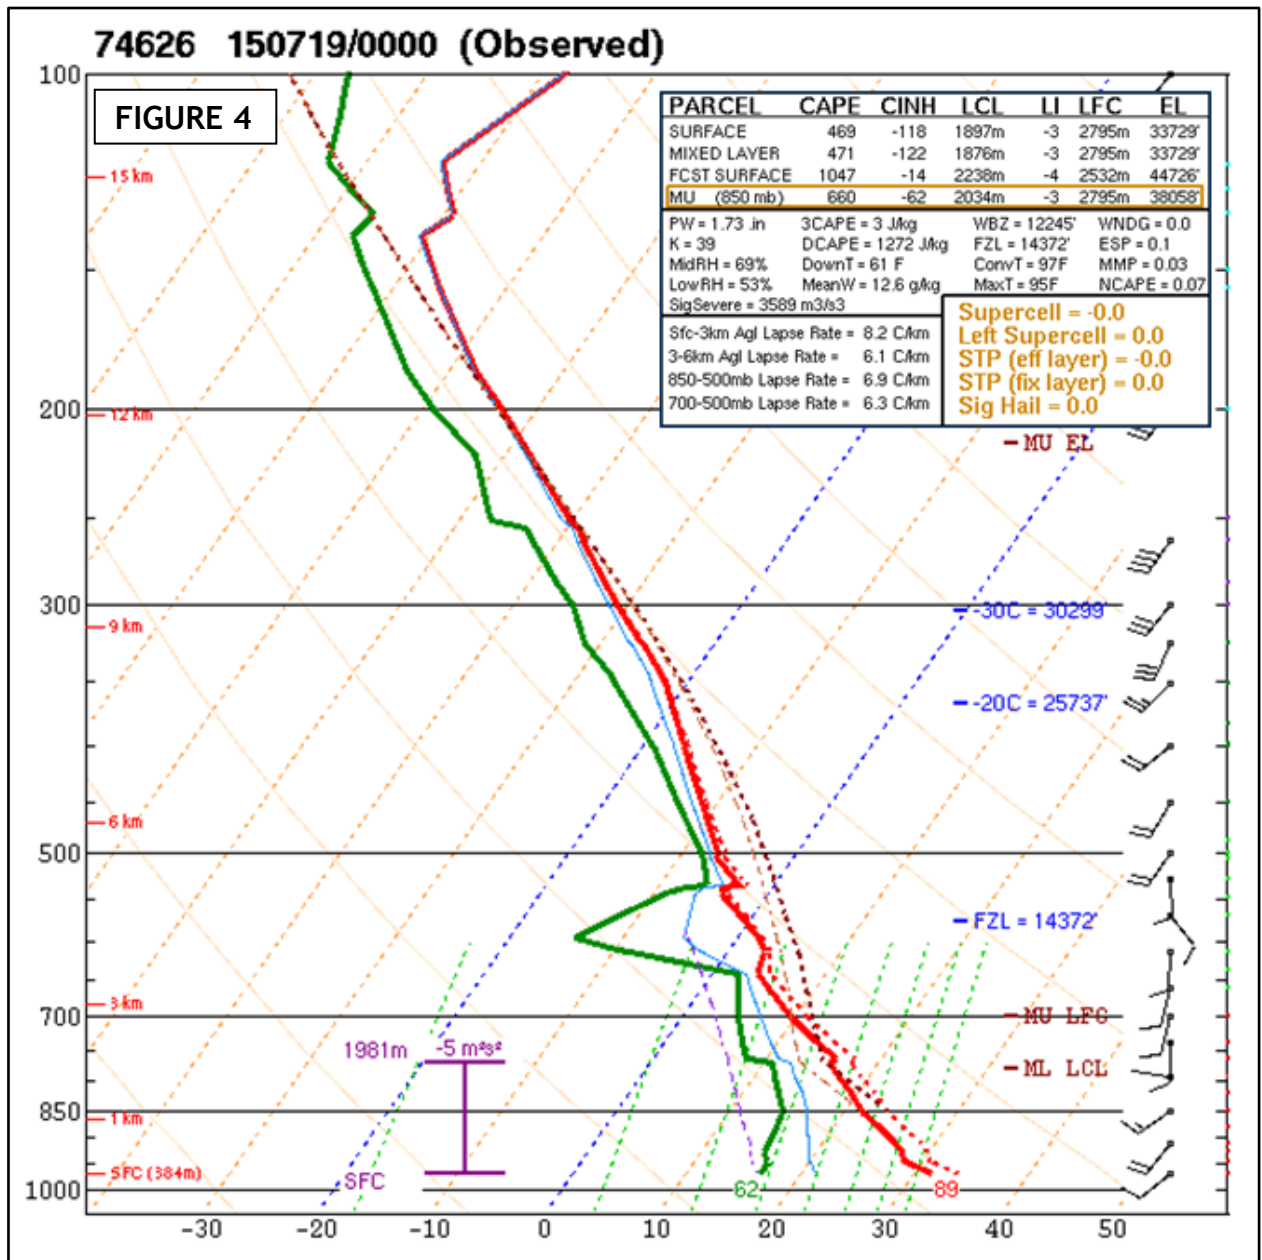
**Figure 4:** Observed Skew-T/log P (vertical profile of the atmosphere above Phoenix) diagram at 5:00pm MST on July, 18<sup>th</sup>, 2015. Sounding generated from NOAA/SPC. The vertical axis is pressure in (hPa) and the horizontal axis is temperature in (°C). The thick solid red line is the temperature profile. The thick solid green line is the moisture profile. The dashed red lines are the atmospheric parcel profiles. The vertical axis on the right displays the wind speed and direction at each level in knots. Thin solid brown lines sloping from upper left to lower right are constant potential temperature (°K). Thin dashed brown and blue lines sloping from right to left are isotherms (°C). Thin dashed green lines sloping from right to left are mixing ratio (g/kg). The table in the top left displays various parcel attributes and thermodynamic indices.

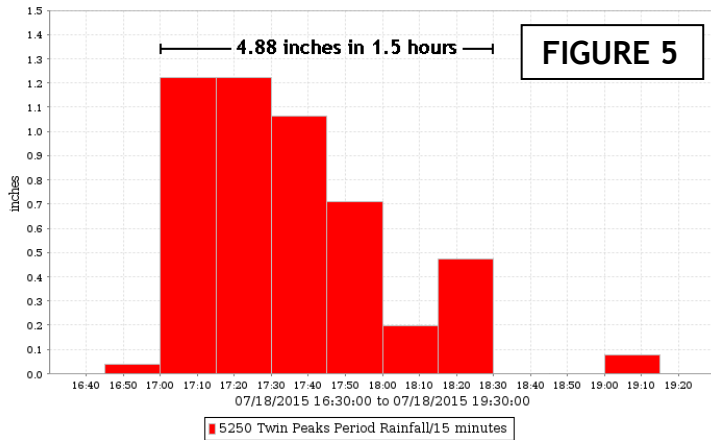
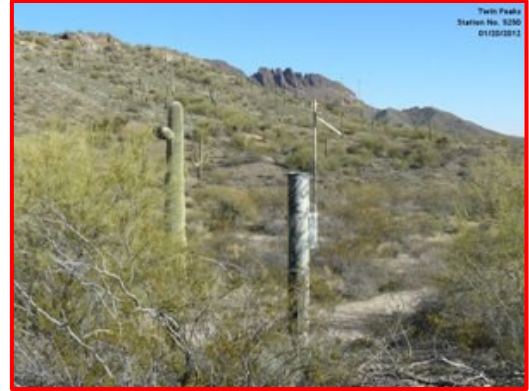
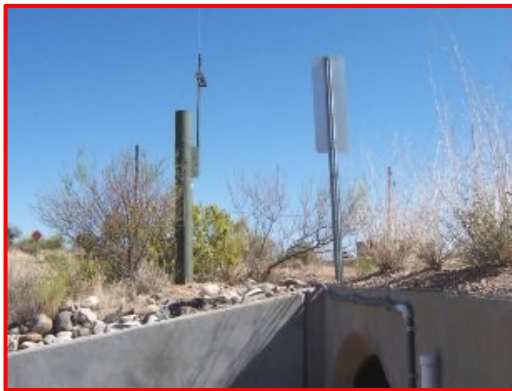
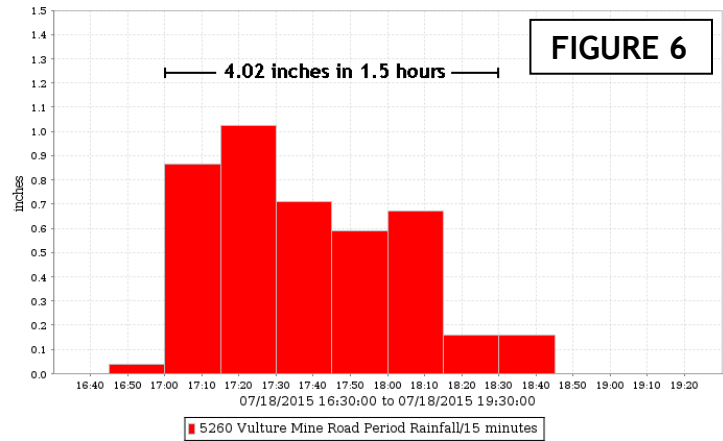
15-minute time distributions for selected rain gages are shown in Figures 5-8 below:

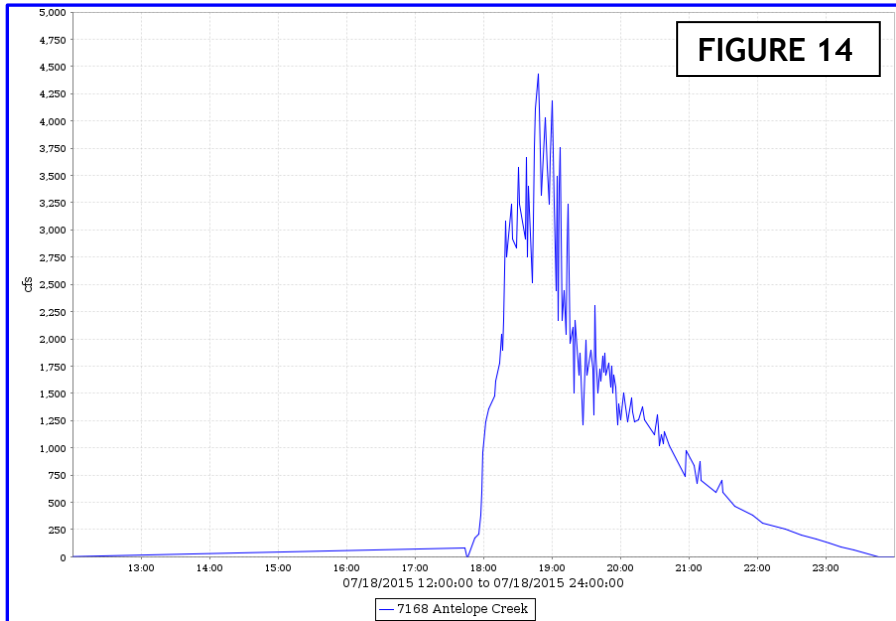
Antelope Creek (ID #7168)

This gage is located about 1.7 miles upstream from the Martinez Creek gage (7013). It flows into Martinez Creek about one quarter mile upstream from the Martinez Creek gage station. The flow here was the second largest flow of record since installation in 2003 - probably the result of rain and streamflow the previous day. Peak discharge high water marks were verified by survey.

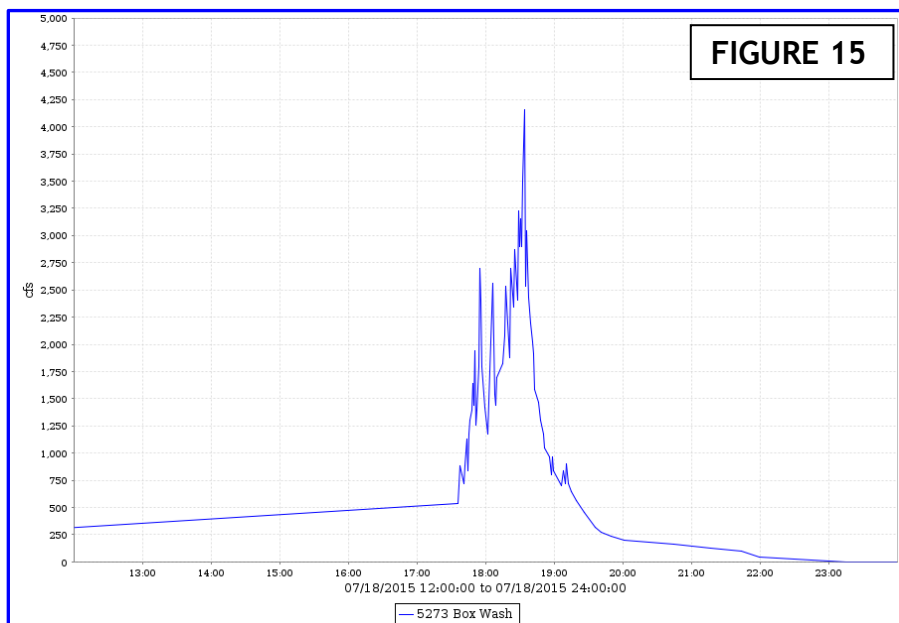
Box Wash (ID #5273)

Box Wash is located south of Wickenburg, but its watershed is adjacent to those for Flying E Wash and Hartman Wash. It experienced similar high flows for the event. The flow here was 4,160 cfs at 5.65 feet gage height. It is by far the largest discharge recorded since installation in 2003. Peak discharge high water marks were verified by survey.

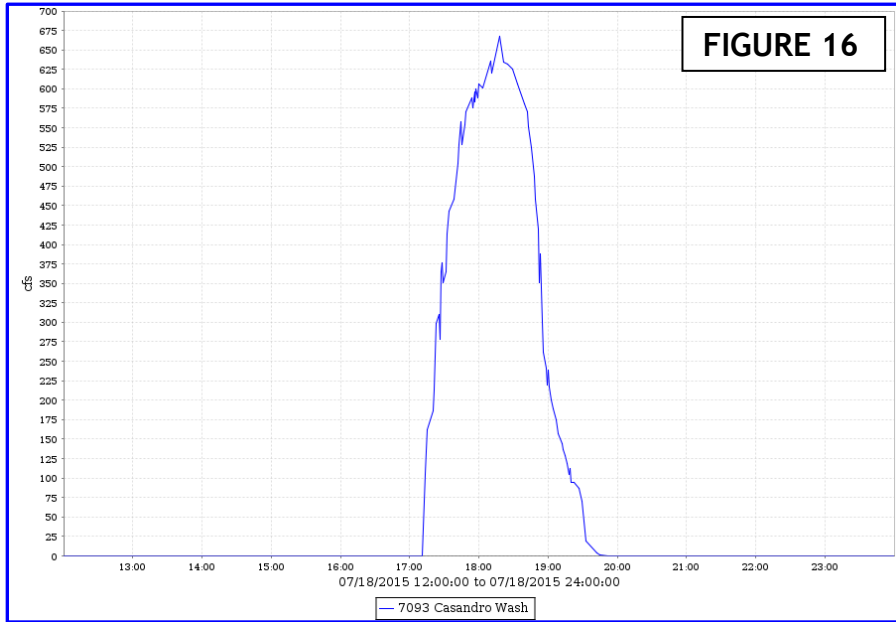
Casandro Wash (ID #7093)

This gage is located on the upstream side of the US60 culverts about one half mile east of Vulture Mine Road. The culverts are two 6-foot high by 6-foot wide boxes. The water level in the channel at the entrance to the culvert exceeded the top of the culvert but did not overtop the roadway. The rating was developed using an HY-8 culvert analysis and is considered good. Peak stage was a record 8.01 feet gage height, and the peak discharge was a record 668 cfs. Peak stage was verified using high water marks on the upstream side of the bridge. The crest-stage gage was overtopped during the event.

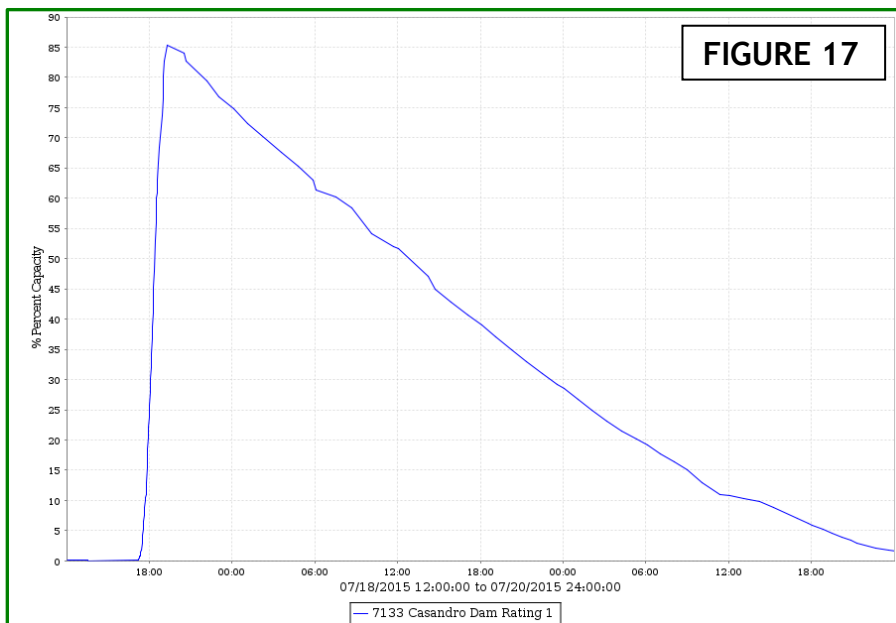
Casandro Dam (ID #7133)

This dam downstream from the Casandro Wash stream station received a record amount of inflow and had a peak impoundment that reached 85% capacity, within 1.6 feet of the emergency spillway crest, and the highest recorded since its construction in 1996.

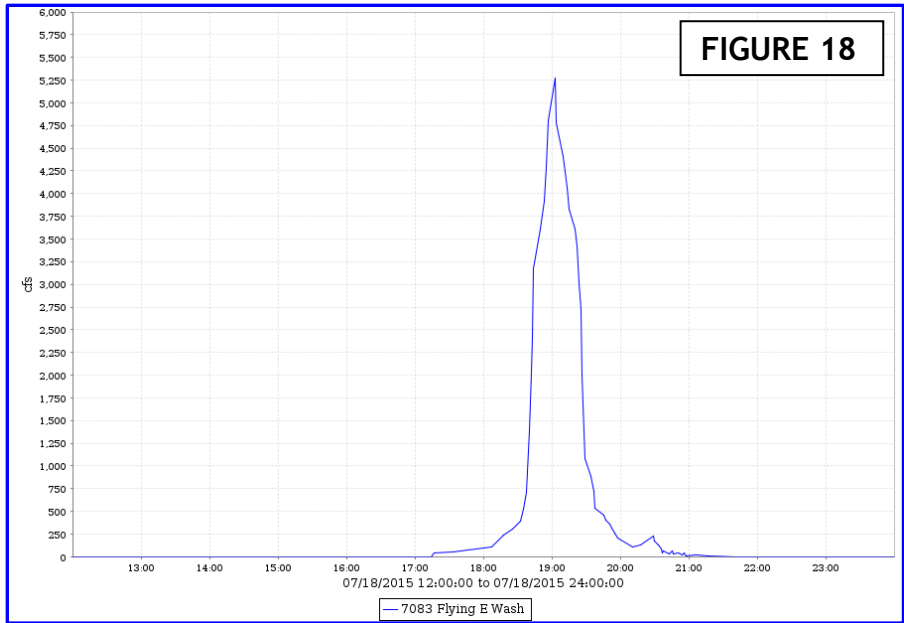
### Flying E Wash (ID #7083)

This gaged wash is located about one-half mile west of Vulture Mine Road on US 60. The watershed had high intensity rainfall, but the transducer gage failed to measure the peak. High water marks were recovered from the crest-stage gage and from a survey of the site. Peak discharge was an estimated 5,250 cfs at 7.07 feet gage height. This is the highest flow recorded since installation in 1994.

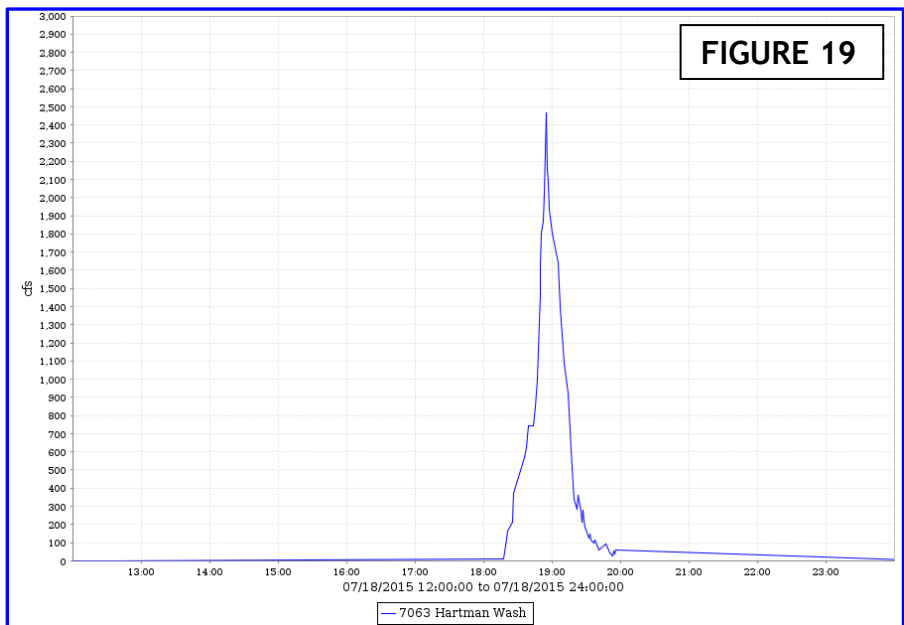
### Hartman Wash (ID #7063)

This wash is located about 2 miles west of Flying E Wash, also along US60. This point on the wash is also monitored by the USGS. The transducer gage at this location also did not work correctly. High water marks were recovered from crest-stage gages and a survey. Best estimate is that the peak stage was at about 6.5 feet gage height upstream, and about 5.0 feet in the culvert. The discharge for this water level is 2,490 cfs.

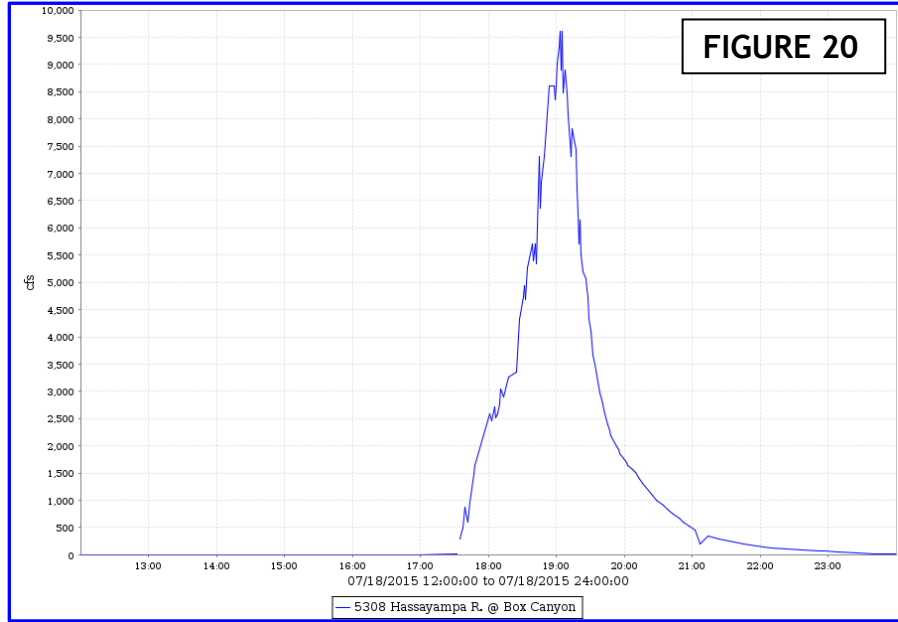
Hassayampa River at Box Canyon (ID #5308)

This station is upstream of the town and all major tributaries. It is about 8 miles upstream from the US60 bridge. This station recorded a flow of 9,601 cfs at 10.80 feet gage height. There have been a number of flows of greater magnitude over the long period of record for this gage. Peak stage was not verified for this event.

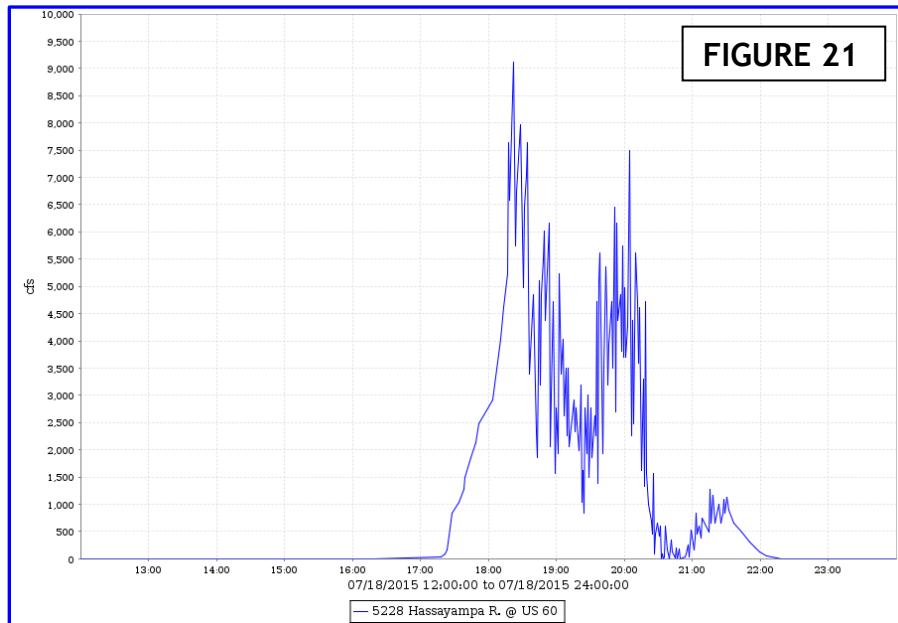
Hassayampa River at US60 (ID #5228)

This gage is located near the center of the town of Wickenburg and is downstream of tributary inflow from the upper watershed including Antelope Creek, Martinez Creek, Hartman Wash, Flying E Wash, Sols Wash near Matthie, and Powder House Wash. This gage had a peak discharge of 9,123 cfs at 3.45 feet gage height. The peak stage could not be verified as of publication of this report. However, analysis of peak discharge and time of peaks for the upstream stations would indicate this peak discharge to be reasonable.

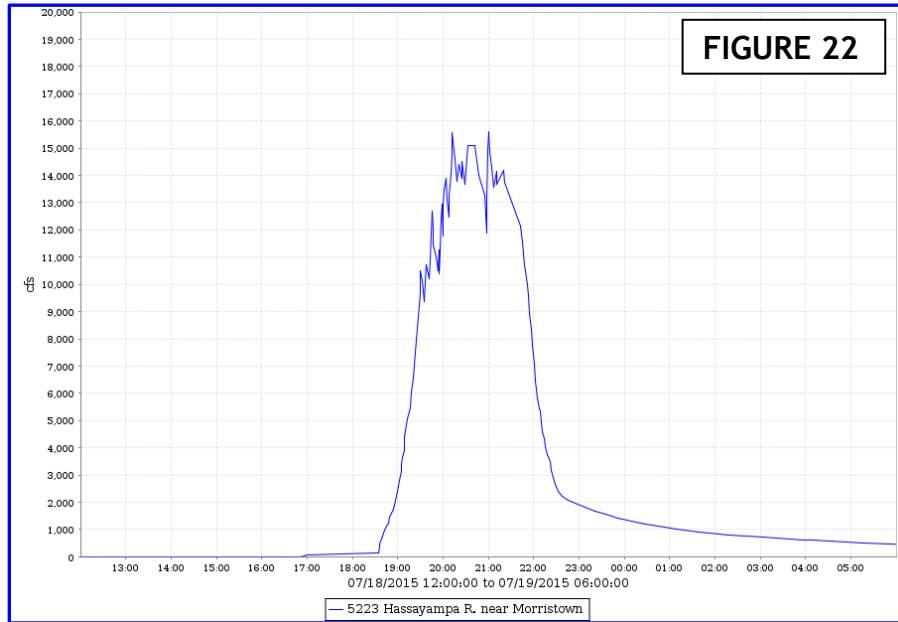
### Hassayampa River near Morristown (ID #5223)

This station is approximately 7.4 miles downstream from the US 60 bridge. The USGS also operates a gage at this location. The peak at this station was 15,606 cfs and a stage of 14.19 feet gage height. The peak occurred about 2.5 hours after the peak passed the US 60 bridge.

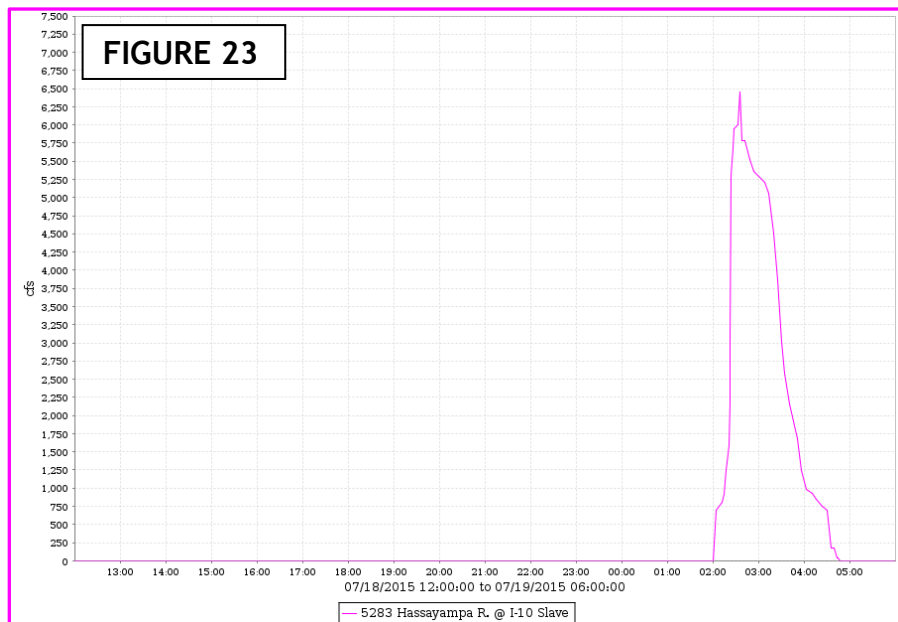
### Hassayampa River at I-10 (ID #5283)

This last station on the Hassayampa River is about 20 miles downstream from the Morristown gage. This station received a small flow, likely as a result of the flows upstream. Using an average velocity and channel distance, the flow was estimated to arrive at this station at 07/19/2015 03:00. The actual arrival time was 07/19/2015 at 02:36, which confirmed that the flow originated from the Wickenburg event. Much of the flow from Morristown did not go the full 20 mile trip - it soaked into the river bottom. The peak at I-10 was 6,456 cfs and 3.22 feet gage height.

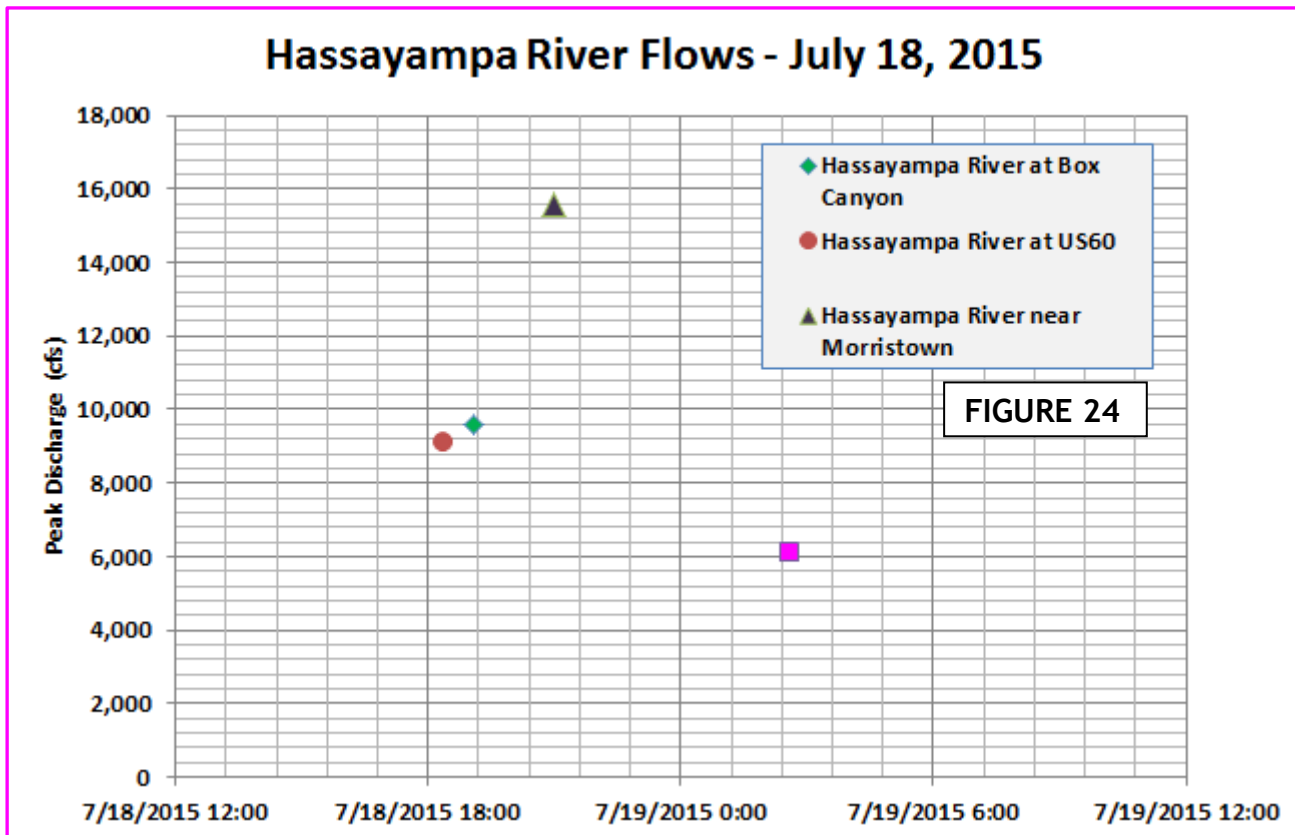
Figure 24 shows the peaks at the four Hassayampa River gages and when they occurred in time. Inflow from ungaged washes downstream of US 60, especially Cemetery Wash, contributed to the much higher peak at Morristown.

Table 5 shows distances and travel times between various stream gages in the Wickenburg area. The average velocity was taken from HEC-2 and HEC-RAS hydraulic models. Since US 60 peaked before Box Canyon, the peak could not have come from there. US 60 peaked before every other contributing gage except Powder House, so its peak likely came from Powder House and other small upstream washes, plus a contribution from Sols Wash and its tributaries below the Matthie gage. The estimated arrival and actual times over the 20.24 miles from Morristown to I-10 were remarkably close - the actual average velocity was 5.3 feet/second.

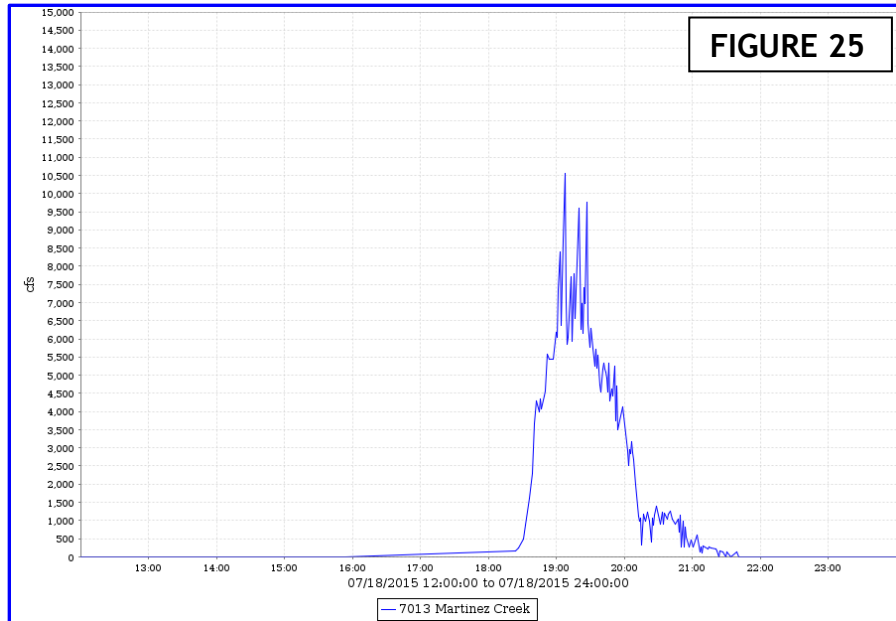
### Martinez Creek (ID #7013)

The Martinez Creek gage is located about one mile upstream of Scenic Loop Road. Flow at this gage is from Martinez Creek and Antelope Creek, both of which have large watersheds. Peak stage values tend to be very large here due to a 90 degree bend the water must make at the gage location. The peak discharge was estimated in a contraction about 300 feet upstream from the level gage. Peak discharge for this event is 10,300 cfs which is the highest recorded to date.

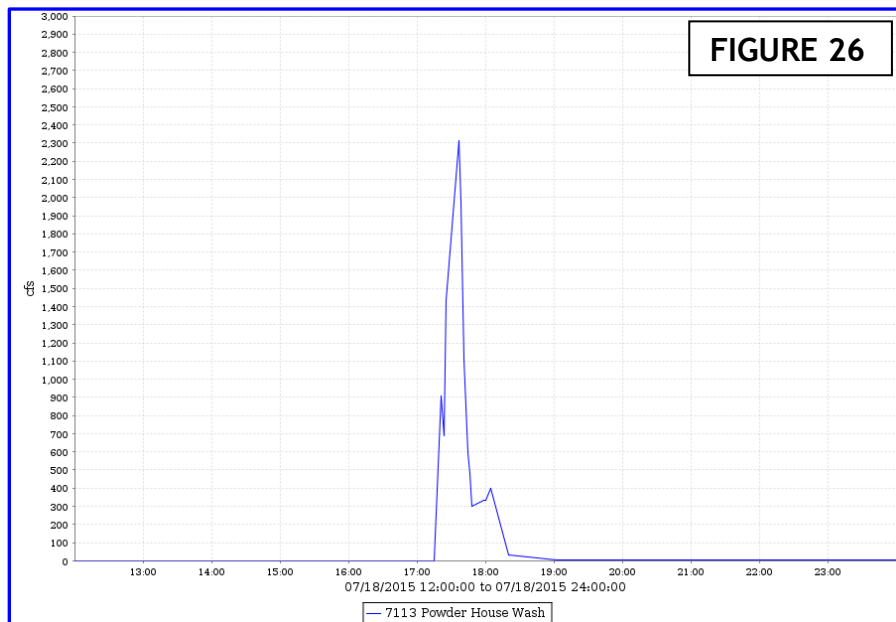
### Powder House Wash (ID #7113)

This gage is on a small watershed east of the Hassayampa River. It is a very steep wash that discharges into the Hassayampa River just above the US 60 bridge. Runoff from the event produced the largest flow of record since 1995 when the gage was installed. The peak stage was 2.42 feet, with a computed discharge of 2,300 cfs. High water mark data were verified with a survey and from the crest-stage gage.

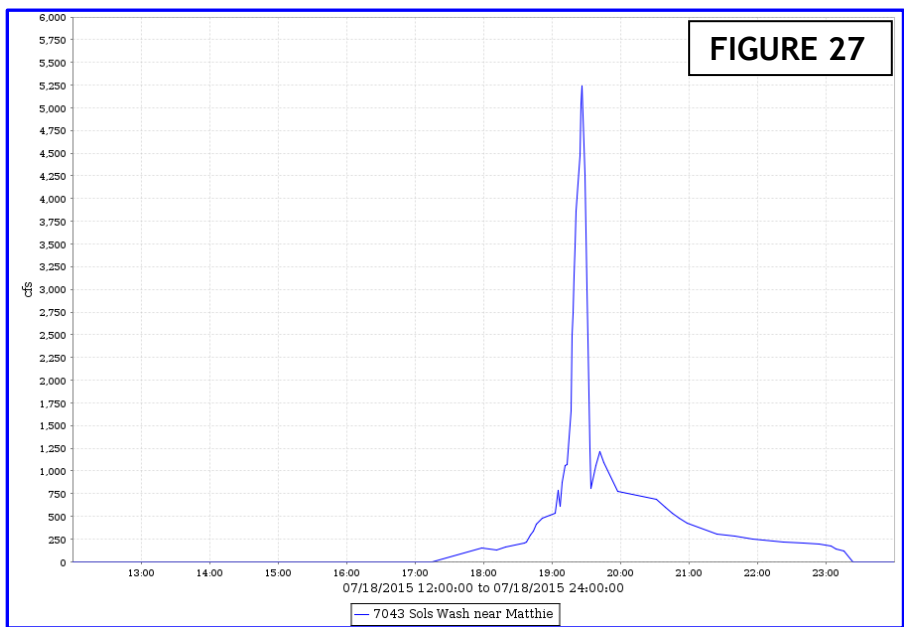
Sols Wash near Matthie (ID #7043)

This gage is located about one mile upstream from Vulture Mine Road, and about 4.5 miles upstream from the US 60 bridge. The peak discharge at this station was 5,240 cfs at 4.40 feet gage height. High water marks were verified from a survey of the site following the event.

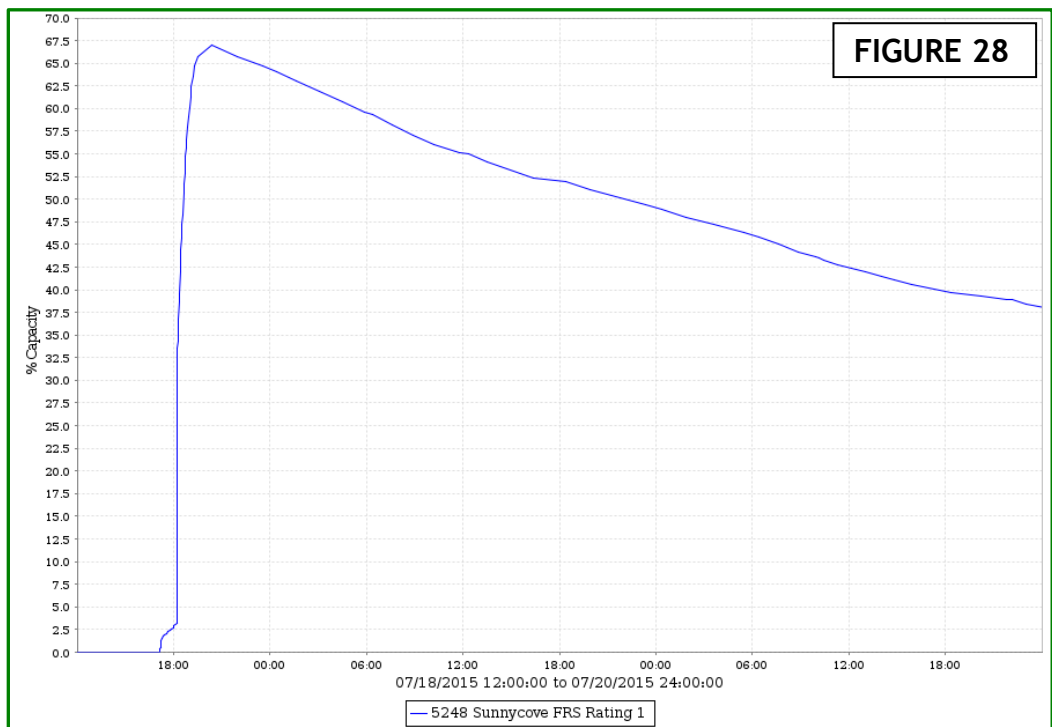
Sunnycove FRS (ID #5248)

This dam is located southwest of the downtown area of Wickenburg, near the town cemetery. Sunnycove FRS recorded a record impoundment, reaching a peak of 31.85 feet gage height, or about 67% of spillway capacity, which is the highest known impoundment.

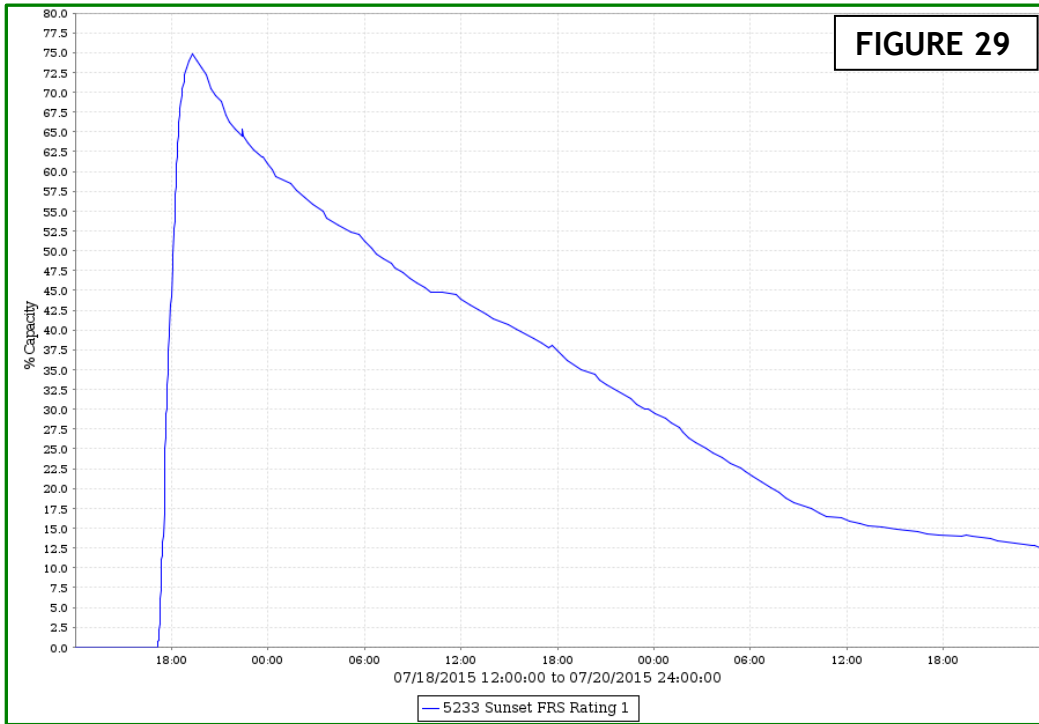
Sunset FRS (ID #5233)

Sunset FRS is located on the south side of US 60 west of downtown Wickenburg. This dam also recorded its highest known impoundment. Records have been kept since 1989. The peak stage was 16.78 feet gage height - about 75% of spillway capacity.

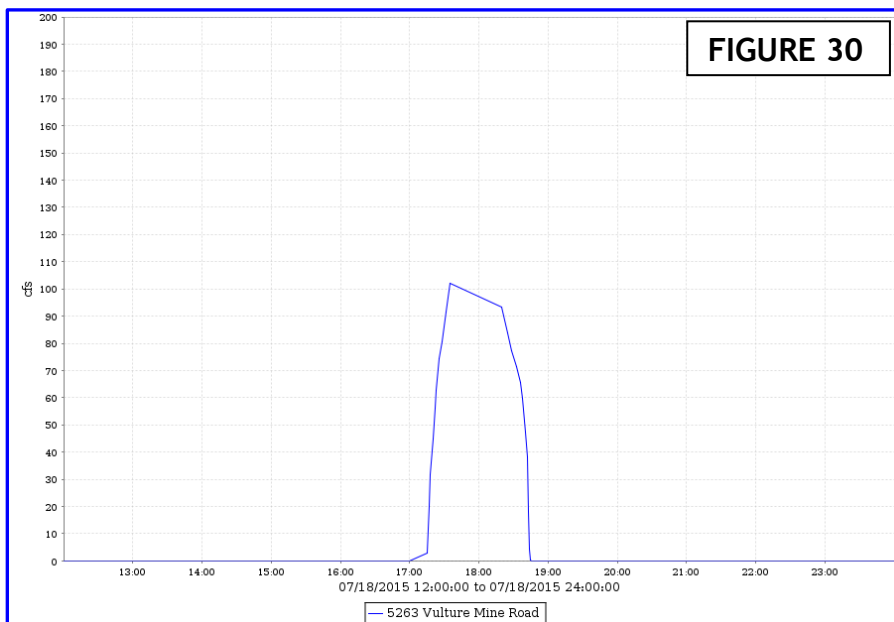
Vulture Mine Road (ID #5263)

This gage is located on a part of Casandro Wash on a small upper watershed. It had a small flow during the event, 102 cfs. There have been larger flows in the past.

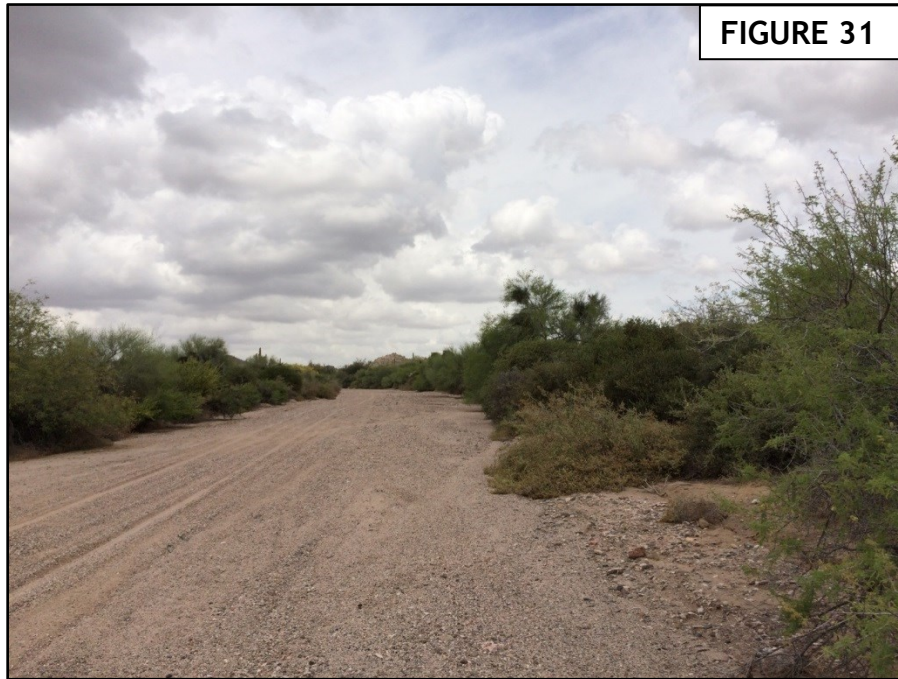
Significant changes to streams occur as a result of high flows. At Box Wash, a significant amount of vegetation was destroyed. The photos below show the scour power of water. The top picture shows the left bank of Box Wash upstream from the gage, taken in May 2015. The bottom photo is the same left bank upstream of the gage, taken on July 20, 2015. Much of the vegetation has been removed and the bank scoured.

*Box Wash, Left bank, May 14, 2015*

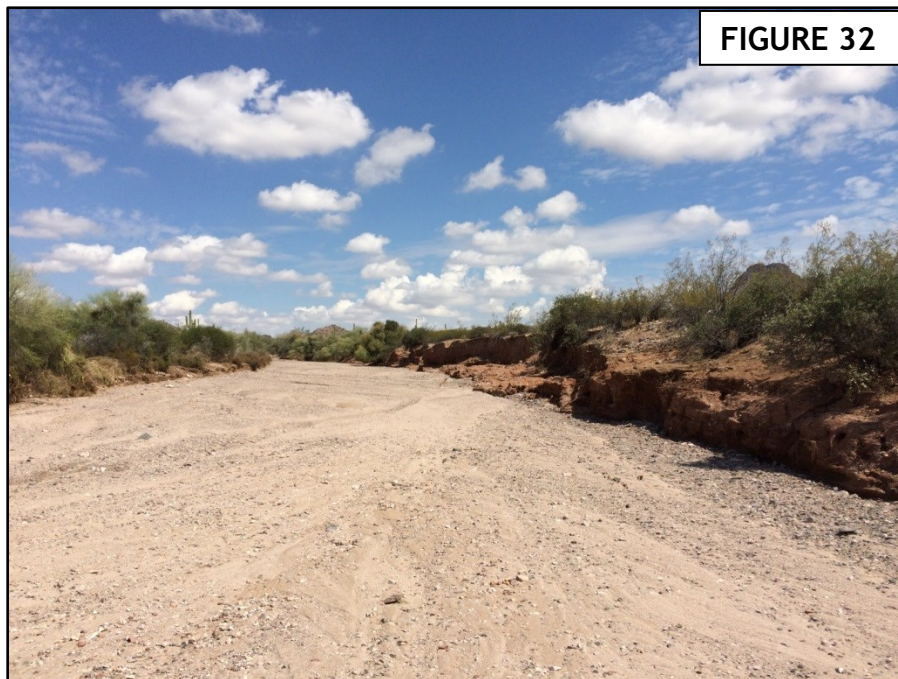
*Box Wash, Left bank, July 20, 2015*

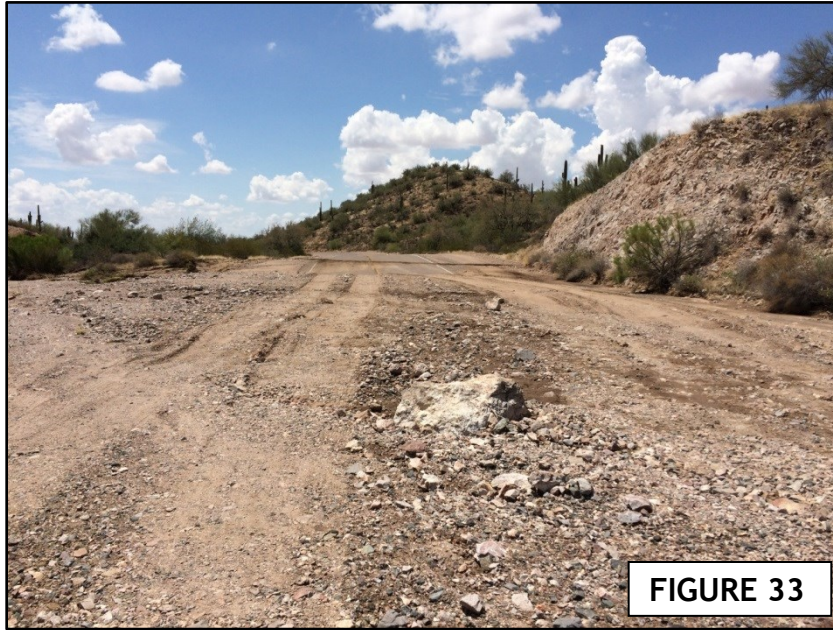
**FIGURE 33**

The photo below shows a large debris flow that occurred on a tributary wash to Box Wash that crosses a paved portion of Vulture Mine Road. Notice the large boulder in the center of the road. The boulder is about 2.5 feet wide and over a foot in height.

*Debris Flow on Vulture Mine Road, south of Box Wash crossing, July 19, 2015*

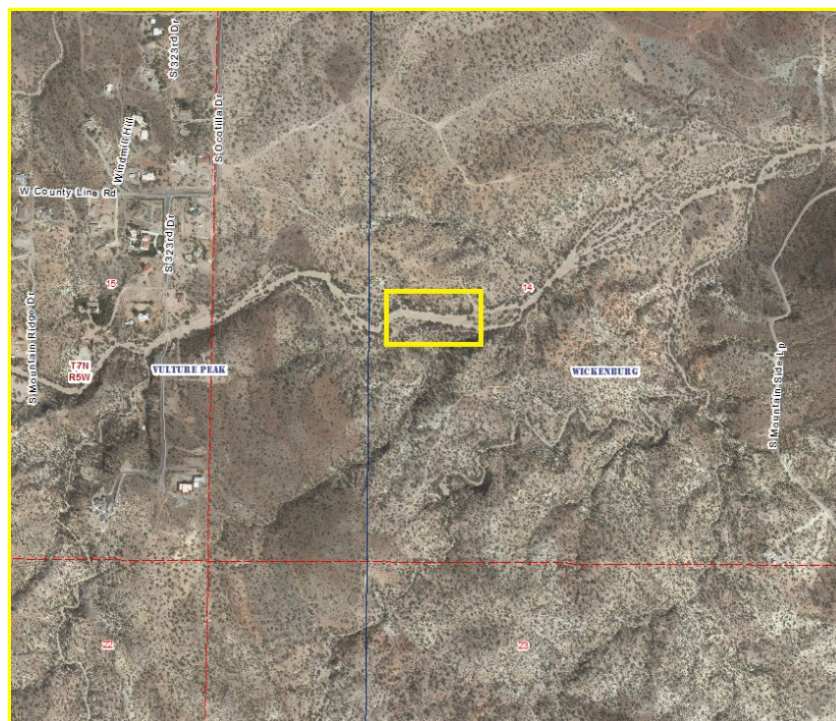
A survey was conducted to acquire data to determine the peak discharge from the July 18 event. First a suitable reach was examined from aerial photos. It was decided to survey a part of the wash that was accessible from Ocotillo Drive. The specific site was about one half mile downstream from 323<sup>rd</sup> Drive. The approximate coordinates are latitude 33.9466, longitude -112.7494. An aerial of the surveyed area is below.

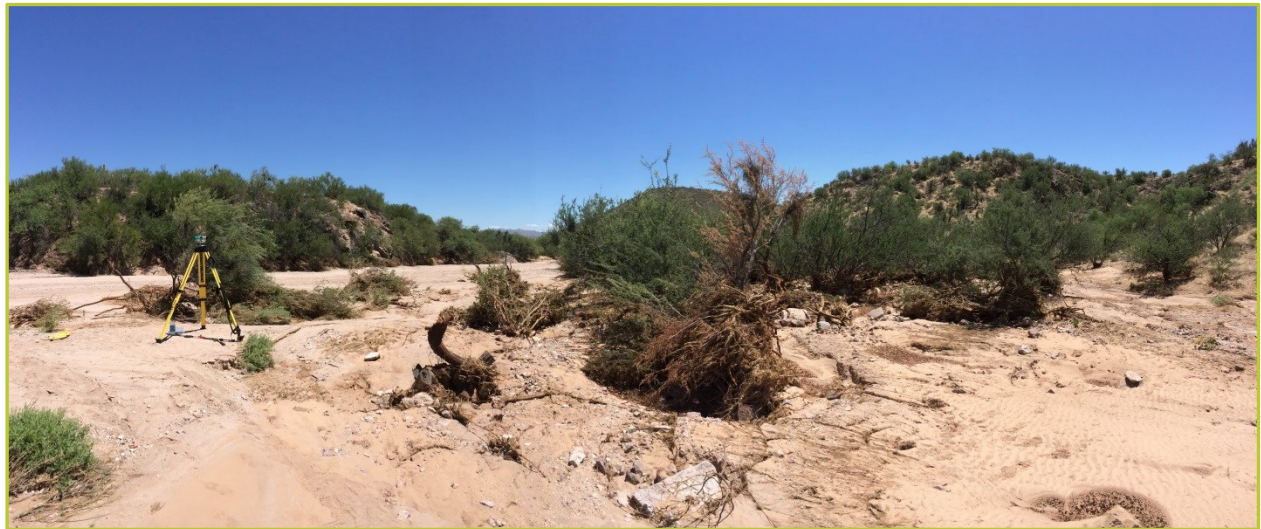
The channel in this section has a well-defined main bed composed of fine sand. There was only a small left over-bank with a wide, heavily vegetated right over-bank. The photo below is of the channel downstream from the furthest upstream cross section surveyed.
