OPEN-FILE REPORT OFR 08-04

RECONNAISSANCE REPORT ON THE EASTER WEEKEND LANDSLIDE OF 21 MARCH 2008, SR-87, GILA COUNTY, ARIZONA

November 2008

Mimi Diaz, Brian F. Gootee, and Ann Youberg
ARIZONA GEOLOGICAL SURVEY

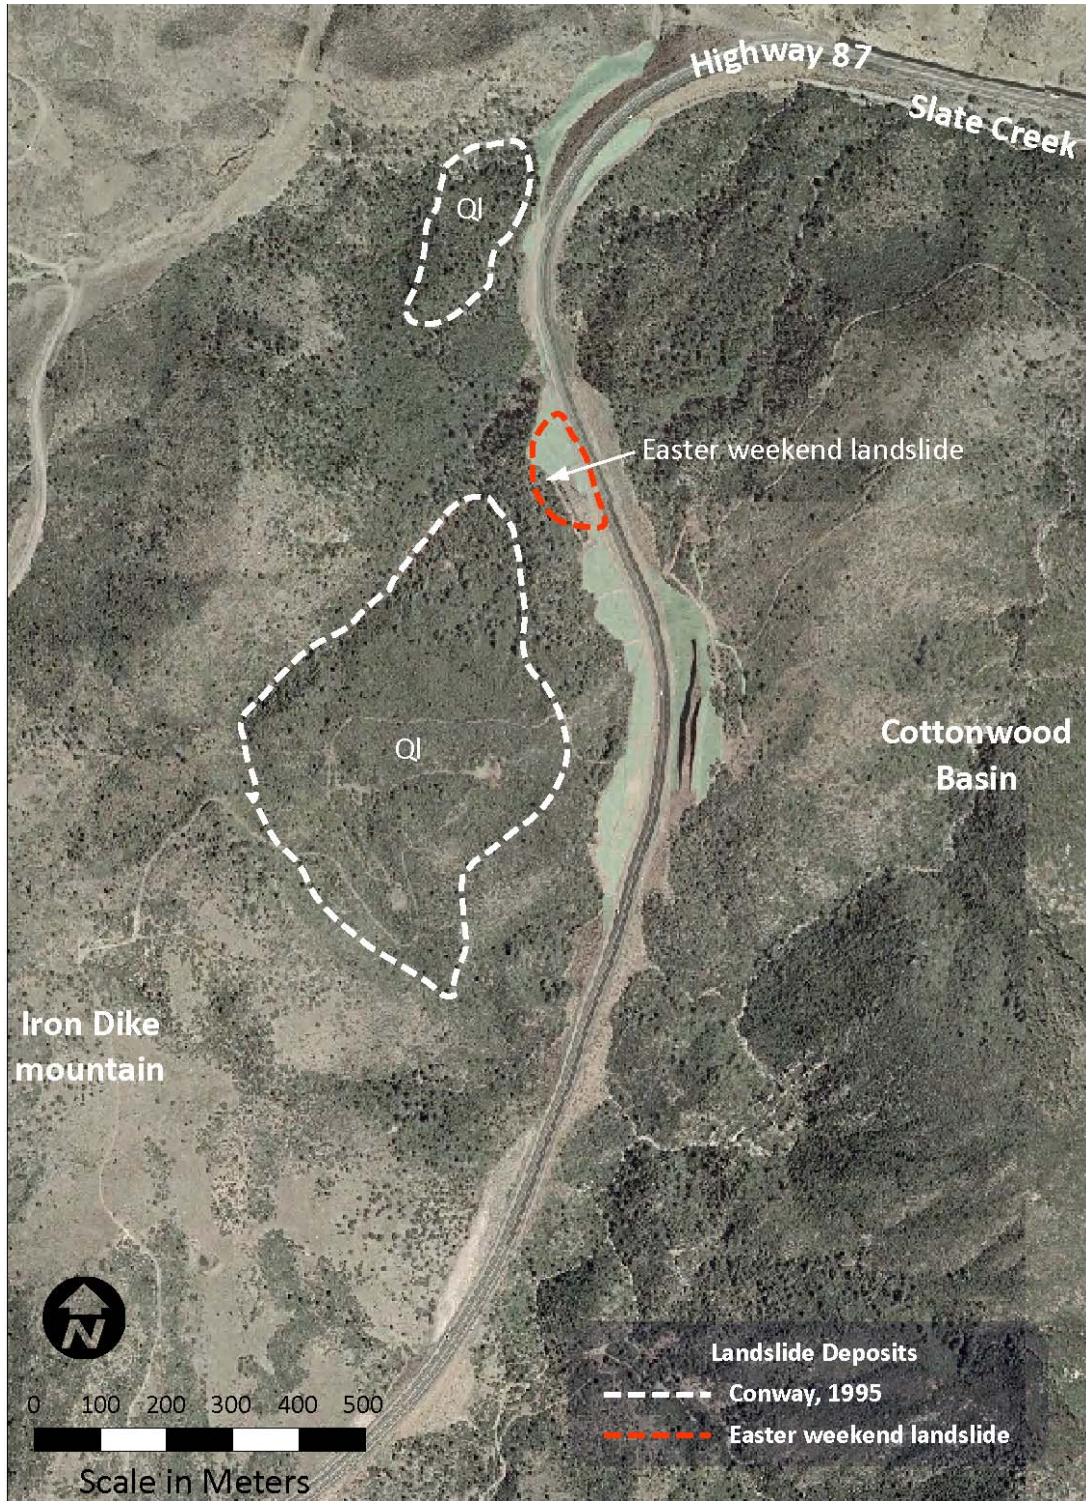
Figure 1 Regional aerial photographic map showing probable extent of landslide deposits as mapped by Conway (1995).

“Iron Dike landslides” after Iron Dike Mountain, a prominent peak located three-quarters of mile southwest of the Easter weekend landslide (Figure 1).

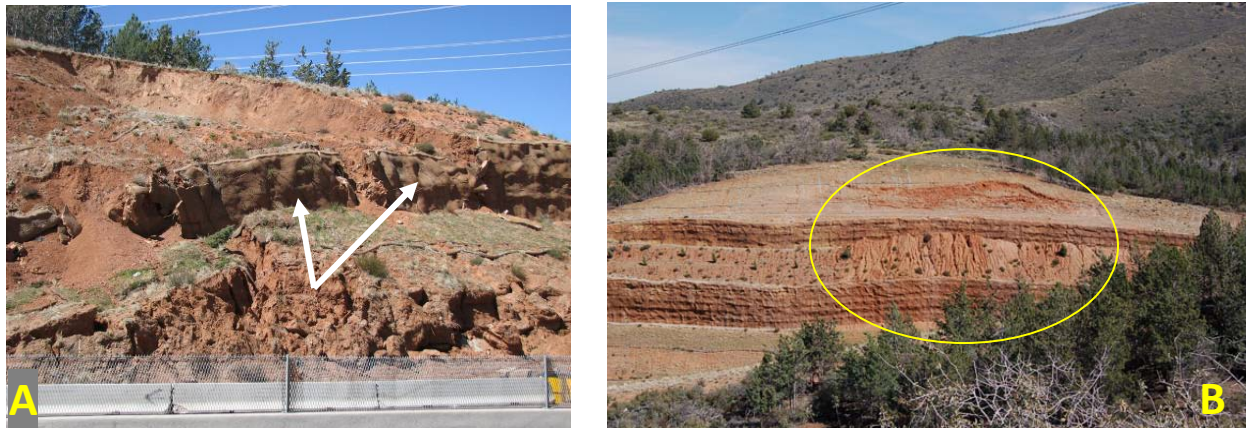
Figure 2. Slope failures that occurred during winter 2007-2008 near mile marker 224. **A.** The southern-most landslide on the west side of the highway; note the broken shotcrete (white arrows). The metal fence in the foreground is the median of the highway; the Jersey barriers behind the fence are on the shoulder of the southbound lane, separating the highway from debris. **B.** Slope failure (inside yellow ellipse) in material from an older landslide on the east side of SR-87. Scarps are present above the highest tier of soil nail walls; material is moving down slope over both walls. Photos taken on 23 March 2008 (A) and 25 March 2008 (B) by M. Diaz.

Data from the Maricopa County Flood Control District's ALERT precipitation gage on Mt. Ord (5960), approximately 2.5 miles east-southeast of the landslide, provides an estimate of precipitation in the landslide area during the winter of 2007-08. This gage recorded 14 inches of precipitation between 1 October 2007 and 21 March 2008, when the main landslide occurred (Appendix A). Smaller mass movements occurred on both the western (Figure 2A) and eastern (Figure 2B) slopes throughout the winter of 2007-2008, prompting ADOT to place protective barriers (k-bars or Jersey barriers) between the western slope and the highway. Ironically, the gage recorded only 0.24 inches of rain between 1 March and 21 March; this fell in about a 75-minute period on 17 March. This rain event may have caused the pore pressure to exceed stable limits, thereby increasing the pressure against the soil nail walls and decreasing the shear strength of the materials within the paleo-landslide mass.

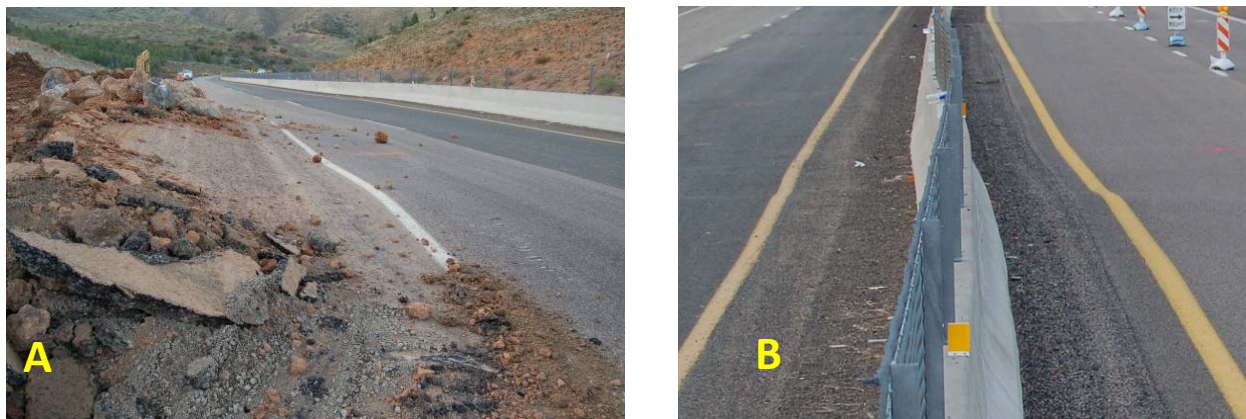
Figure 3 A. Close-up of the lower part of the landslide buckling the highway. **B.** The landslide displaced the road and divider about 1 foot to the east. Both views looking north. Photos taken on 23 March 2008 by B.F. Gootee.

On 21 March, sections of the western slope failed in a larger landslide. Based on displaced material and the buckling of SR-87 southbound lanes, it appeared that some of the northern part of the slide plane extended under the highway (Figure 3A). The southbound lanes of the highway were buckled and broken, for approximately 50 feet along the length of the highway. One section of the freeway was buckled up to approximately 3 feet in height (Figure 4). The median was displaced about 1 foot eastward (Figure 3B), and the northbound lanes buckled to a lesser extent than the southbound lanes. Contractors doing emergency repairs reported that the buckled section fluctuated vertically for at least five days afterward.

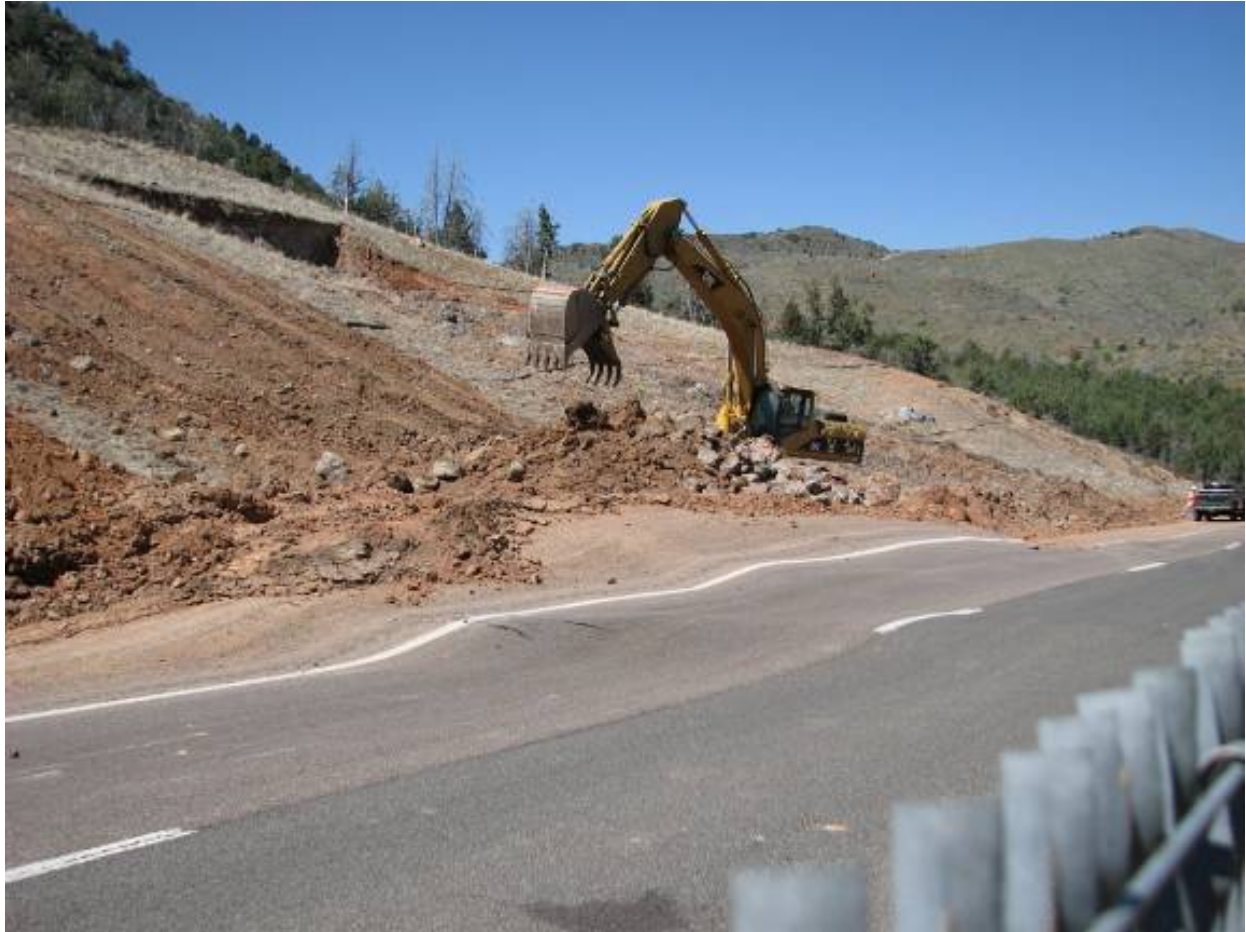
Figure 4 The Easter weekend landslide pushed up the highway, deforming both south- and northbound lanes. The southbound lanes (shown here) buckled approximately 3 feet high and 50 feet along the length of the highway. View is to northwest. Photo taken on 23 March 2008 by M. Diaz.

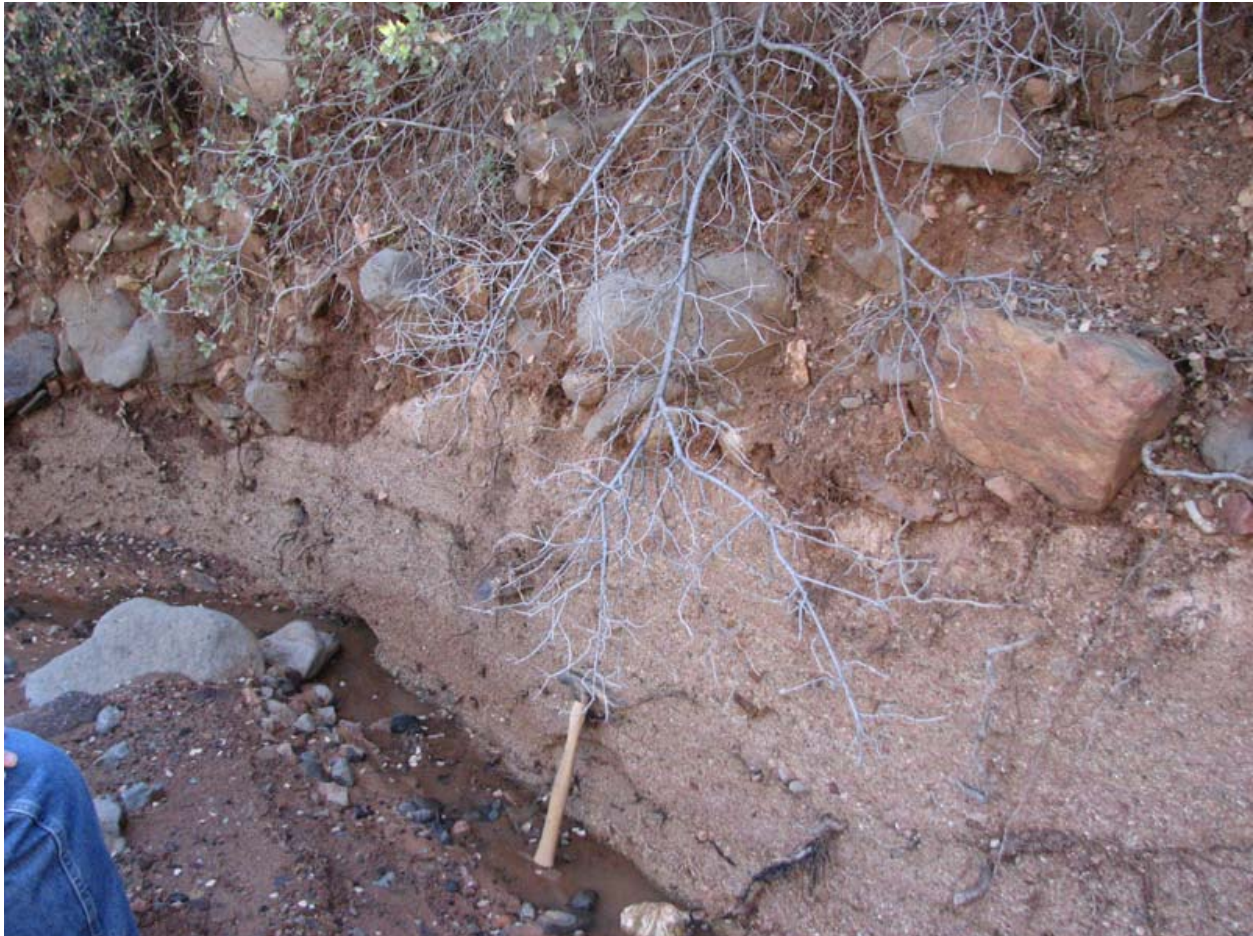
Figure 5 Unsorted, matrix-supported clastic material that is suggestive of a debris flow deposit (top) above moderately indurated, bedded basin-fill deposits along one of the drainages at the downslope exposure of the landslide. Note the irregular erosional surface below the deposits in the wall of the outcrop. Photo taken on 28 March 2008 by M. Diaz.

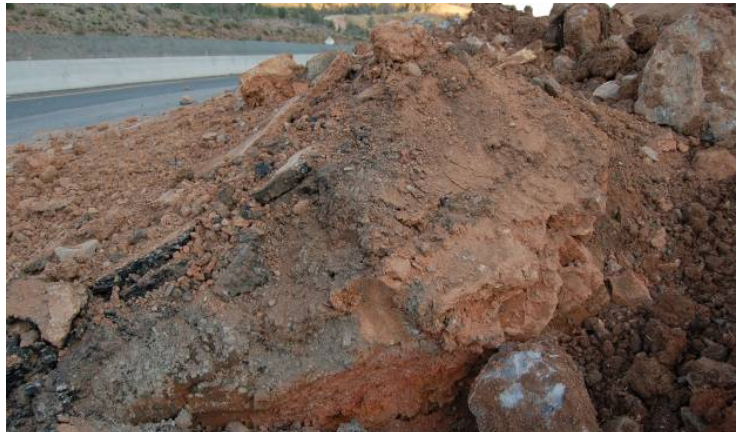
Figure 6 Portion of the Easter weekend landslide that damaged the highway. Note pavement, gray artificial fill under the pavement, and red, clay-rich, moist sediment under the fill. Photo by B.F. Gootee, 23 March 2008.

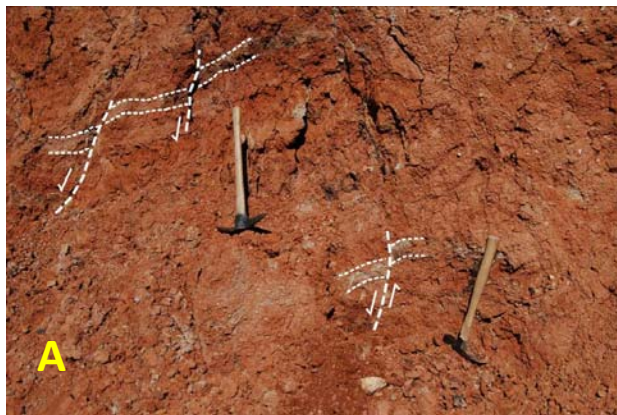
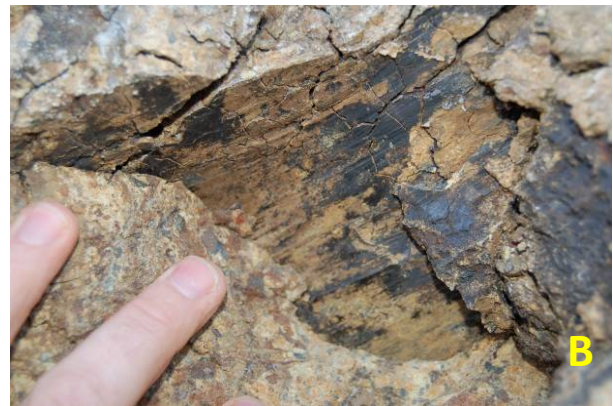
Figure 7 A. Example of internal shearing within the slide mass (head scarp on the east side of the highway). White dashed lines indicate sheared features; white arrows indicate direction of relative motion. Similar structures are also visible in the Easter weekend slide mass on the west side of the highway. **B.** Slickensides observed in the interior of the landslide (on the west side of the highway) indicate shearing in the clayey gravel. Photos taken on 28 March 2008 (A) and 23 March 2008 (B) by B.F. Gootee.

The main body of the paleo-landslide (and thus the Easter weekend landslide) is composed of clayey sand and sandy clay; however, areas within the body of the paleo-landslide contain mostly clay with lenses and beds of sand. The volume of clay present varies from nearly 100% at the probable failure plane of the Easter weekend landslide (Figure 6) to <5% near the surface. The interior of the landslide is deformed in places, with sheared surfaces (Figure 7A) and slickensides (Figure 7B) present, and undeformed in other
