OPEN FILE REPORT OFR-08-05

GEOLOGY AND GEOLOGICAL HAZARDS FIELD TRIP OF SABINO CANYON: RESULTS OF THE JULY 2006 STORMS

June 2008

Ann Youberg & Joseph P. Cook
ARIZONA GEOLOGICAL SURVEY

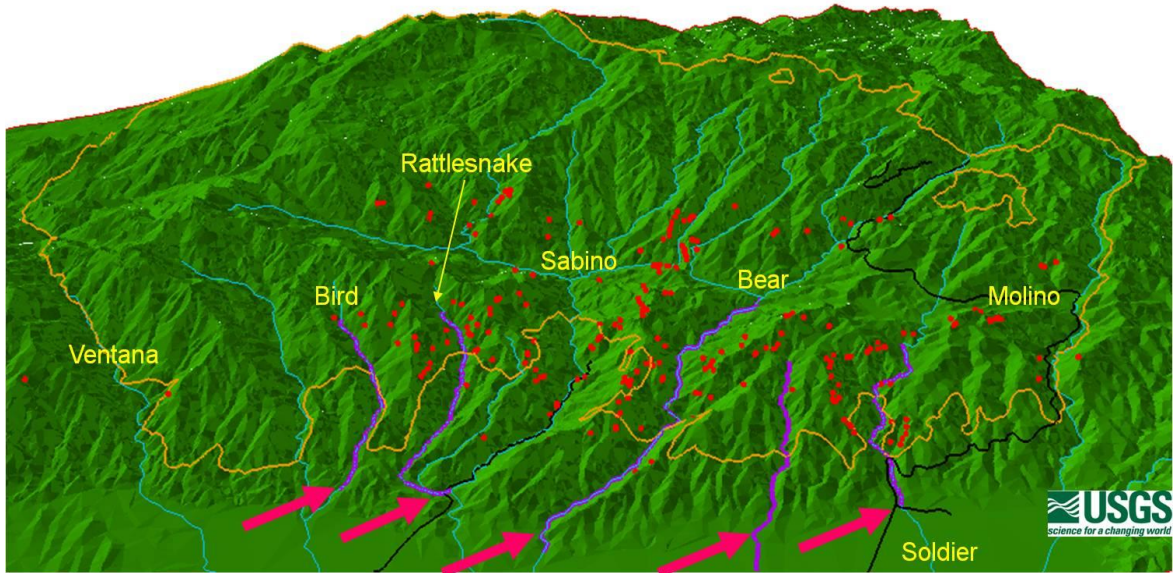
Figure 1. Initiation points (red) and debris flows exiting or nearly exiting the front range (purple with pink arrows). Modified from Webb et al. PowerPoint presentation.

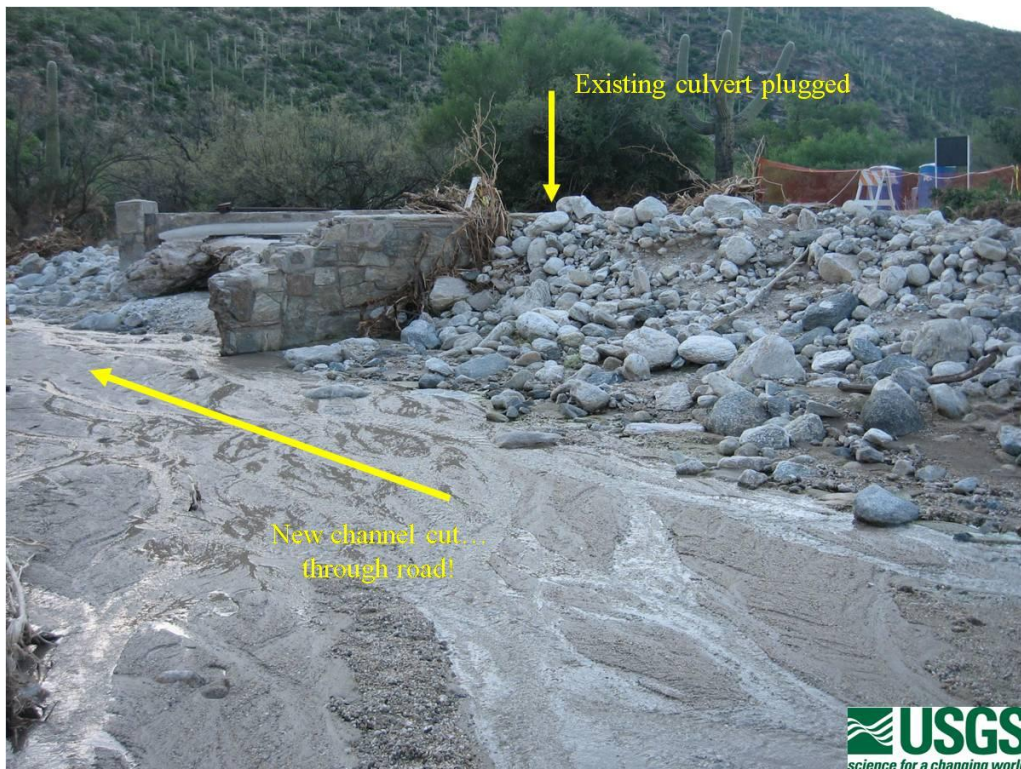
Figure 3. View downstream of the remaining part of Rattlesnake bridge. Photos: US Geological Survey.

The Rattlesnake debris flows from several drainages coalesced and flowed about 2 miles destroying the bridge. Take a few minutes here to walk in the wash. Look at the new culverts. What do you think about conveyance of more debris? Examples of debris-flow levees can be seen on river-right (think of rafting down a river to determine river-right and river-left) between the bridge and Sabino Creek. Walk out to the confluence. Look upstream.

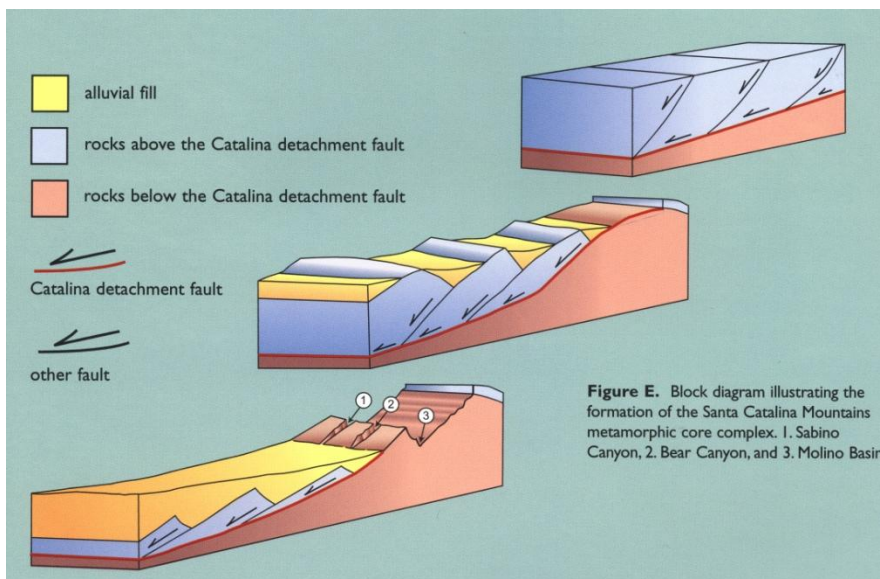
Figure 5. Modified from Bezy, AZGS Down-to-Earth 17.

Figure E. Block diagram illustrating the formation of the Santa Catalina Mountains metamorphic core complex. 1. Sabino Canyon, 2. Bear Canyon, and 3. Molino Basin.

from crustal stretching or thinning in which rock nearer the surface is broken in a brittle manner while rock at depth is stretched and deformed plastically (Figures 4 and 5). Minerals composing a rock become ductile at different temperatures. In granite, the original igneous rock, the main rock-forming minerals are quartz, feldspar, and mica (muscovite or biotite). Quartz and mica become ductile at a lower temperature than feldspar. This phenomenon, when combined with shearing of the rock at depth, can result in interesting metamorphic rock fabrics such as banded or augen gneiss.

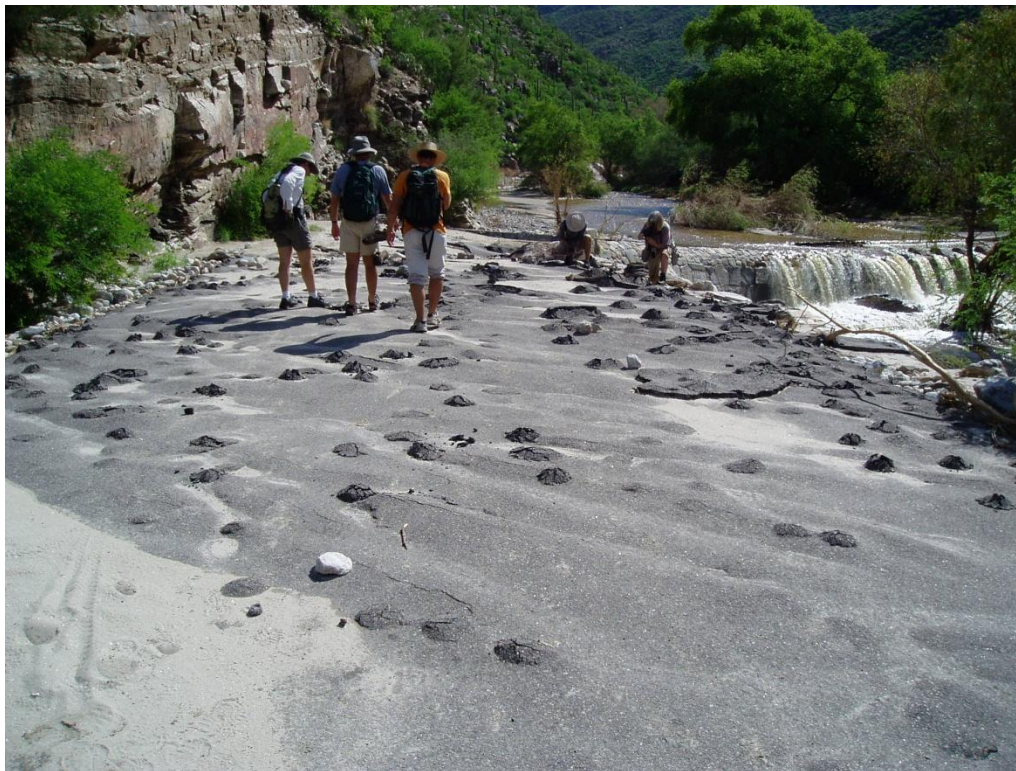
Figure 6. Interesting road damage.

What are these features in the road? During the floods, water scoured under the asphalt washing away finer material (sand and silt) leaving larger pebbles and cobble. When the wet asphalt settled the remaining rocks broke through, forming what one person thought looked like little volcanoes (Figure 6).

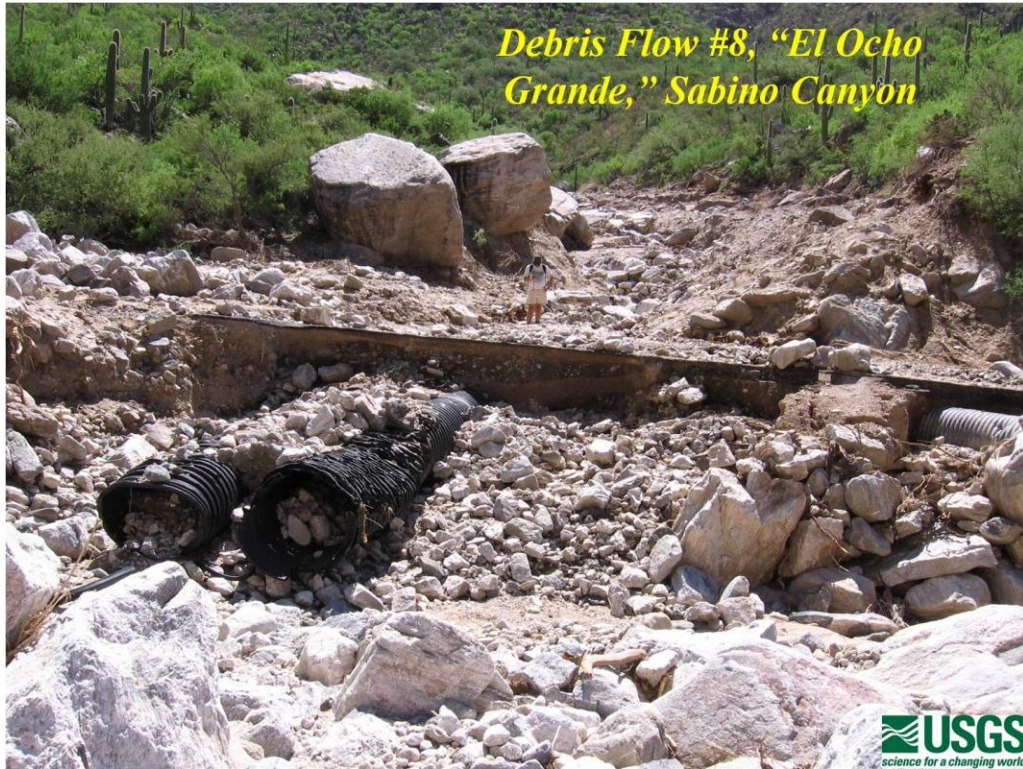
Figure 7. Ocho Grande is the largest debris flow in Sabino Canyon. This is not the first time Ocho Grande has had a debris flow. Photo. US Geological Survey.

One of the most impressive debris flows in Sabino Canyon was located at Tram Stop 8. It has been informally named Ocho Grande. Very large boulders (not shown in figures) were moved in this debris flow, and the channel was scoured quite deeply. Black PVC culverts filled with sediment which then held the culverts in place as the road washed away (Figure 7).

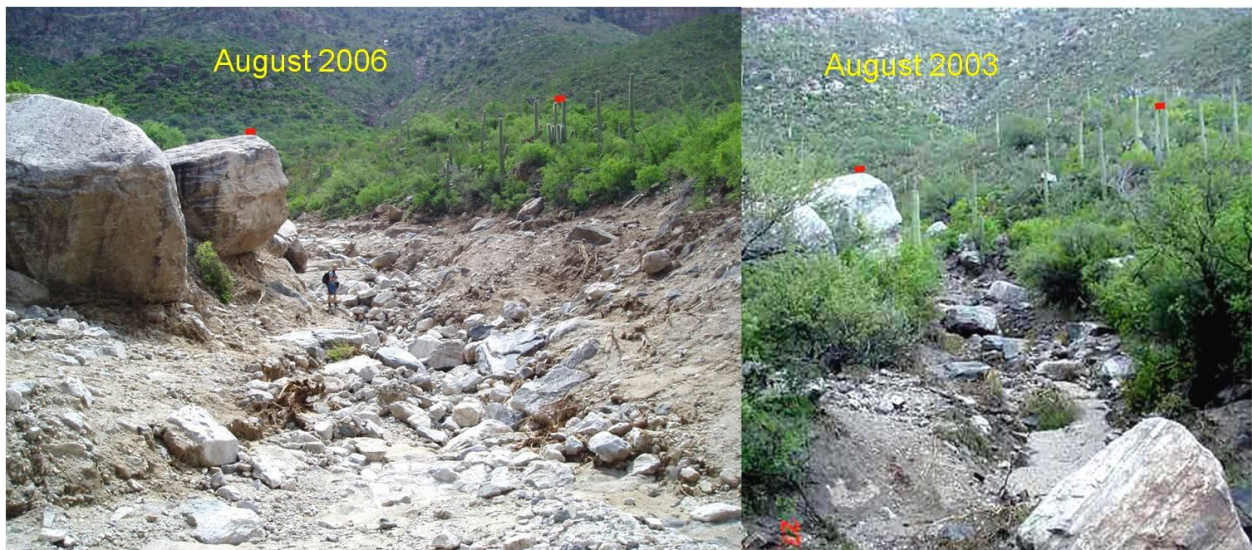
Figure 8. Ocho Grande in 2006 on left. Right is a 2003 Post-Aspen Fire debris flow in the channel of Ocho Grande. To orient yourself in these three photos look at the large boulders on the left side of the channel and photos. August 2003 Photo: US Forest Service.

This drainage, and the drainage at Tram Stop 9, also had debris flows after the 2003 Aspen Fire. Post-fire debris flows can be triggered by much smaller rain events than the late July, 2006, storms. The following figures show comparisons between the 2003 post-fire debris flow and the 2006 precipitation event debris flow. Red bars in Figure 8 show the same location within the two photos. Figures 9 and 10 show Ocho Grande's debris-flow deposits on the tram road. Note the difference in the number and size of boulders.

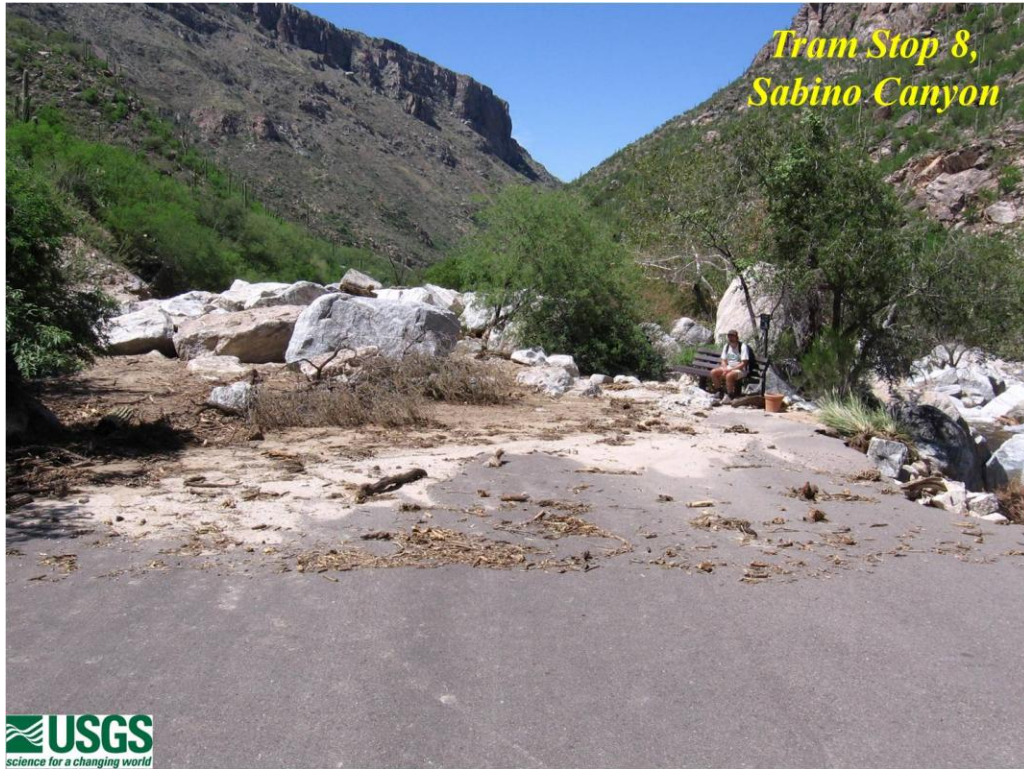
Figure 9. Debris fan of Ocho Grande in 2006. Photo: US Geological Survey.

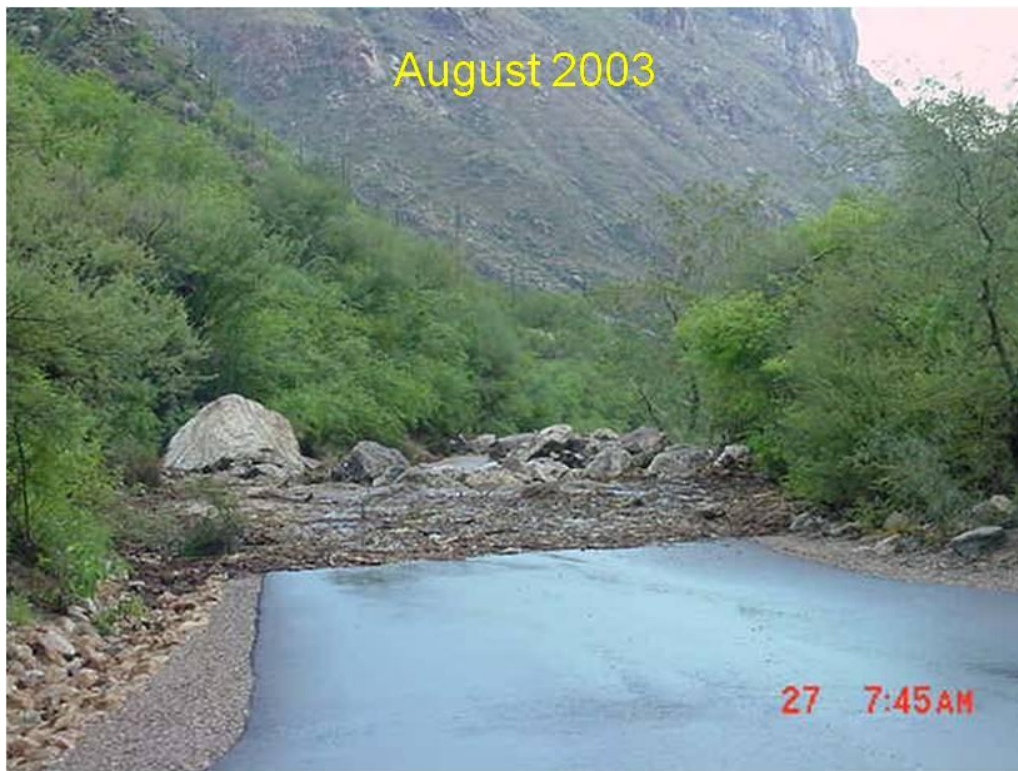
Figure 10. Post-Aspen Fire debris flow fan at Ocho Grande, 2003. Photo: US Forest Service.

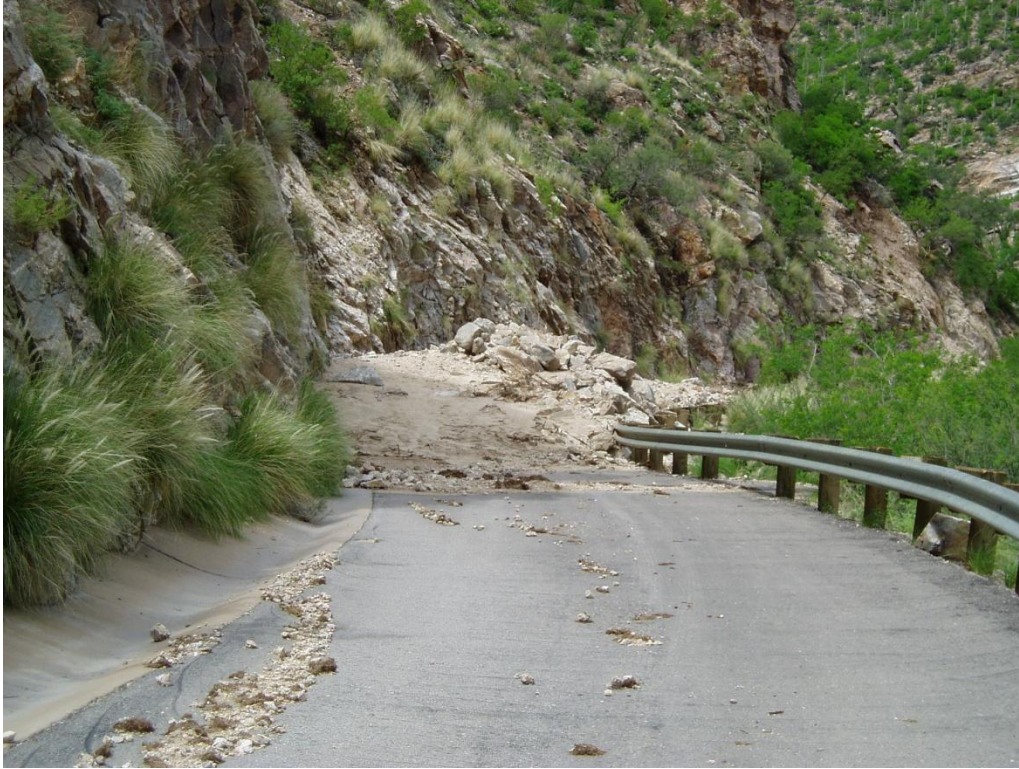
Figure 11. The road to Stop 9. Several debris flows crossed this section of road.

The road up to Tram Stop 9 affords excellent views of numerous debris flows in this location. Figure 11 shows a debris flow deposit, now removed, on the road up to Stop 9. Figure 12 was taken on the approach to Stop 9. Figures 13 and 14 show the difference in debris-deposit thickness, and size of material transported. The rest station shown in Figure 14 is buried under the debris in Figure 13. Only the roof was removed.

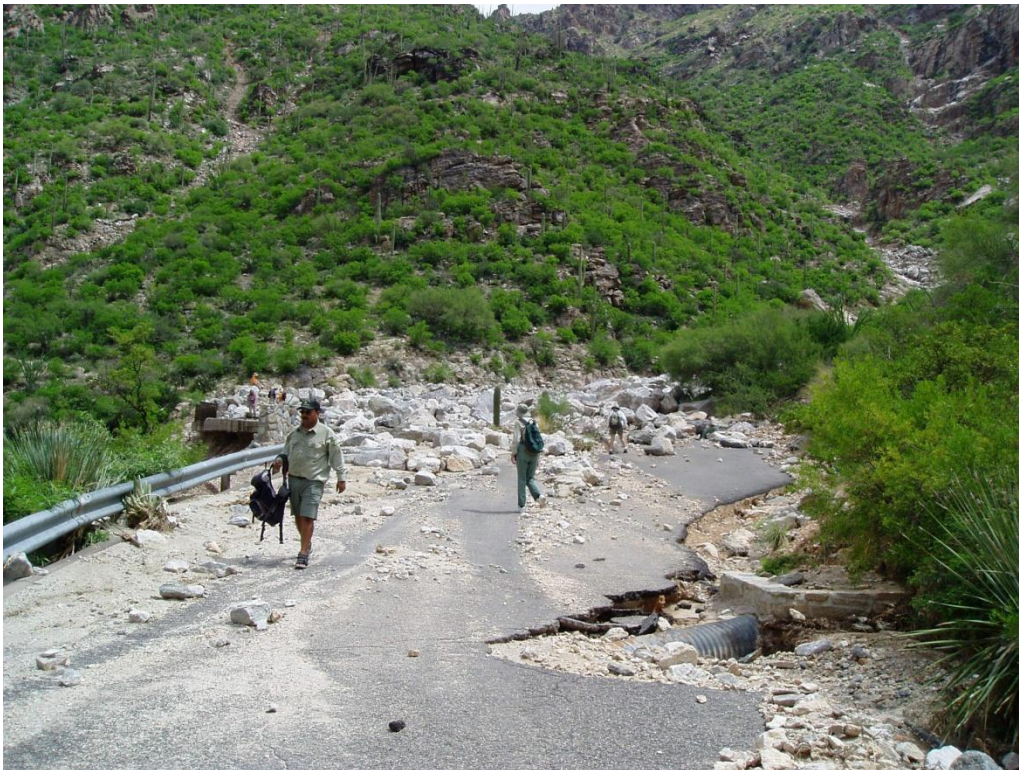
Figure 12. Tram Stop 9. Debris flow chute in upper right of photo.

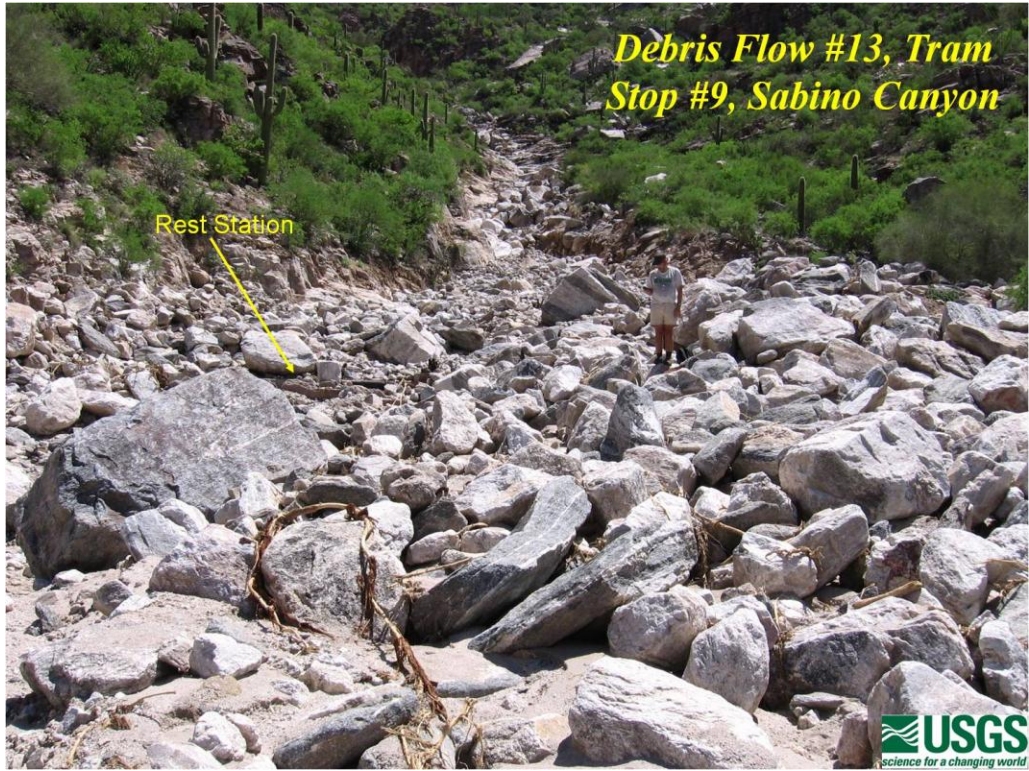
Figure 13. Tram Stop 9. The rest station was buried by the debris flow.

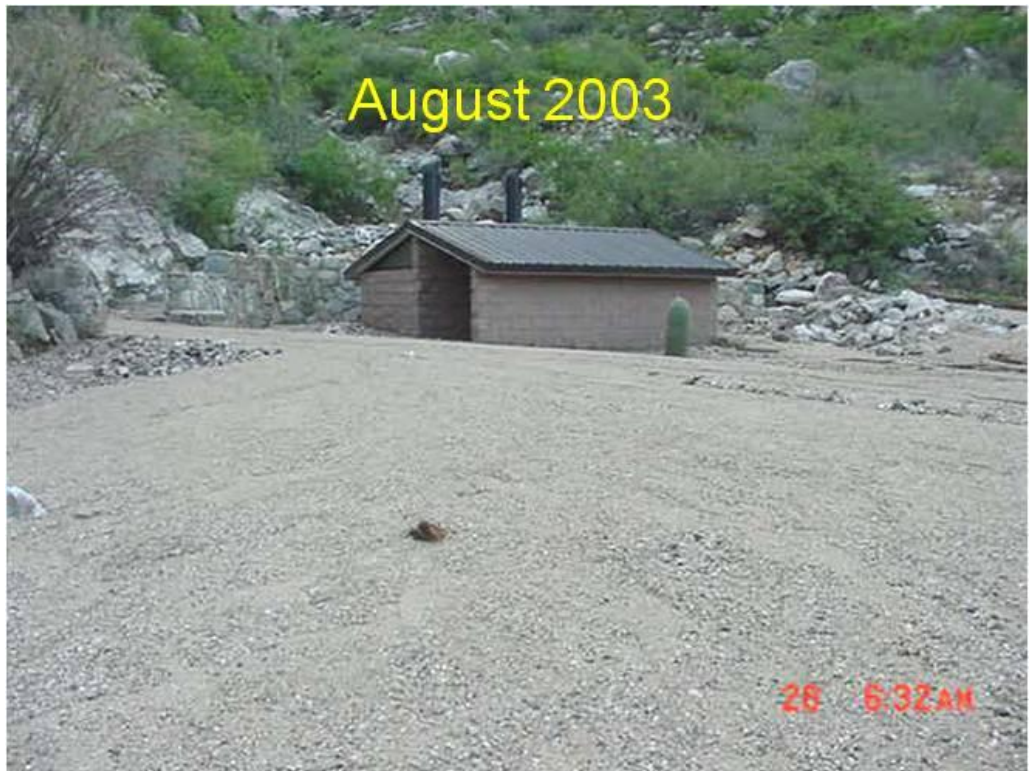
Figure 14. Photo of the rest station at Tram Stop 9 after the Post-Aspen Fire debris flow. As you can see there is a vast difference in clast size between these debris flows.
