Storm of July 26, 2007 In the Area of Indian Springs Road West of Phoenix International Raceway

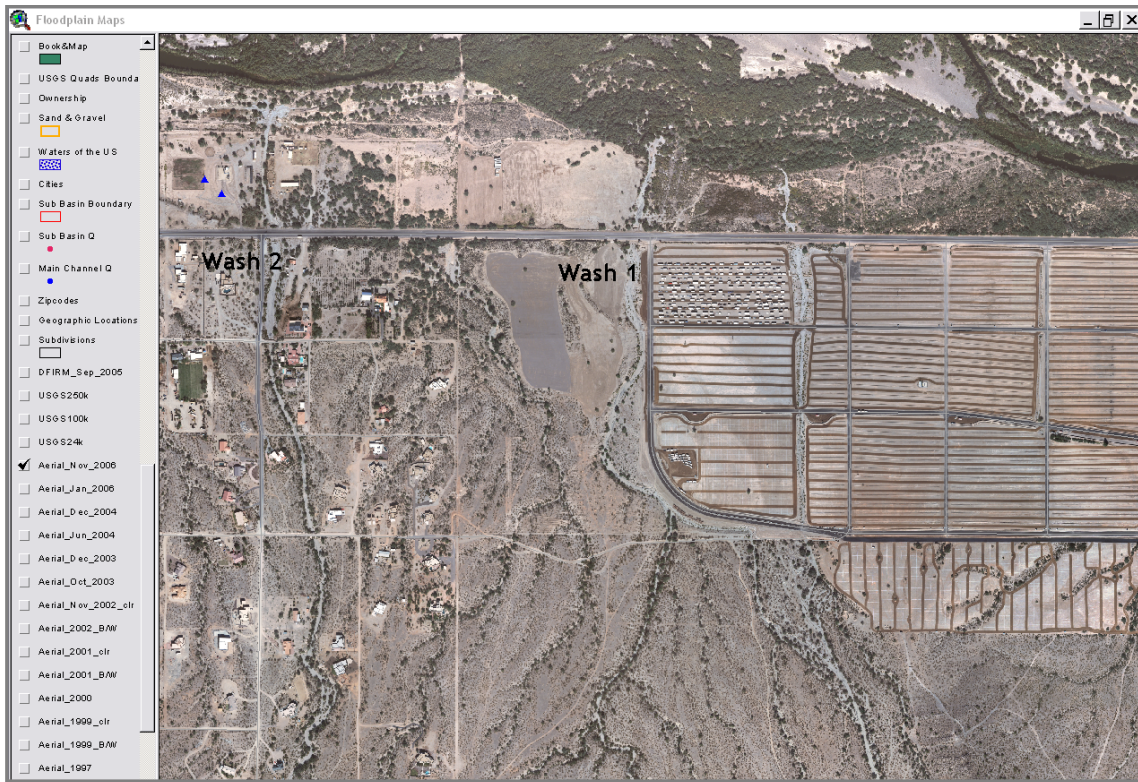
These are aerial photos of the wash crossings. Wash #3 below is west of washes 1 and 2 above. The striped areas east of Wash #1 are the western parking areas for PIR.

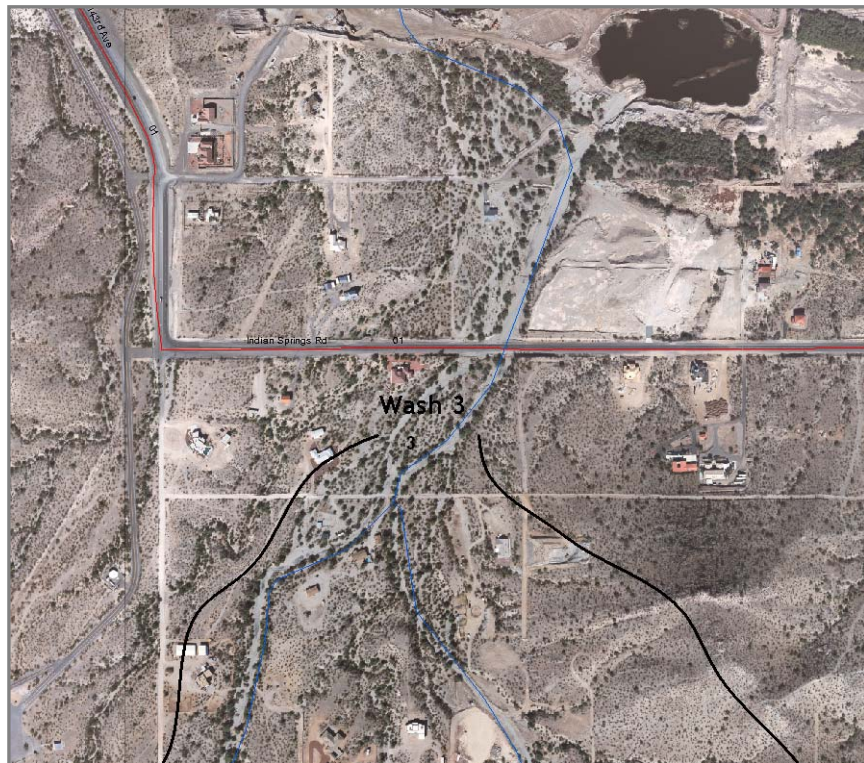
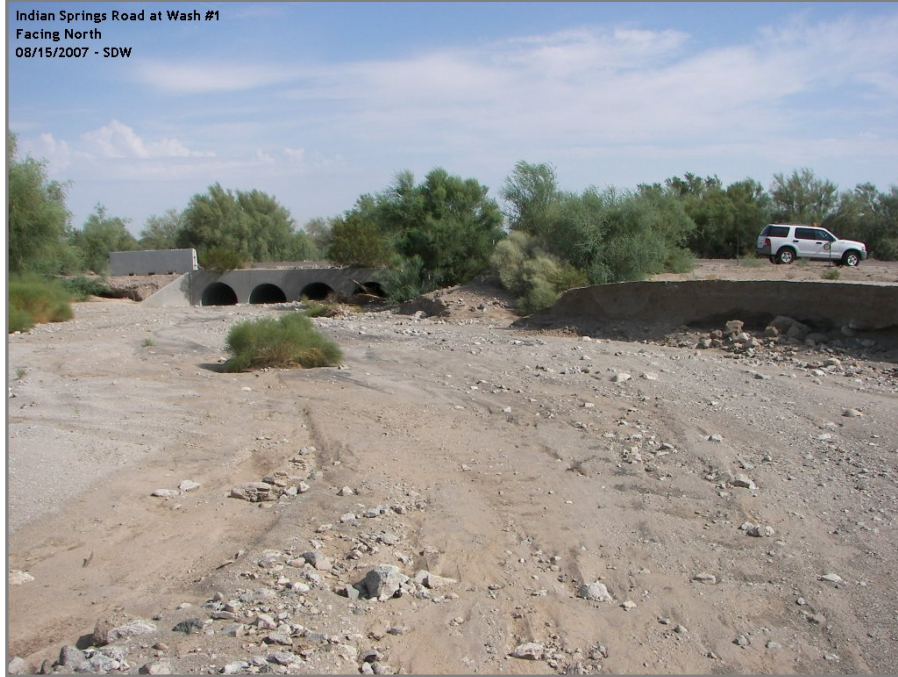
These photos show the crossing point of Wash #1 with Indian Springs Road. The four culverts were likely overtopped during the event of 7/26/07, and water flowed over the road from south to north. There is not much of a swale at the crossing so the water was likely less than 1 foot deep, but the flooded area was likely much wider than the culverts or the wash itself.

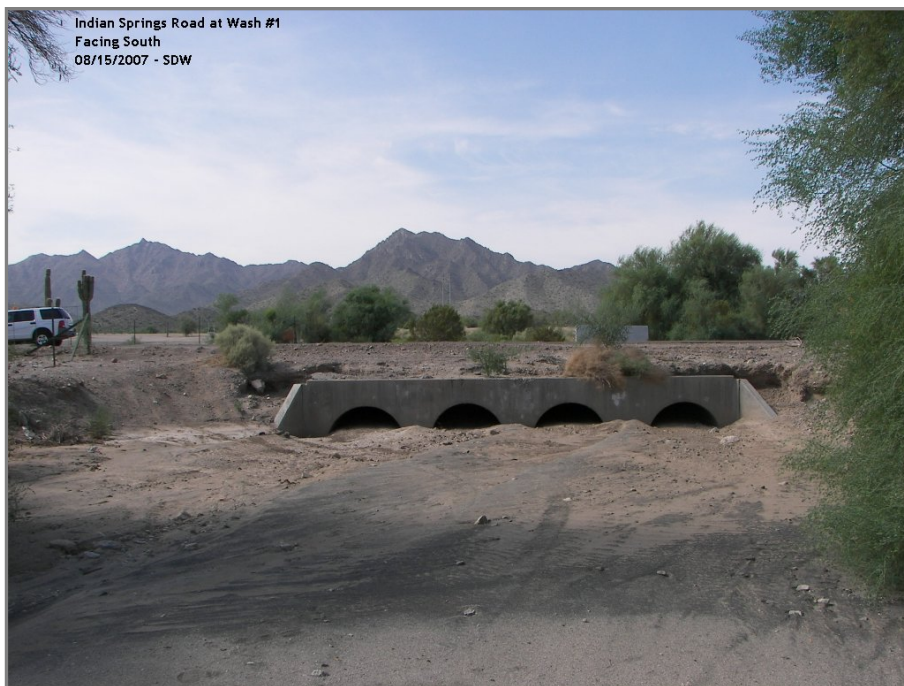
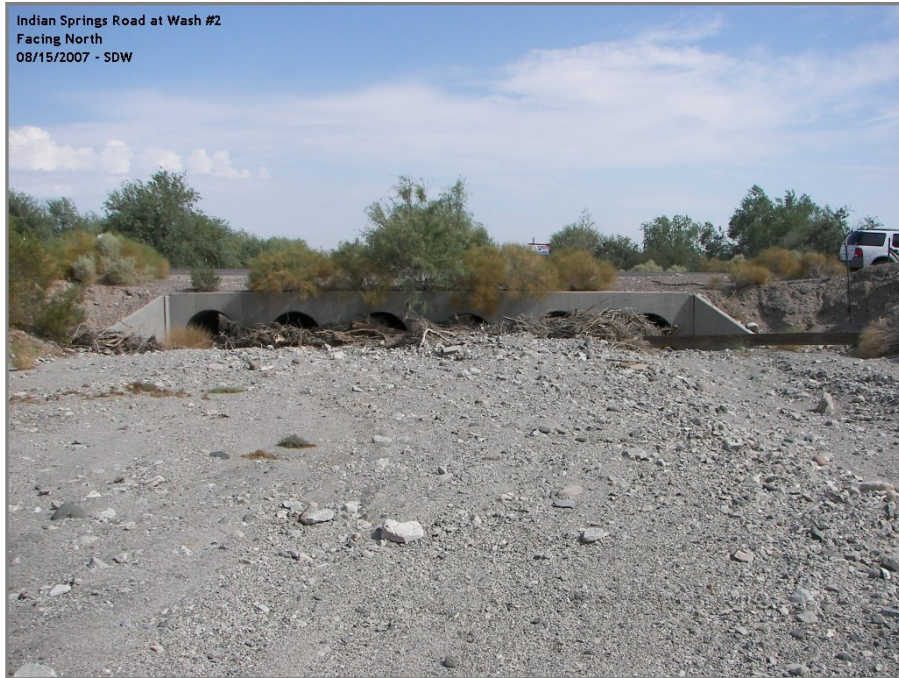
These photos show the crossing point of Wash #2 with Indian Springs Road. The six culverts were likely overtopped during the event of 7/26/07, and water flowed over the road from south to north. Again, there is not much of a swale at the crossing so the water was likely less than 1 foot deep, but the flooded area was likely much wider than the culverts or the wash itself.
