## GEOLOGIC REPORT OF THE DEVILS KITCHEN SINKHOLE

Paul A. Lindberg

February 2010

Section 1, Township 17 N, Range 5 E  
Sedona, Yavapai County, Arizona

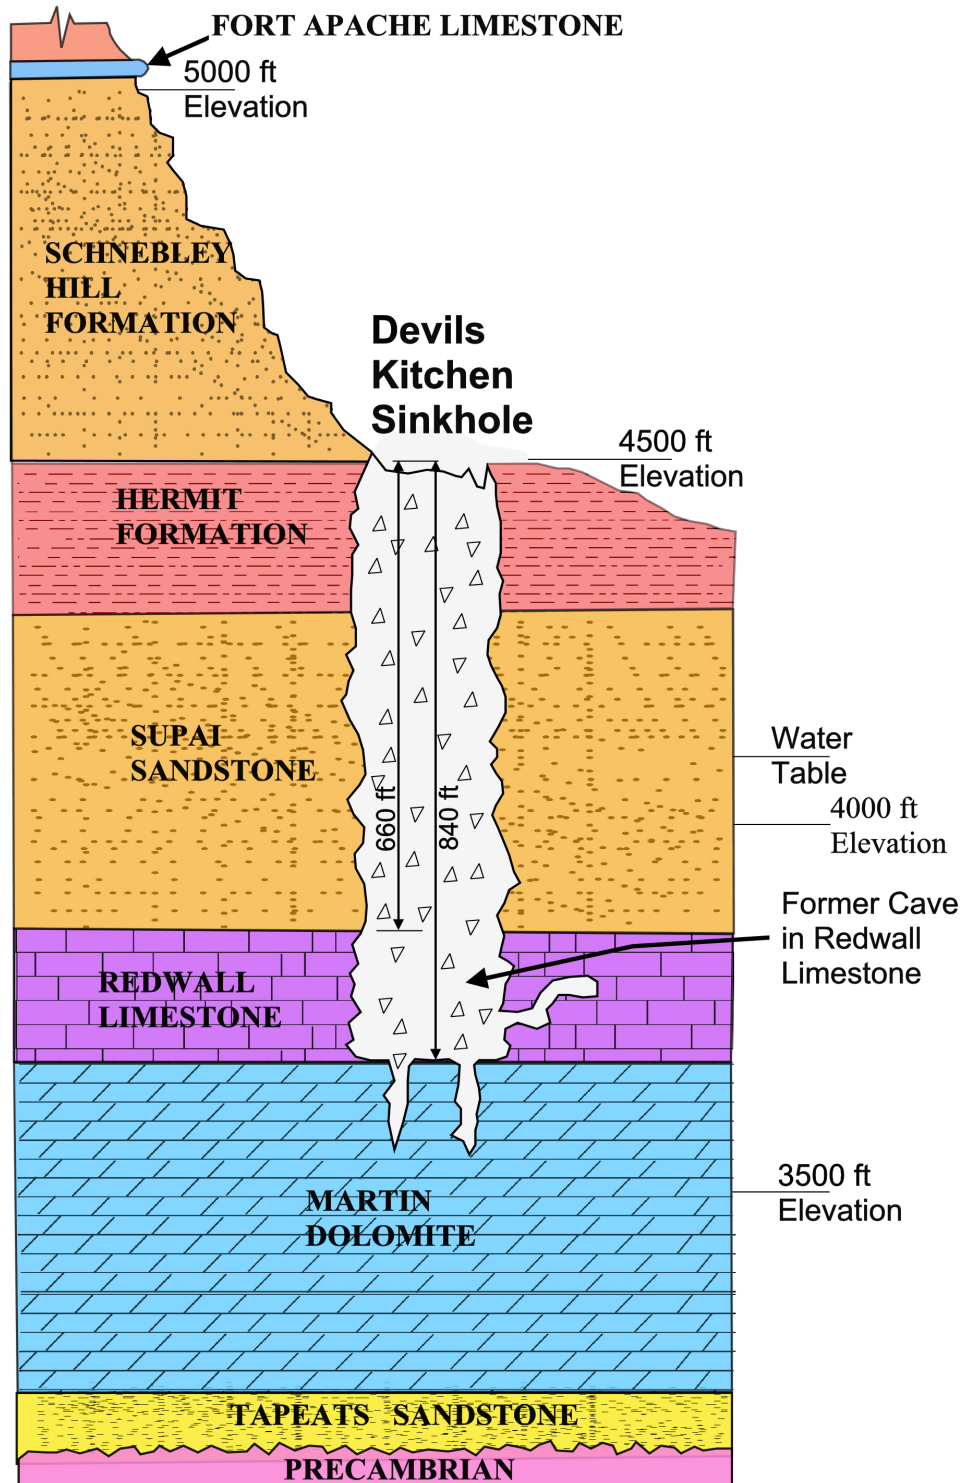
Figure 2 shows a stratigraphic cross section of the rock strata in the vicinity of the Devils Kitchen sinkhole. The stratigraphic subdivisions have been derived from various recent sources and are believed to be accurate enough for the purposes of this report.

*(\*) More recent correlation work shows that the bedrock lip of the Devils Kitchen sinkhole is situated in Schnebly Hill Sandstone and its contact with underlying Hermit formation lies about 40-60 feet below the sinkhole lip. The softer shaly sediments under the eastern wall of the sinkhole, as seen in Cross Section B-B', is now defined as the uppermost part of the Hermit formation that forms the prominent undercut situated 40 feet below the sinkhole rim. In addition, there are new refinements of elevations and rock formation thicknesses.)*

Figure 2. Schematic cross section of rock strata in vicinity of Devils Kitchen sinkhole. The elevations and geologic formation contacts may vary by small amounts due to interpretational differences. A solution cave with the Redwall Limestone (approximately 200 feet in diameter and 180 feet high) collapsed due to lack of roof support. Over a period of time the caprock caved in and finally broke through to the surface (1880s?).

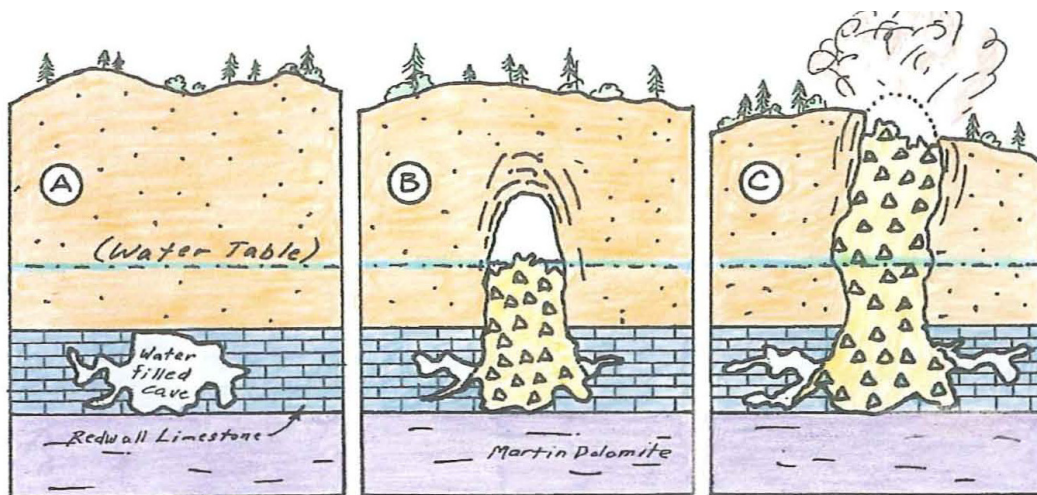
Figure 8 illustrates how this process of upward-stoping took place. It is highly unlikely that the entire column of rock fell at one time, although it probably did advance by catastrophic pulses. If a collapse of this magnitude took place below the ground surface in a "blind" collapse zone it may be capable of generating an audible "bump" on the surface in much the same manner as that experienced from a large underground mine blast. Such reports should not be taken as frivolous in nature, but be regarded with some concern. While highly unlikely, such events may provide advanced warning [as] to future sinkhole development.

Figure 8. Schematic cross-sections illustrating how a sinkhole may develop. Part A shows a limestone cave beneath a cover of sandstone, much the same as seen at the Devils Kitchen area. Part B shows that as the cave got too large to support the roof rocks it began to cave in the overlying strata. The broken rock which occupies the enlarging cavity is called breccia. Part C show how the upward-stoping collapse finally breaches through the surface.
