City of Bisbee Comprehensive Transportation Plan

Task Assignment
MPD 34-10

Final Report

February 20, 2012

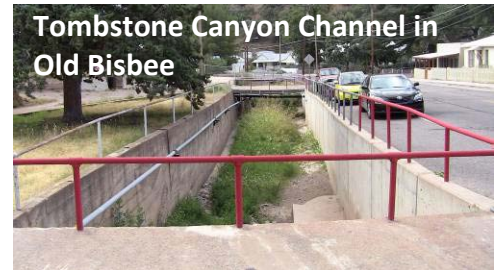
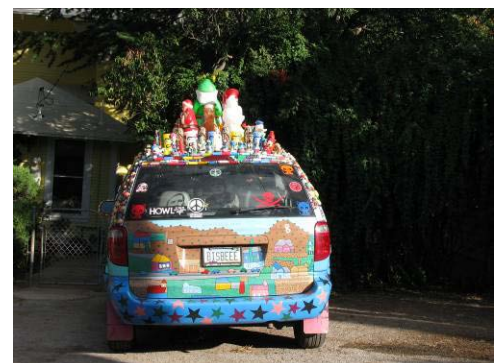
- Some of the public staircases and retaining walls have no handrails and safety rails, or the rails are in poor condition.

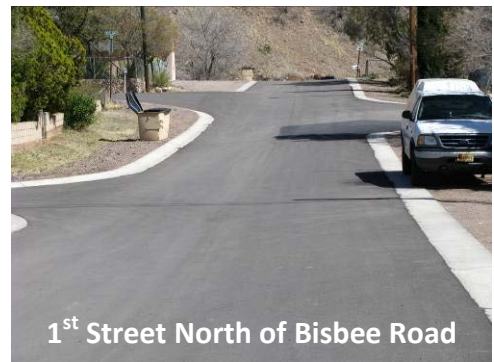
Over half the street segments rated poor to failed condition; meaning they have deteriorated to the point that major rehabilitation or complete reconstruction of the street would be the best remedy. To paraphrase the remarks made by several stakeholders, *“the streets are in bad condition, but the residents are used to it and drive more slowly over the roughest areas”*. Of course the consequence is additional wear and tear on vehicles and the corresponding increased maintenance expense; less safe driving conditions because of the poor, rough surfaces; and increased fuel consumption leading to additional fuel costs, more pollution, and extra use of a limited imported resource.

The San Jose/Don Luis neighborhood streets are overall in better condition than the Warren area streets. This is logical since the former neighborhoods are newer. Also as expected, the streets in Old Bisbee, as a whole, are in the poorest condition of the three major neighborhoods since this is the original, and the oldest part, of town with the steepest terrain. See the *Roadway Inventory Table* and the *Street Condition Assessment Maps* contained in *Appendix 5*, for more detailed information on the condition assessment rating of each street segment and the nature of the deficiencies noted.

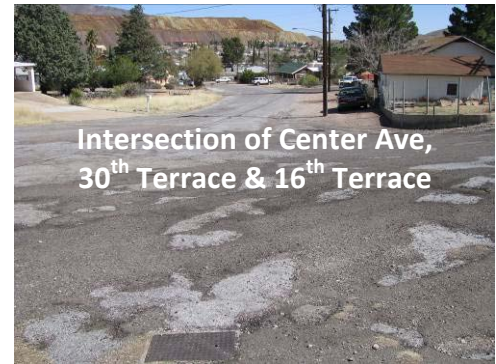
Poor drainage conditions in some areas have contributed to street condition degradation. When any street rehabilitation projects are carried out, it is important that the drainage and grading conditions associated with the street be carefully analyzed and that drainage be accommodated on the street to the greatest extent possible and positive drainage away from the street is provided as well to maximize the life of the investment being made. Otherwise, the street repairs or new construction will have a shorter life than necessary. Improving street related drainage is money well spent and paramount when resources are limited.

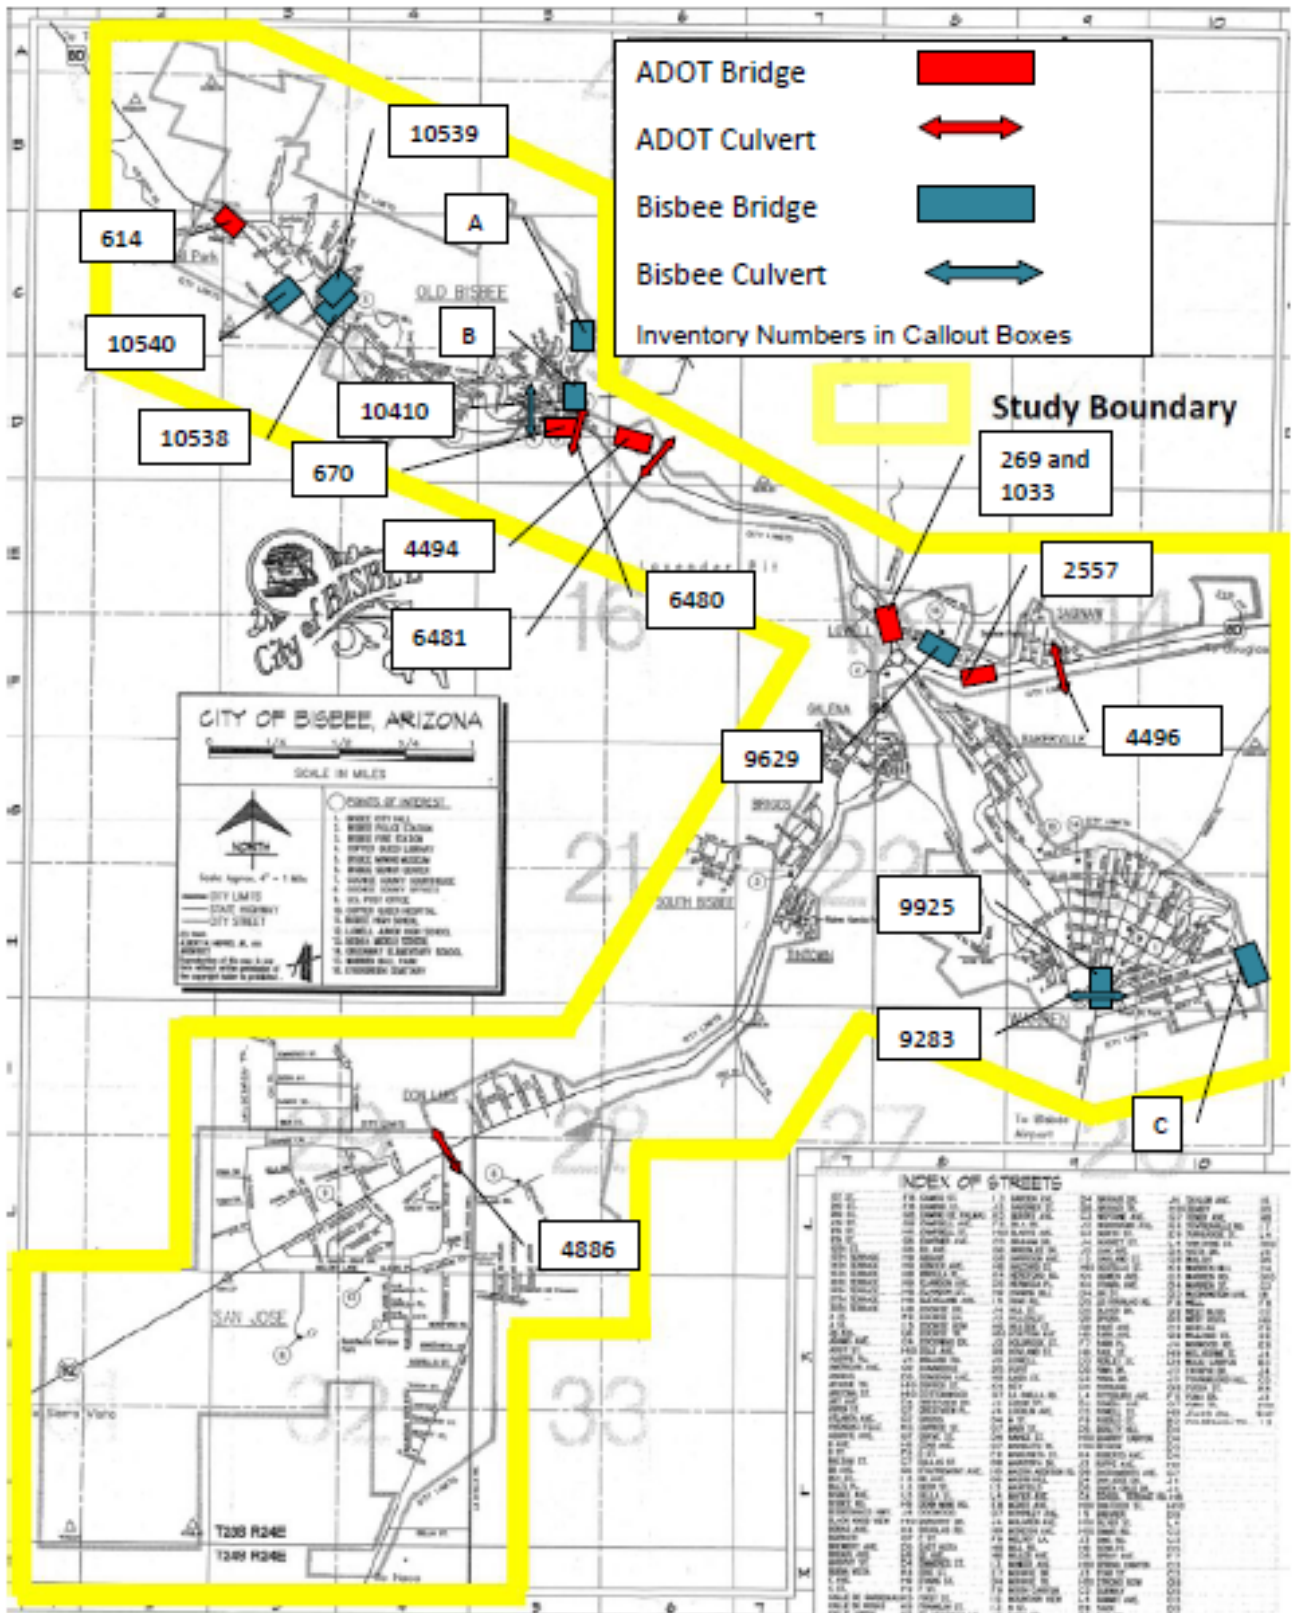
Figure 20 Bridge and Culvert Structure Locations

Three structures were found in Old Bisbee that are not in the regular rotation for inspection. Two of these structures are on OK Street. One of these structures (labeled A on Figure 20) is found near Brewery Gulch and consists of timber decking with built up timber beams. Based on visual observation, the beams are either 4 – 2x8 beams or 4 – 2x10 beams spaced approximately 5’ on center (C/C). The decking is in poor condition and shows strong evidence of failure. The roadway surface is asphalt.

The second structure (labeled B on Figure 20) is located at the intersection of OK Street and Youngblood. This structure is a concrete slab bridge over a drainage way. The structure is in fair condition. The underside of the structure shows signs of efflorescence and overall aging since the structure is approximately 80 to 90 years old. There is a large vertical crack in the downhill side of the abutment wall. The crack shows no sign of recent movement and looks to be stable. There are some signs of deterioration due to water intrusion and vegetation growth on the canal walls. Overall, the structure needs little rehabilitation work and should be added to the biennial inspection list along with the other structures located within the City of Bisbee.

The third structure (labeled C on Figure 20) is on Minder Avenue just north of Black Knob View. This structure is a concrete arch and is in fair condition. The railing on the structure needs repair or replacement due to a vehicle collision. There is some minor cracking and efflorescence due to the structure being about 64 years old.

Per Bisbee officials, during recent rehabilitation work on homes uphill of the structure, a temporary structure was placed over the limits of the wooden bridge so that the trucks would not overstress the structure. This structure is in need of immediate replacement in order to bring it up to standards and allow continued use of OK Street.

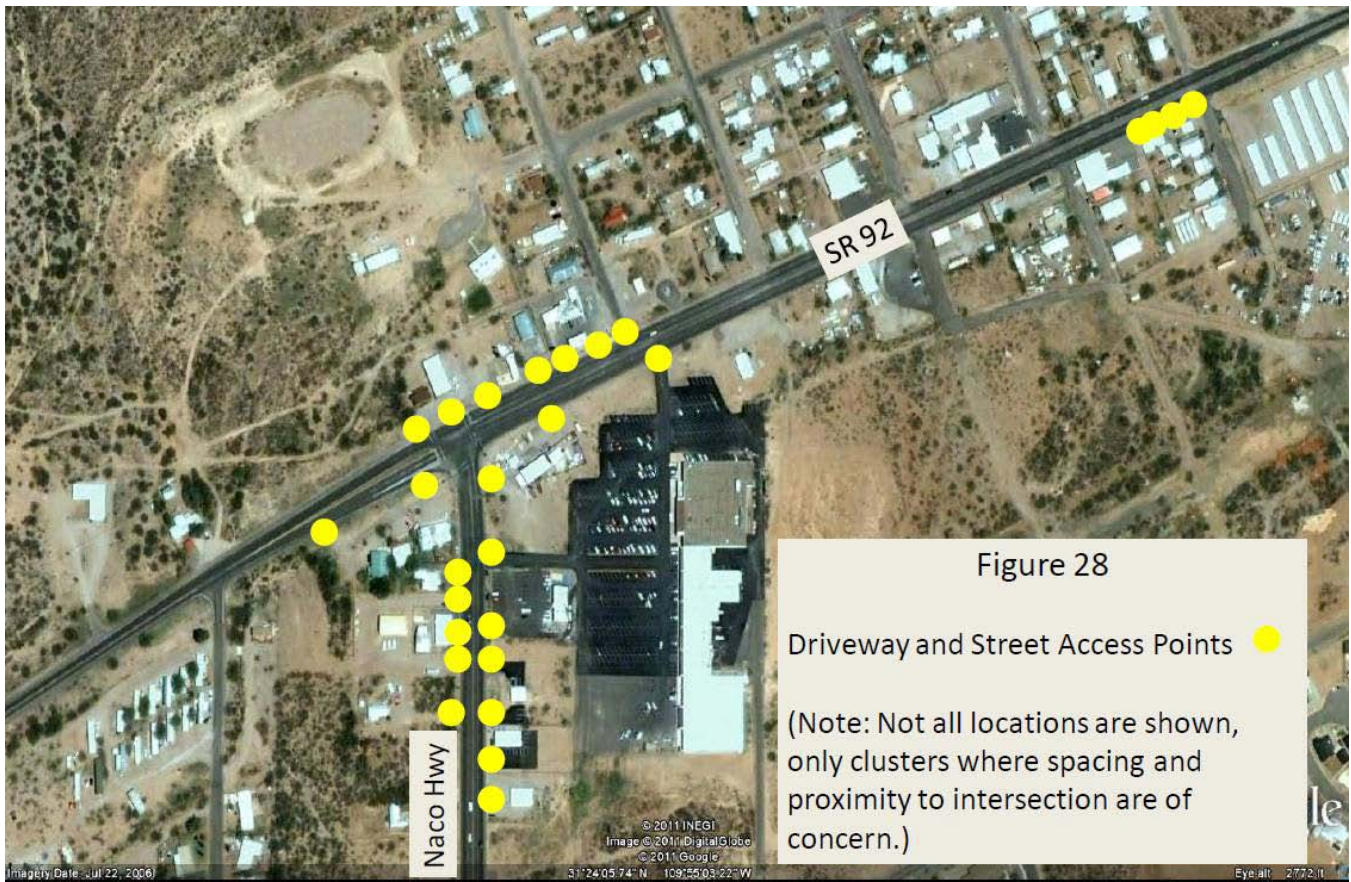
Figure 28 SR 92 and Naco Highway Access Points

- SR 92 has an excessive number of driveway access points in the vicinity of the Naco Highway intersection. Twelve of these are within 700 feet of the intersection and seven are within 100 feet, including one at the direct north side of this “T” intersection.

- At the southwest corner of Taylor Lane and SR 92, there are four driveway openings in a space of less than 100 feet.
- A connection to the Safeway Center from Collins Road to the south would help alleviate conflicts at the entrance on SR 92.

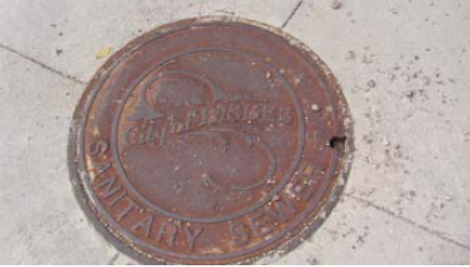
<p>UTILITY IN STREET</p>

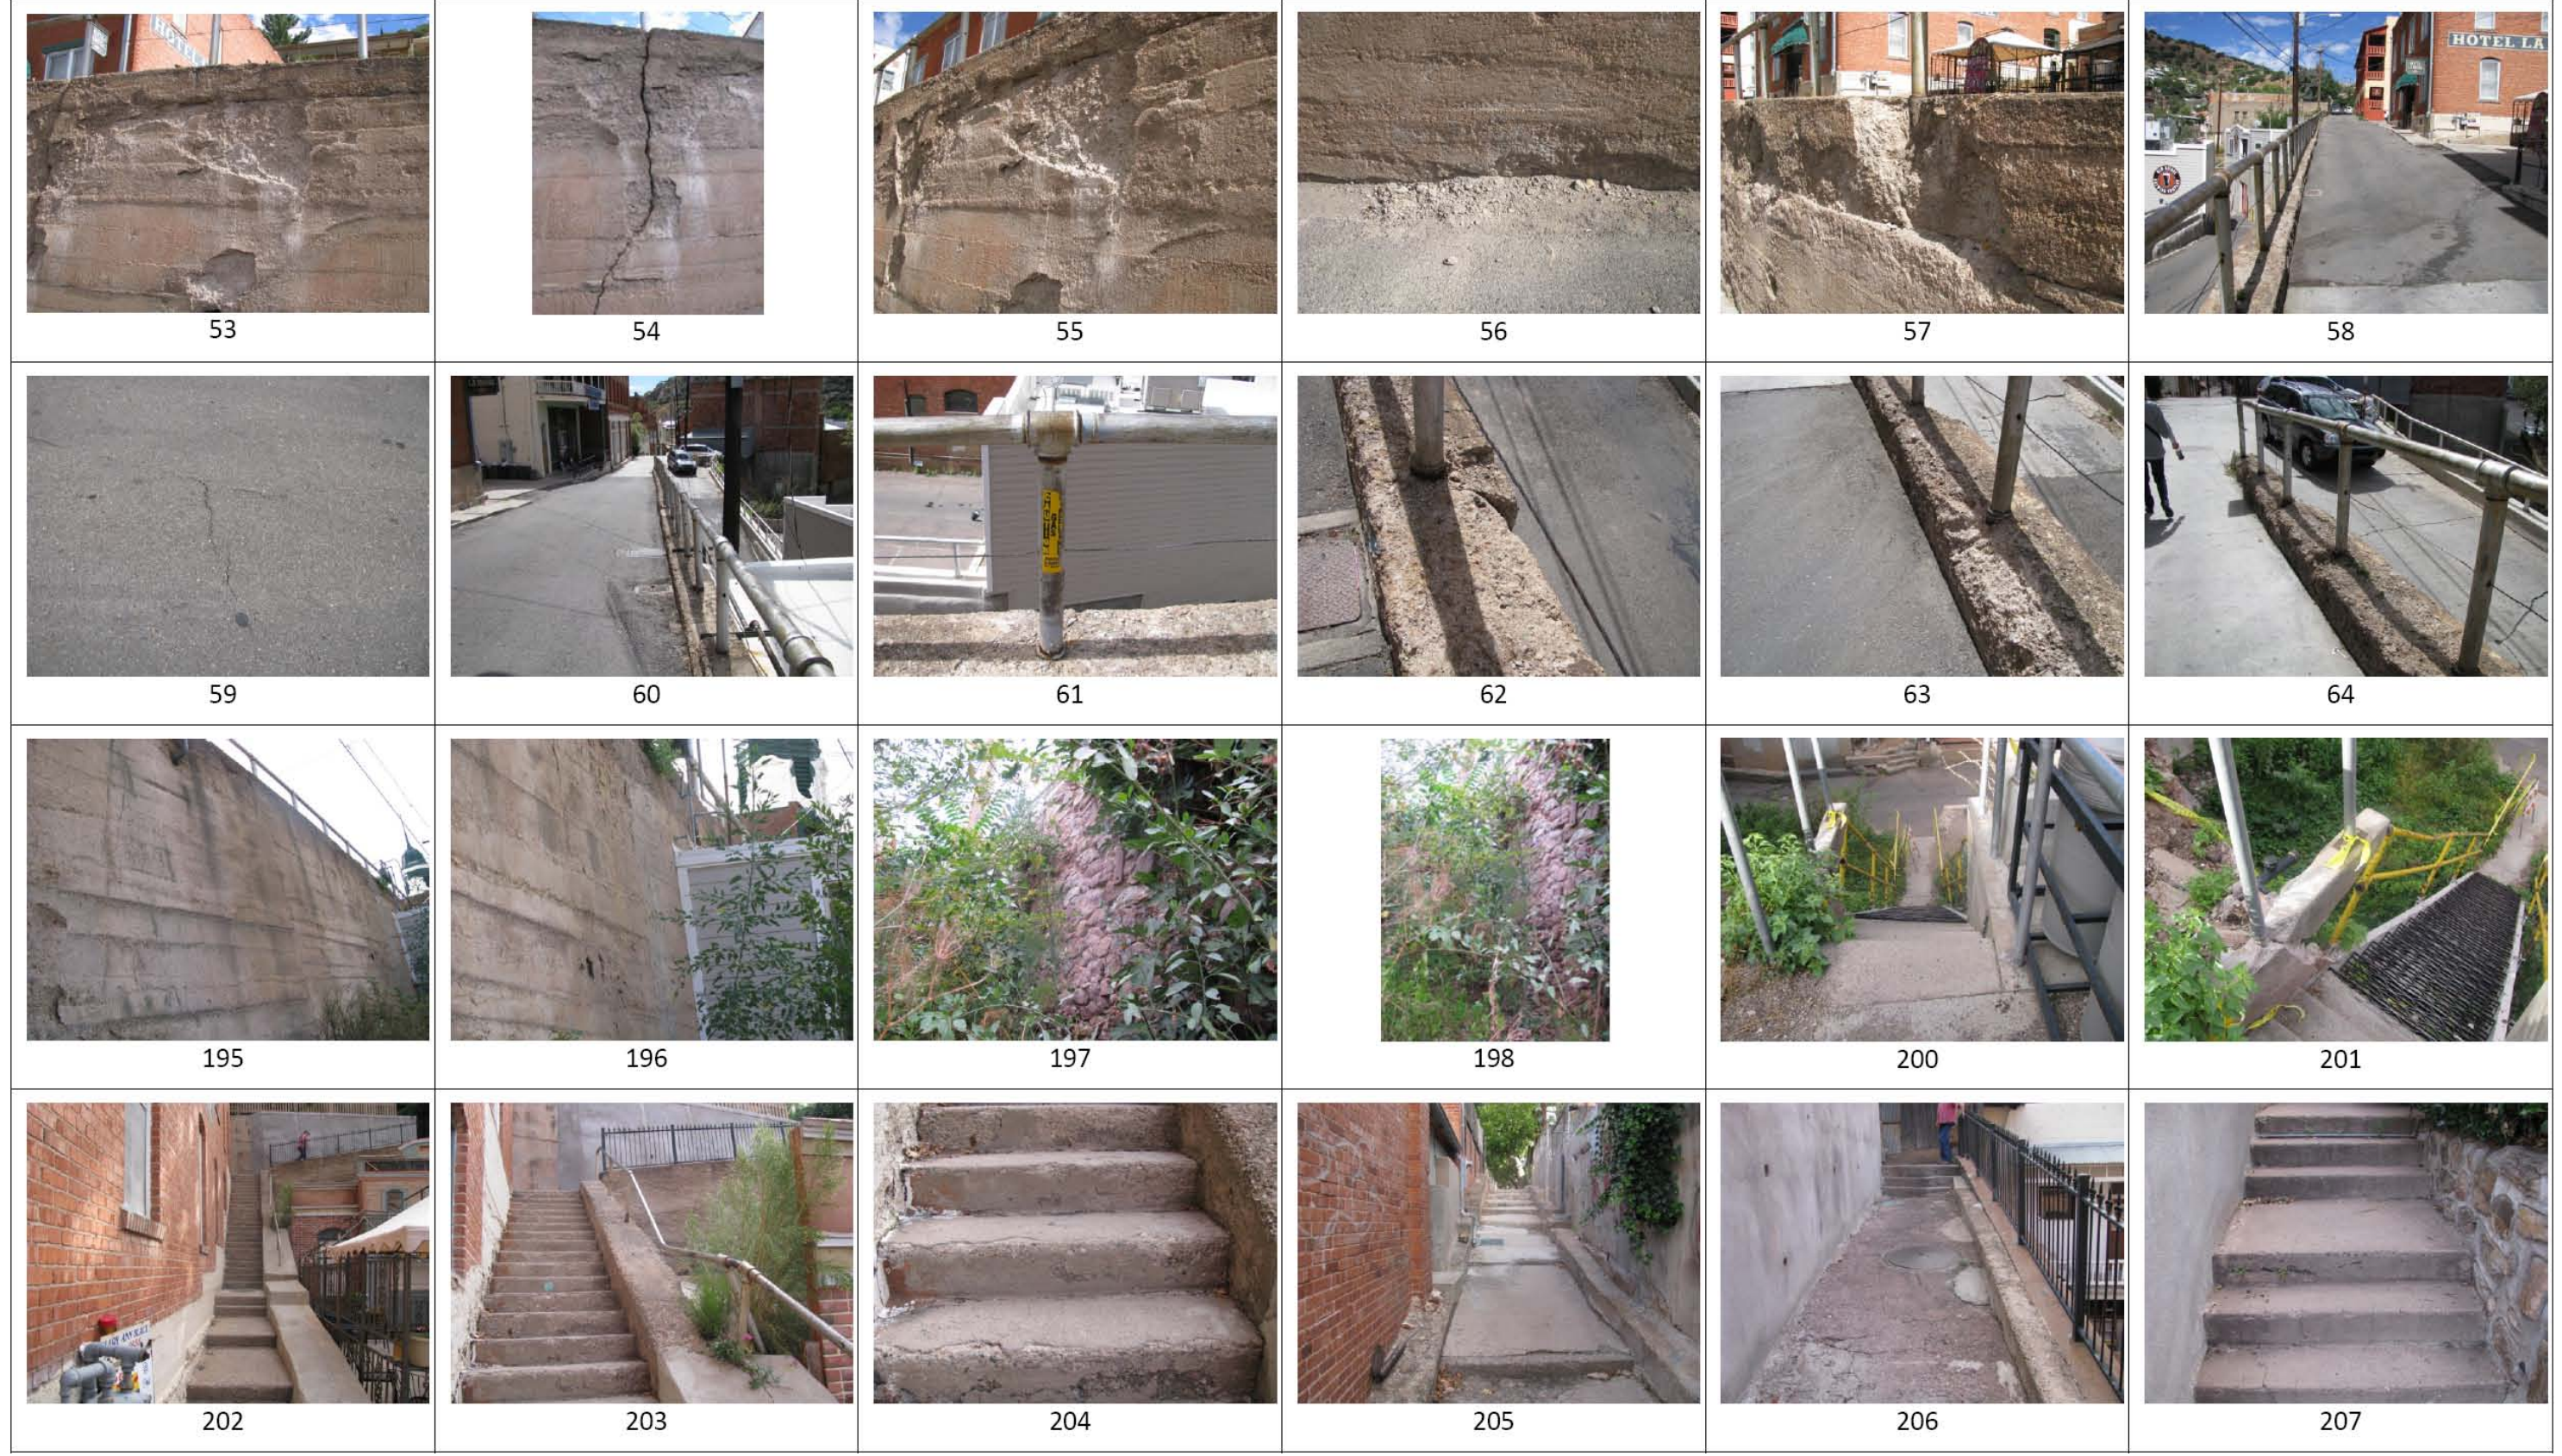
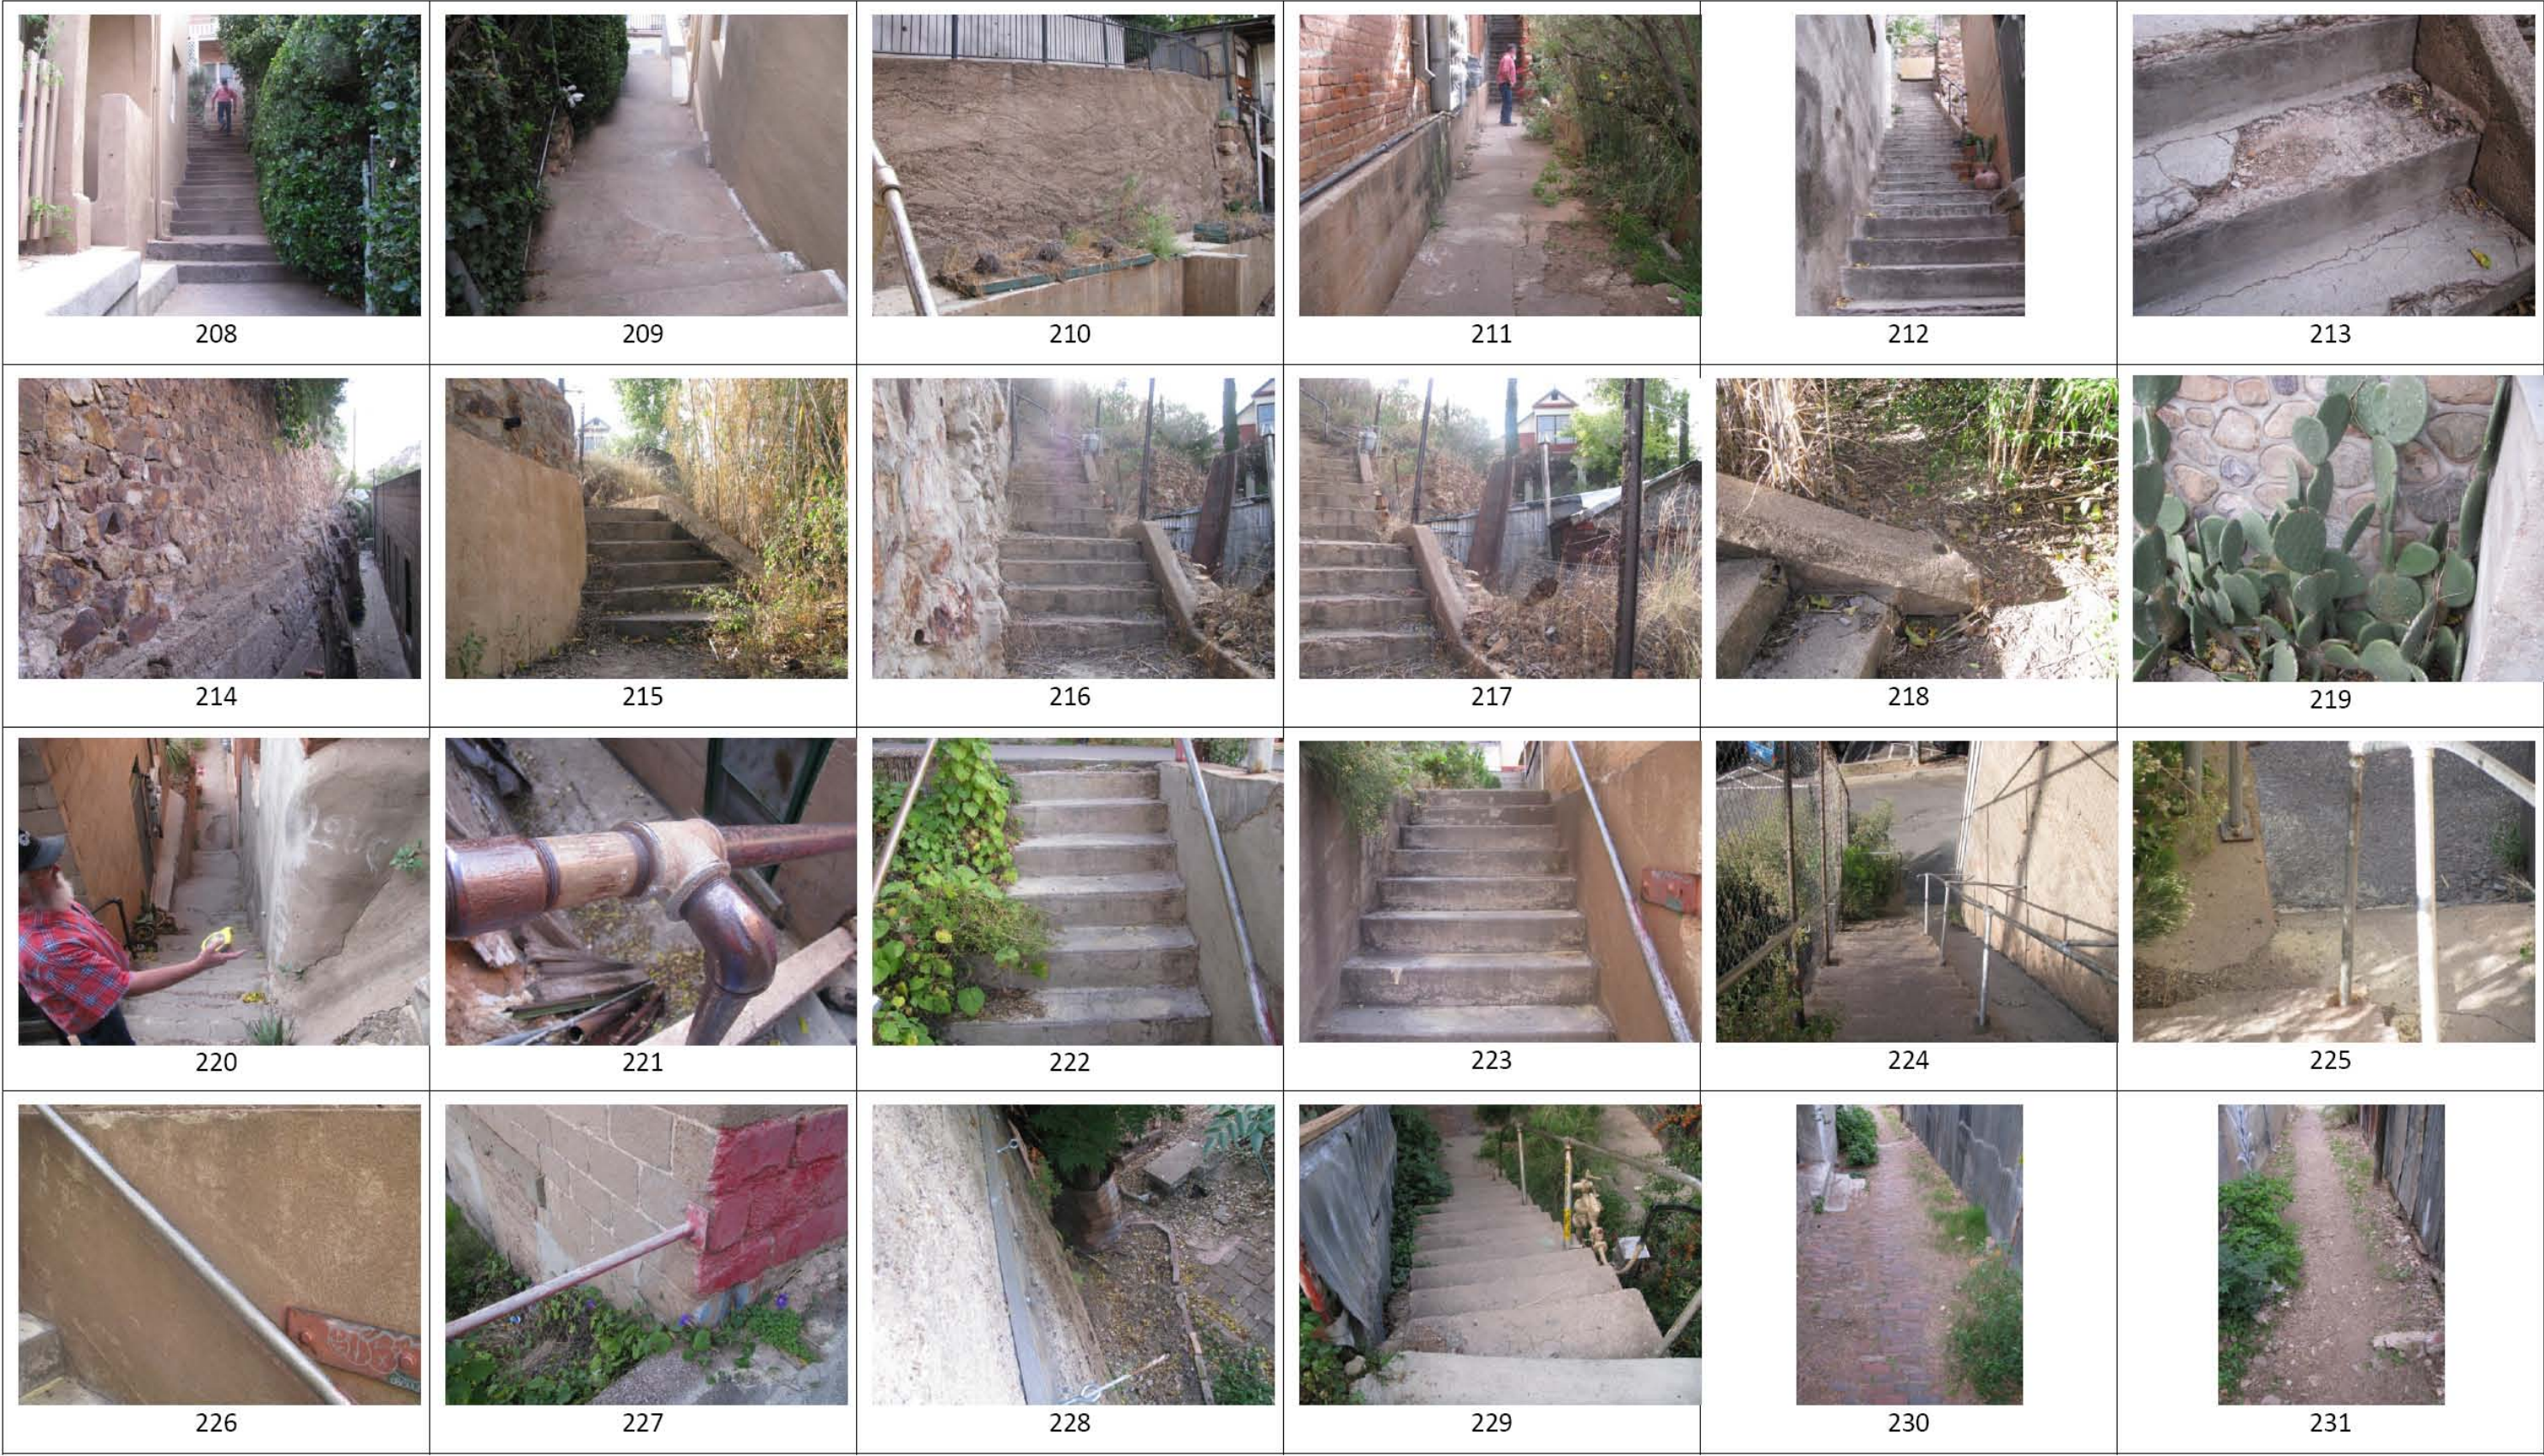
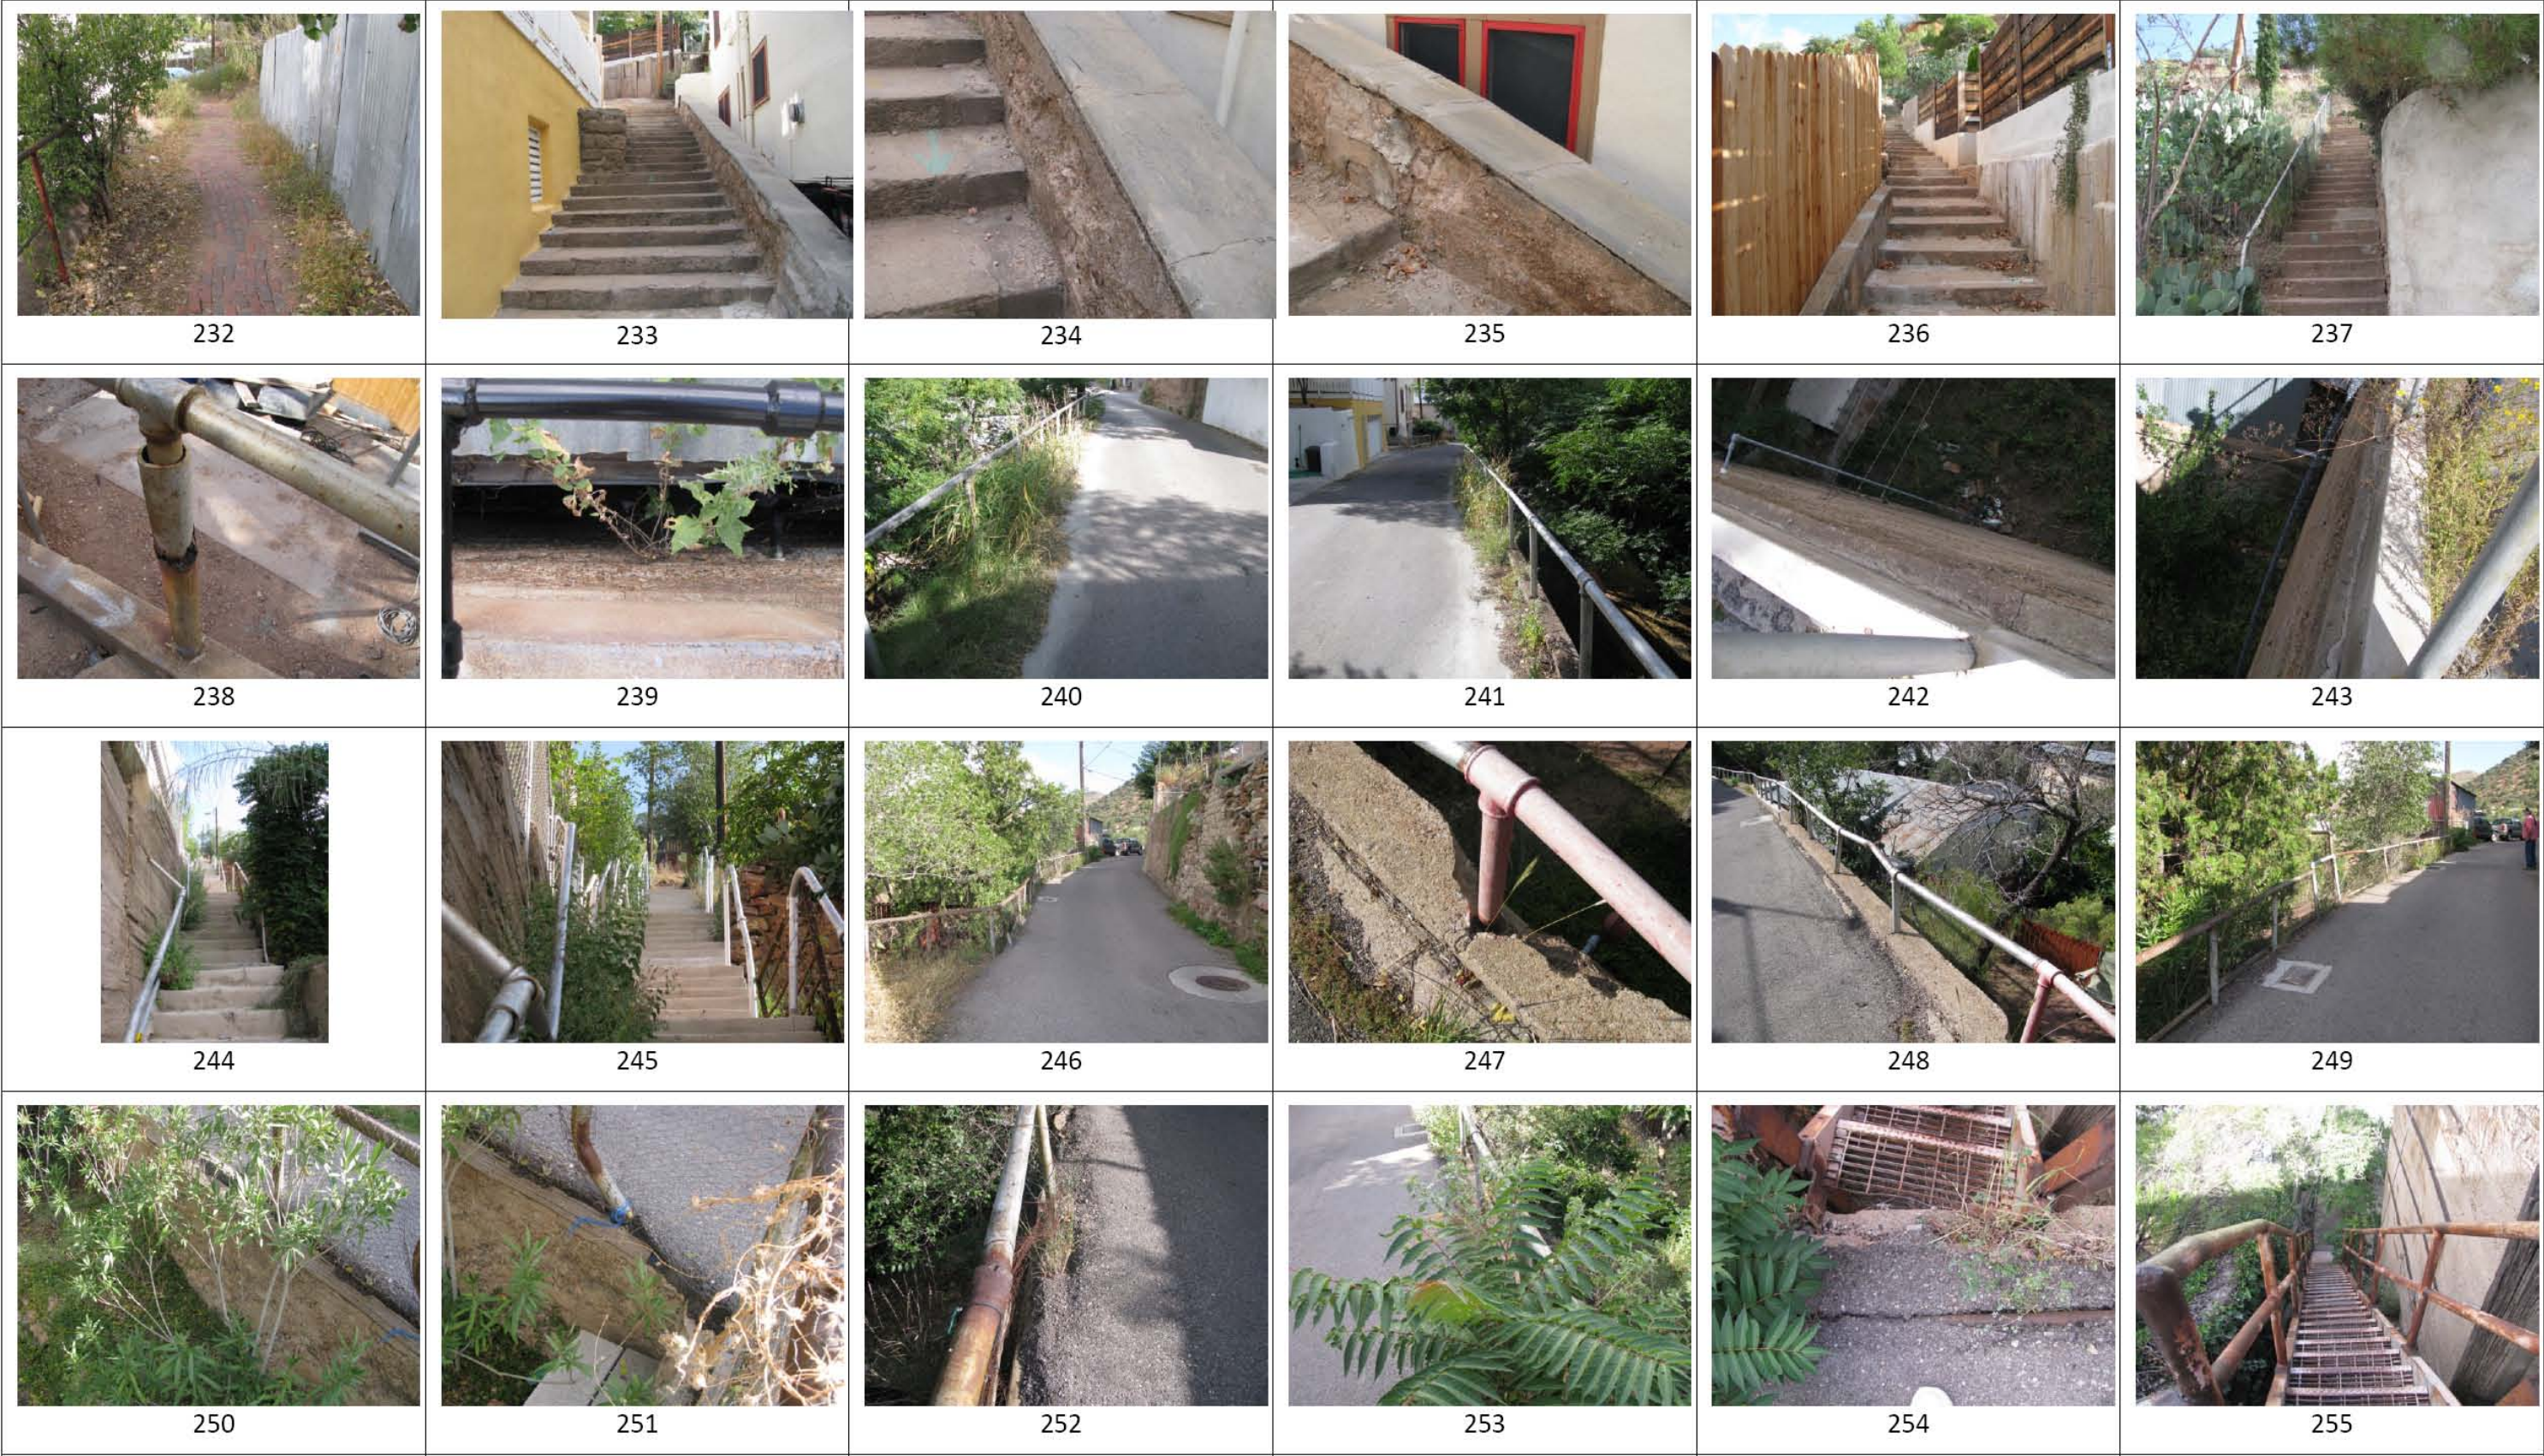
Exhibit 5 Walls & Stairs Inventory – OK Street - Pictures

OK Street	118 OK Street						Good shape. Recent work on top cap. Conduit was placed for future handrail which is currently not installed. (See Pics. 275 - 277)		X				No immediate need of rehabilitation work. May need long term shotcrete face to protect the integrity of the wall.
OK Street	125 OK Street			7'			Wall is in good condition (See Pic. 278)		X				No immediate need of rehabilitation work. May need long term shotcrete face to protect the integrity of the wall.
OK Street	135 OK Street to 139 OK Street			5'			Wall is in Fair Condition (See Pics 279 - 291)			X			No immediate need of rehabilitation work. May need long term shotcrete face to protect the integrity of the wall.
