City of Bisbee Comprehensive Transportation Plan

Task Assignment
MPD 34-10

Final Report

February 20, 2012

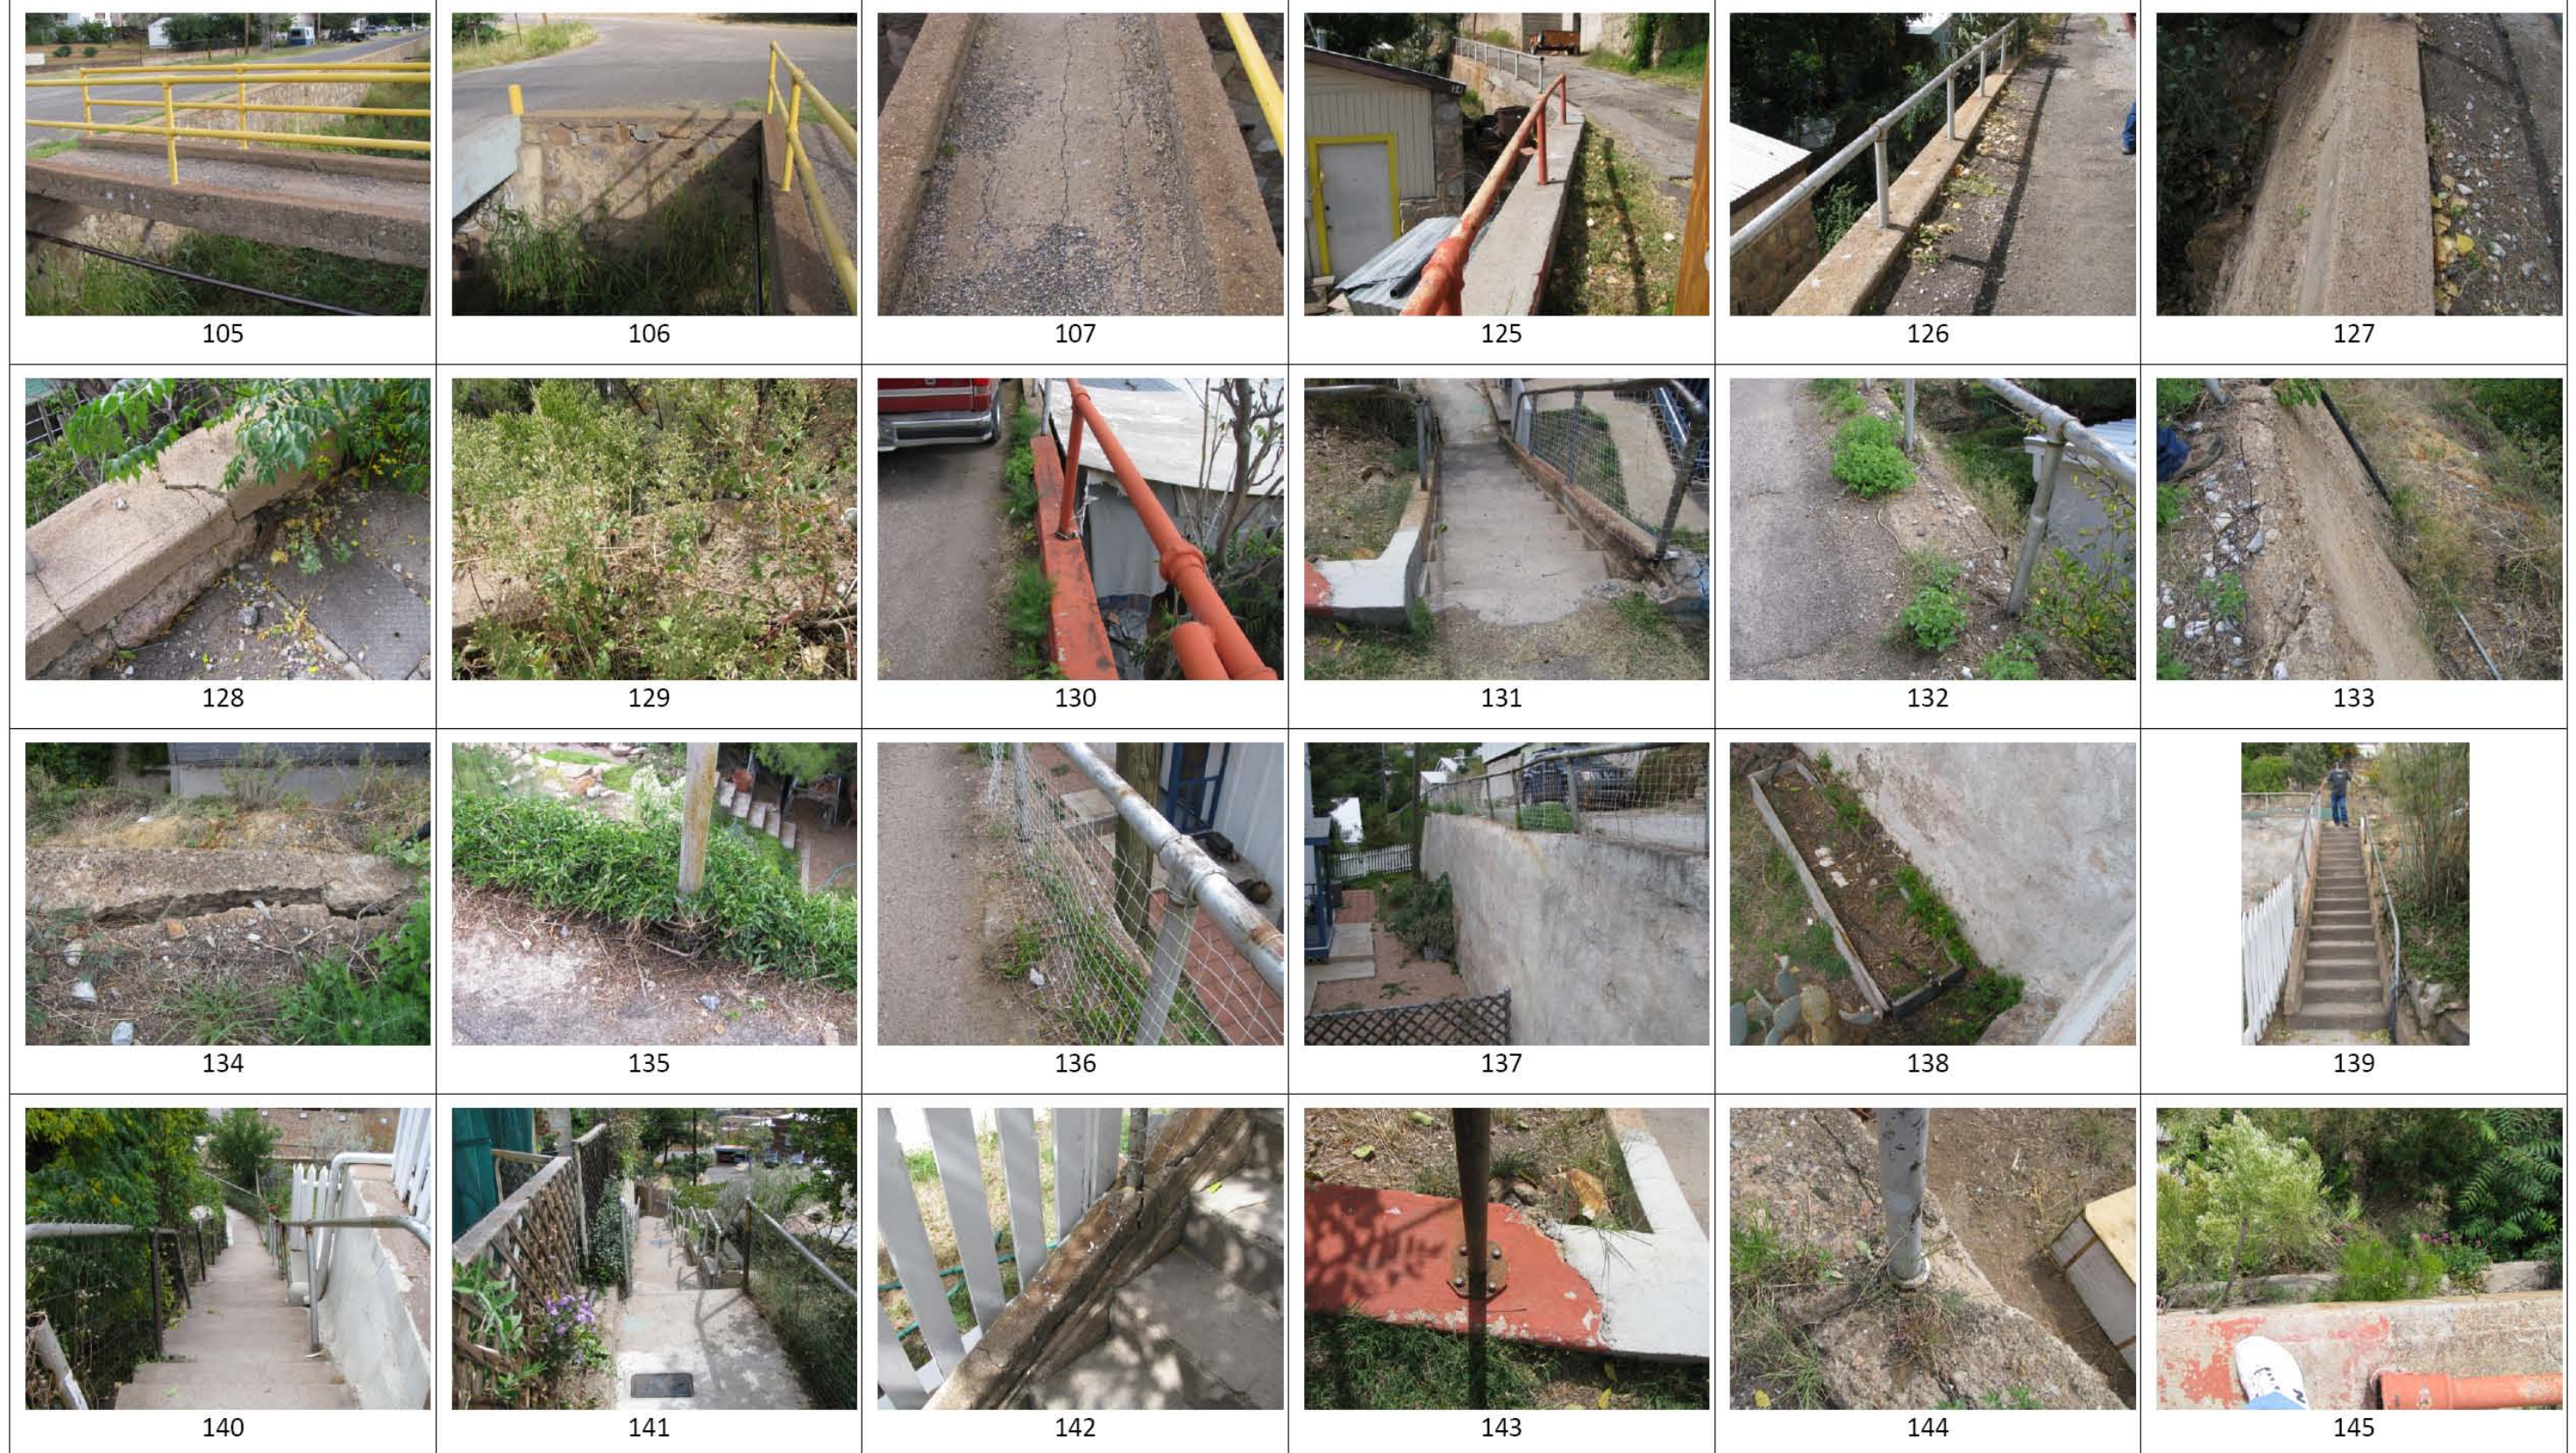
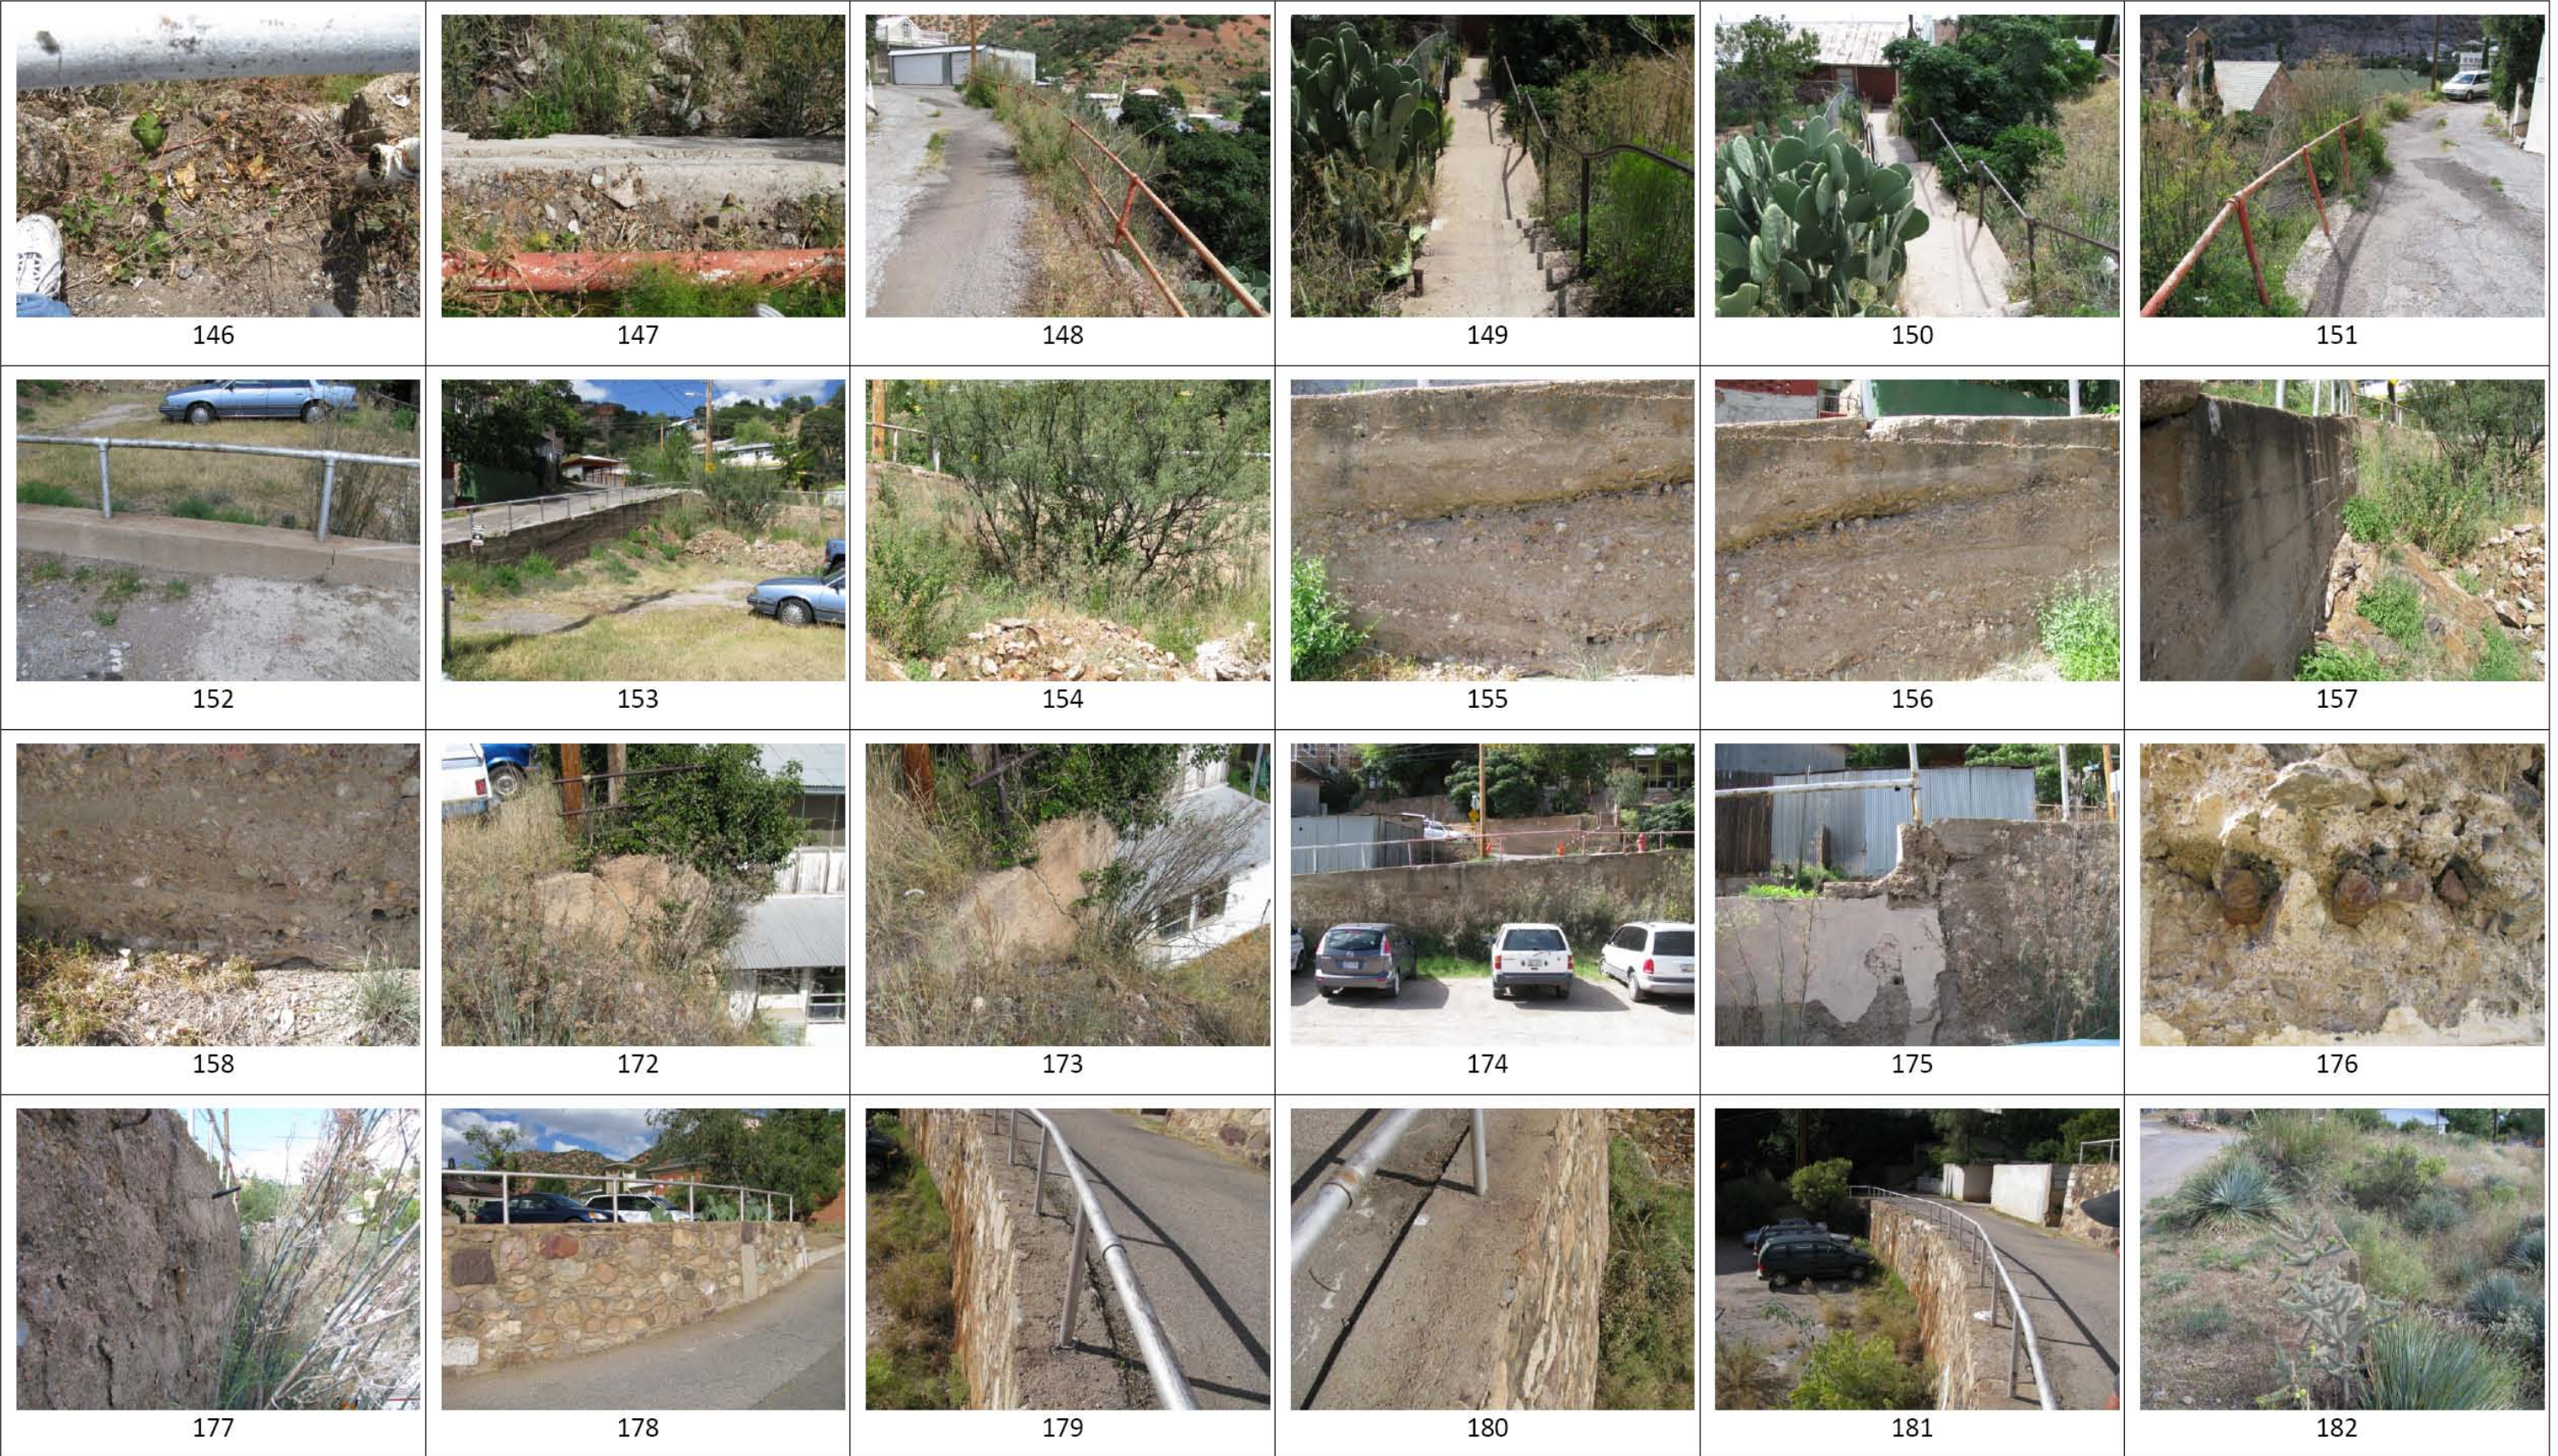
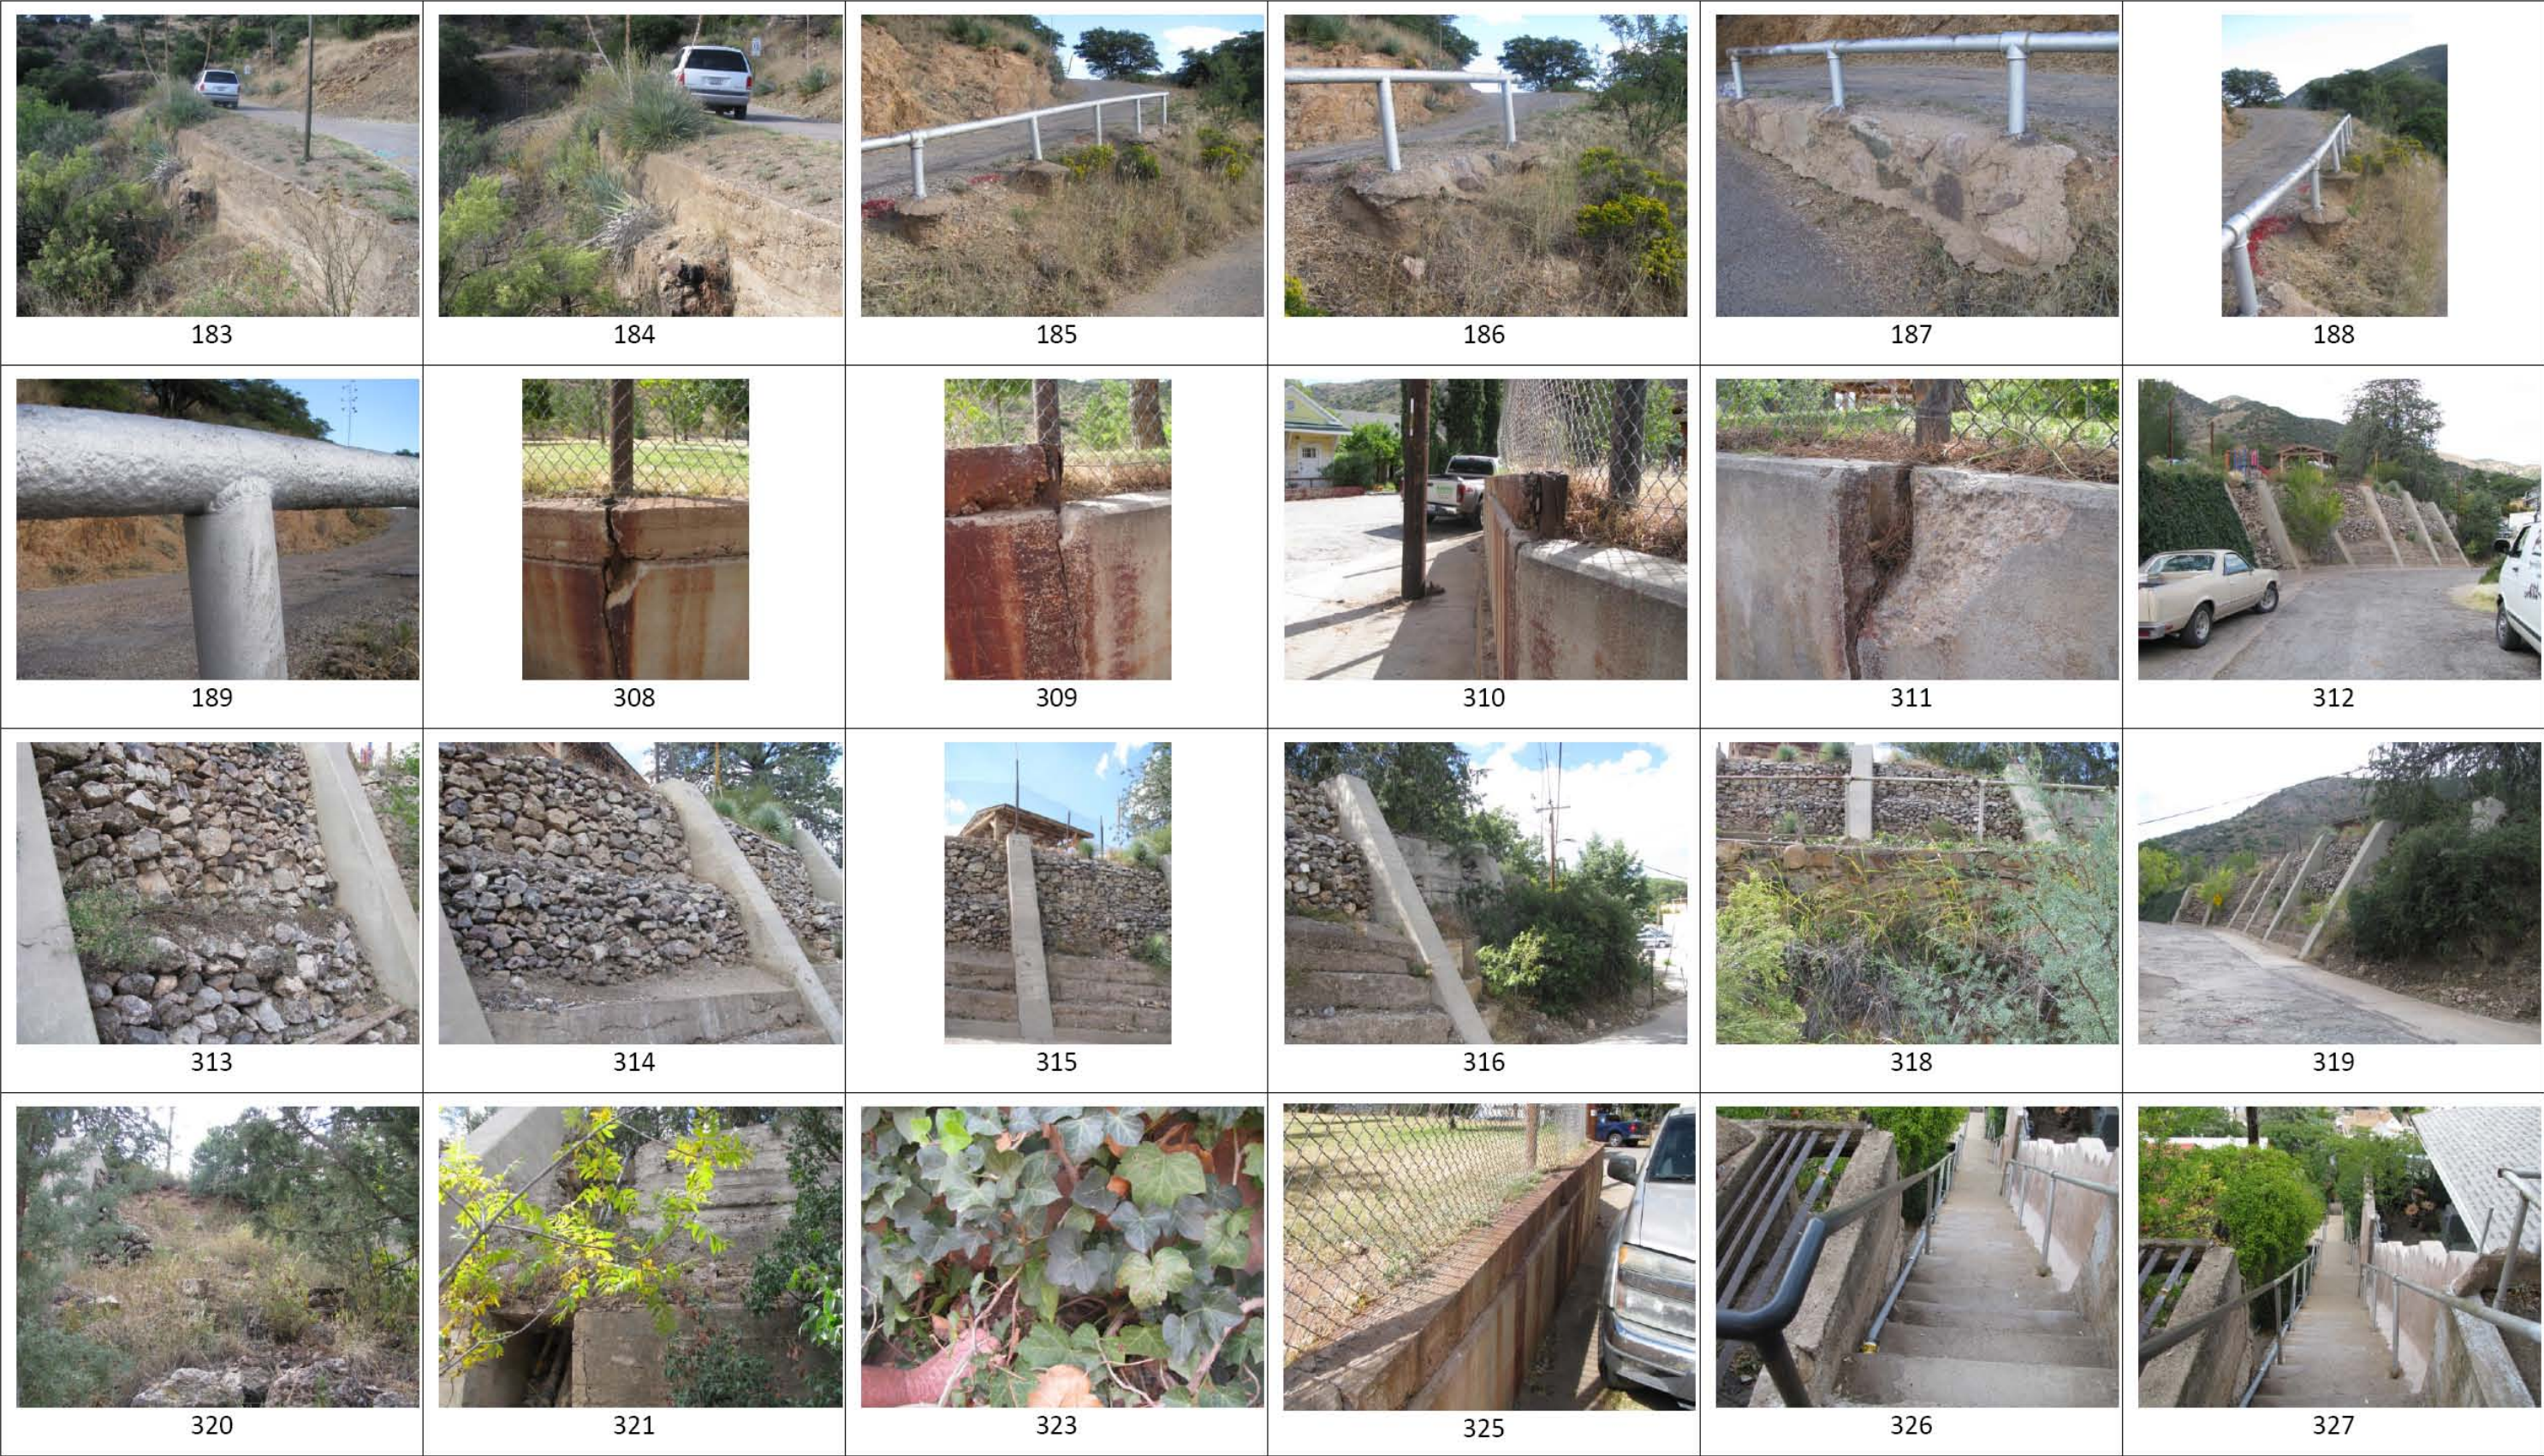
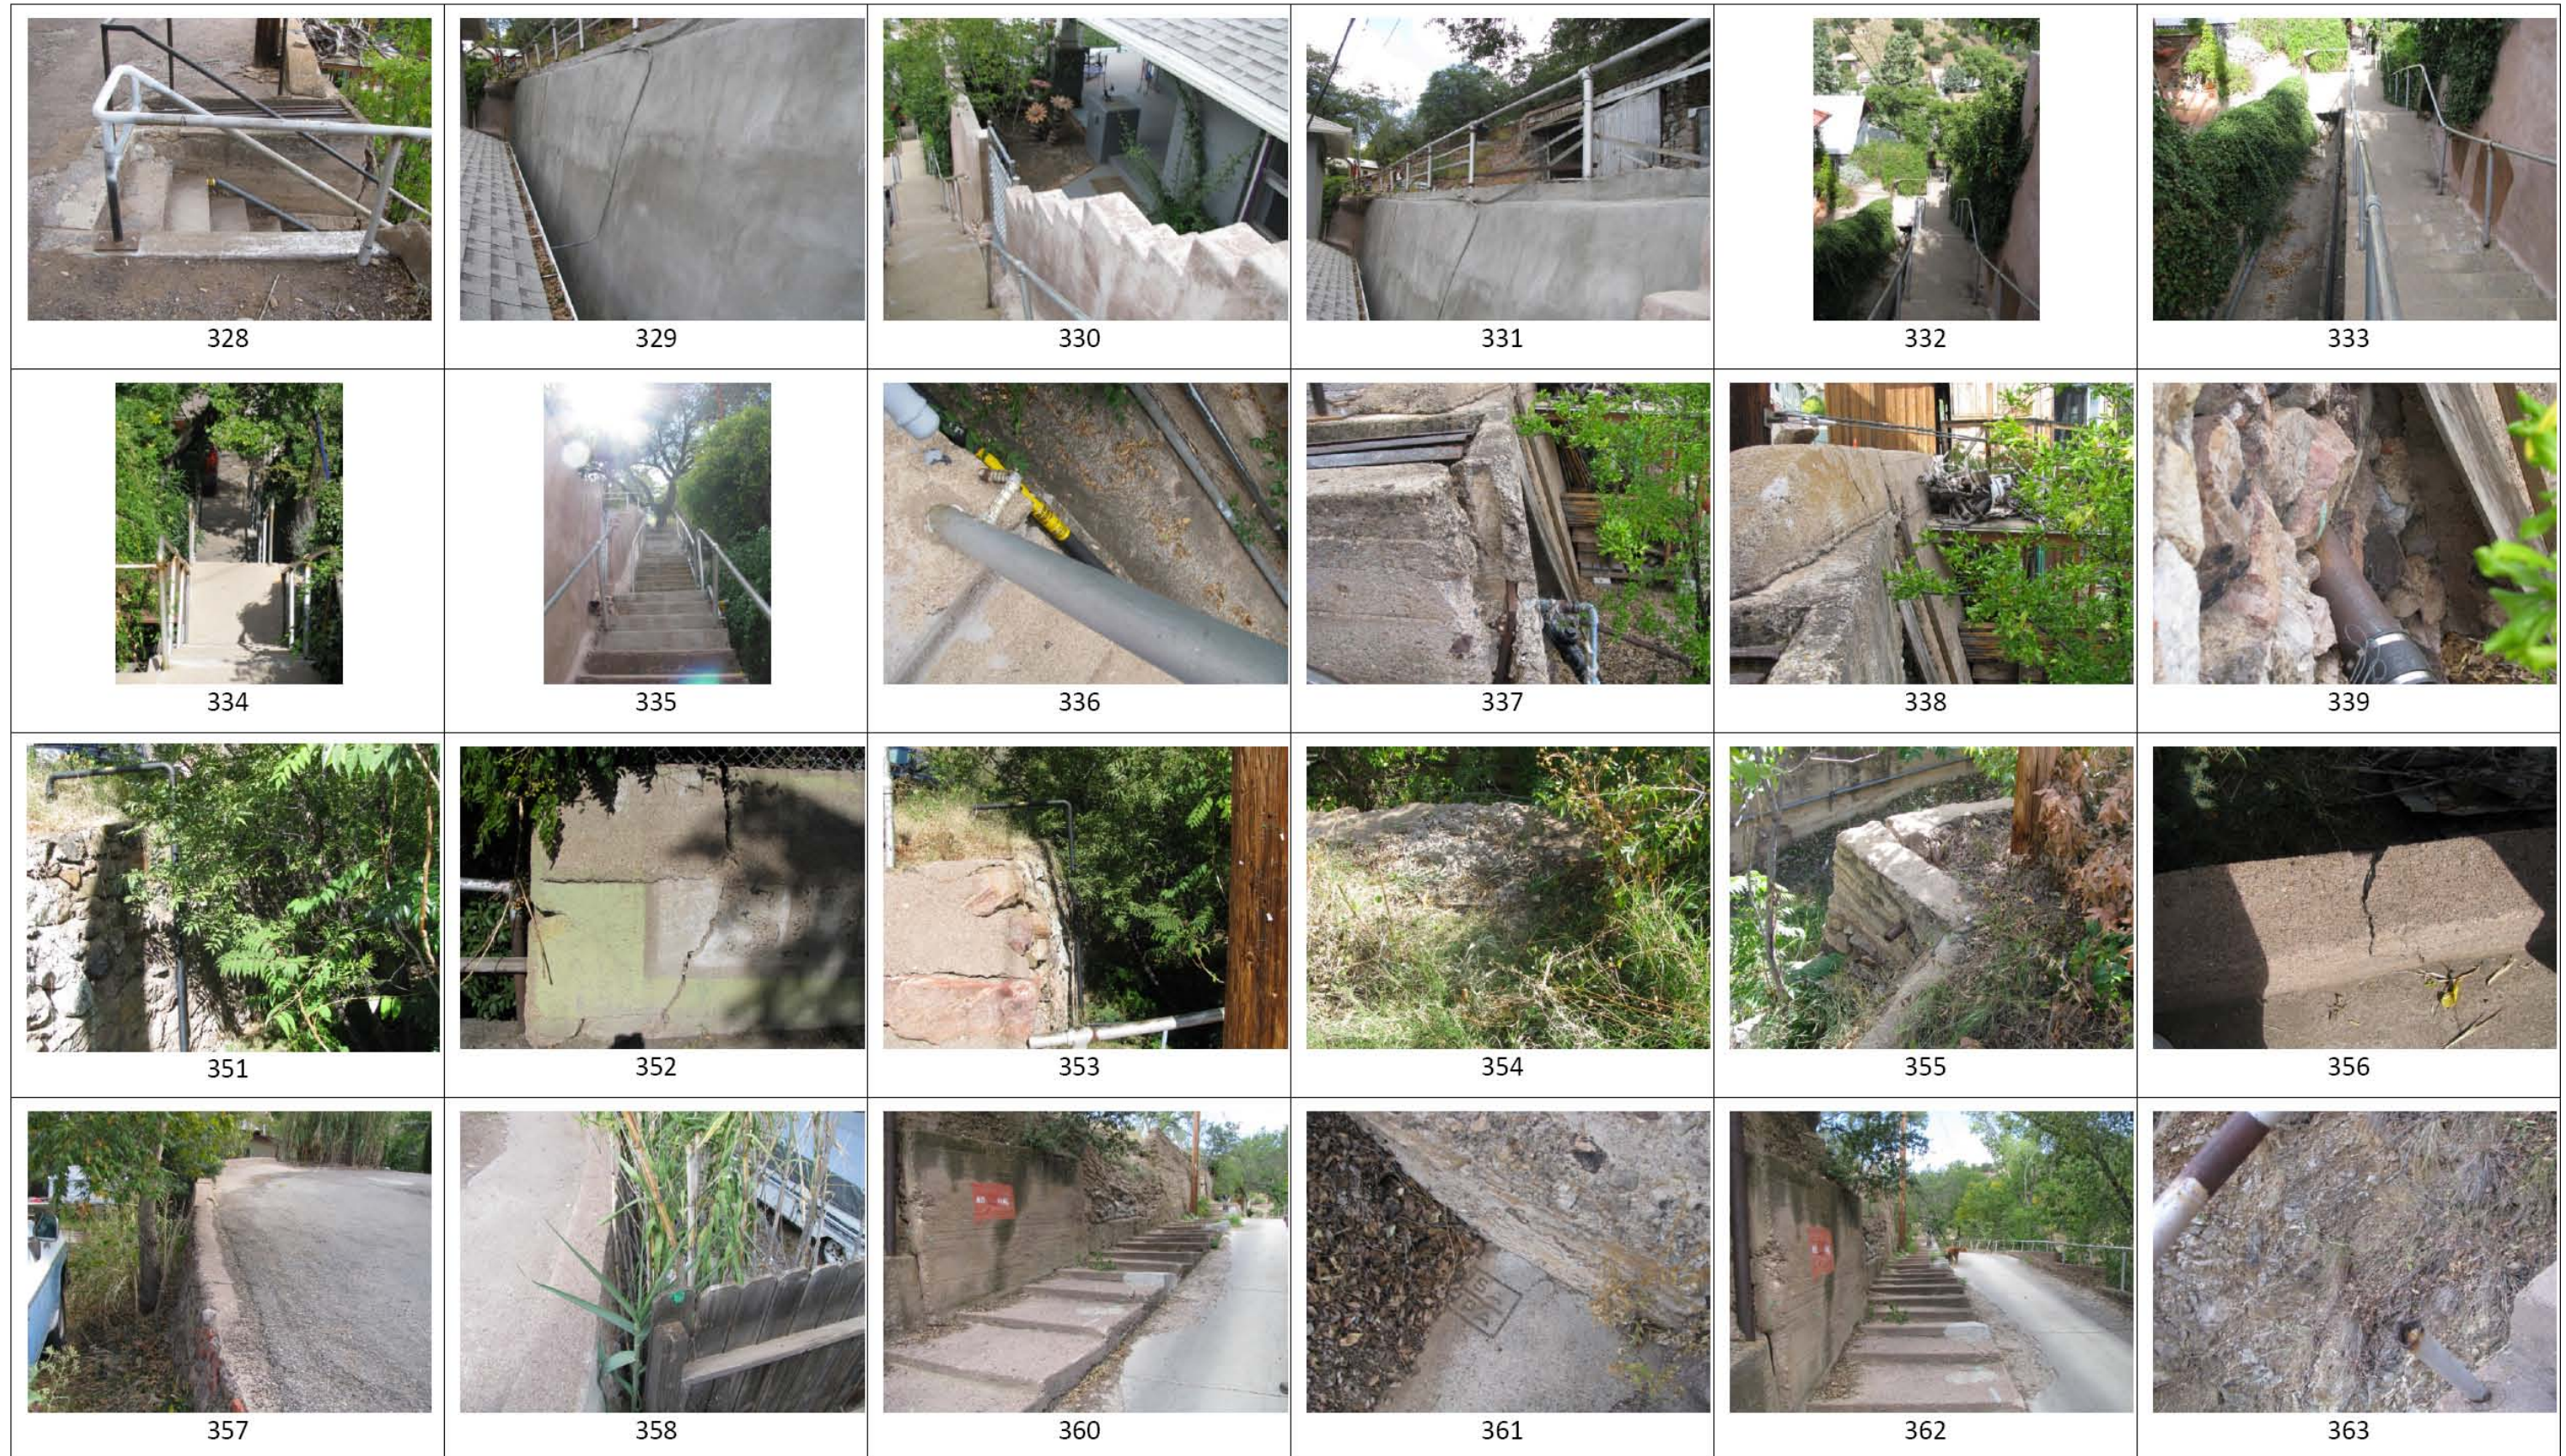
Exhibit 7 Walls & Stairs Inventory – Pictures

Warren Avenue					Concrete	Handrail is in fair condition	Steps/Treads are in poor condition (upper side). The lower side has been recently reconstructed. (See Pics. 488-493)			X			Reconstruct the upper portion of the stairway to match the lower portion.
Wood Canyon					Concrete	Handrail is in fair condition. Some of the members are rusted and are in need of replacement.	The stairs are in fair shape and the bridge over the canal is made of wood beams/wood planks and is in good condition with no observed signs of distress. (See Pics. 494 – 505; 507 - 511)			X			No immediate need of rehabilitation work. Handrail may need to be brought up to code.
