FINAL REPORT
SOUTH BRANCH, UPPER CARMACK
SUB-BASIN MANAGEMENT STUDY
PHASE II

ROBERT L. SHAND, P.E.
Drainage & Flood-Control Engineering
1 W. William Carey Street
Tucson, Arizona 85747
(602) 762-5668

Pima County
Department of Transportation
and
Flood Control District
201 North Stone Avenue
Tucson, Arizona 85701-1207

July 24, 1992

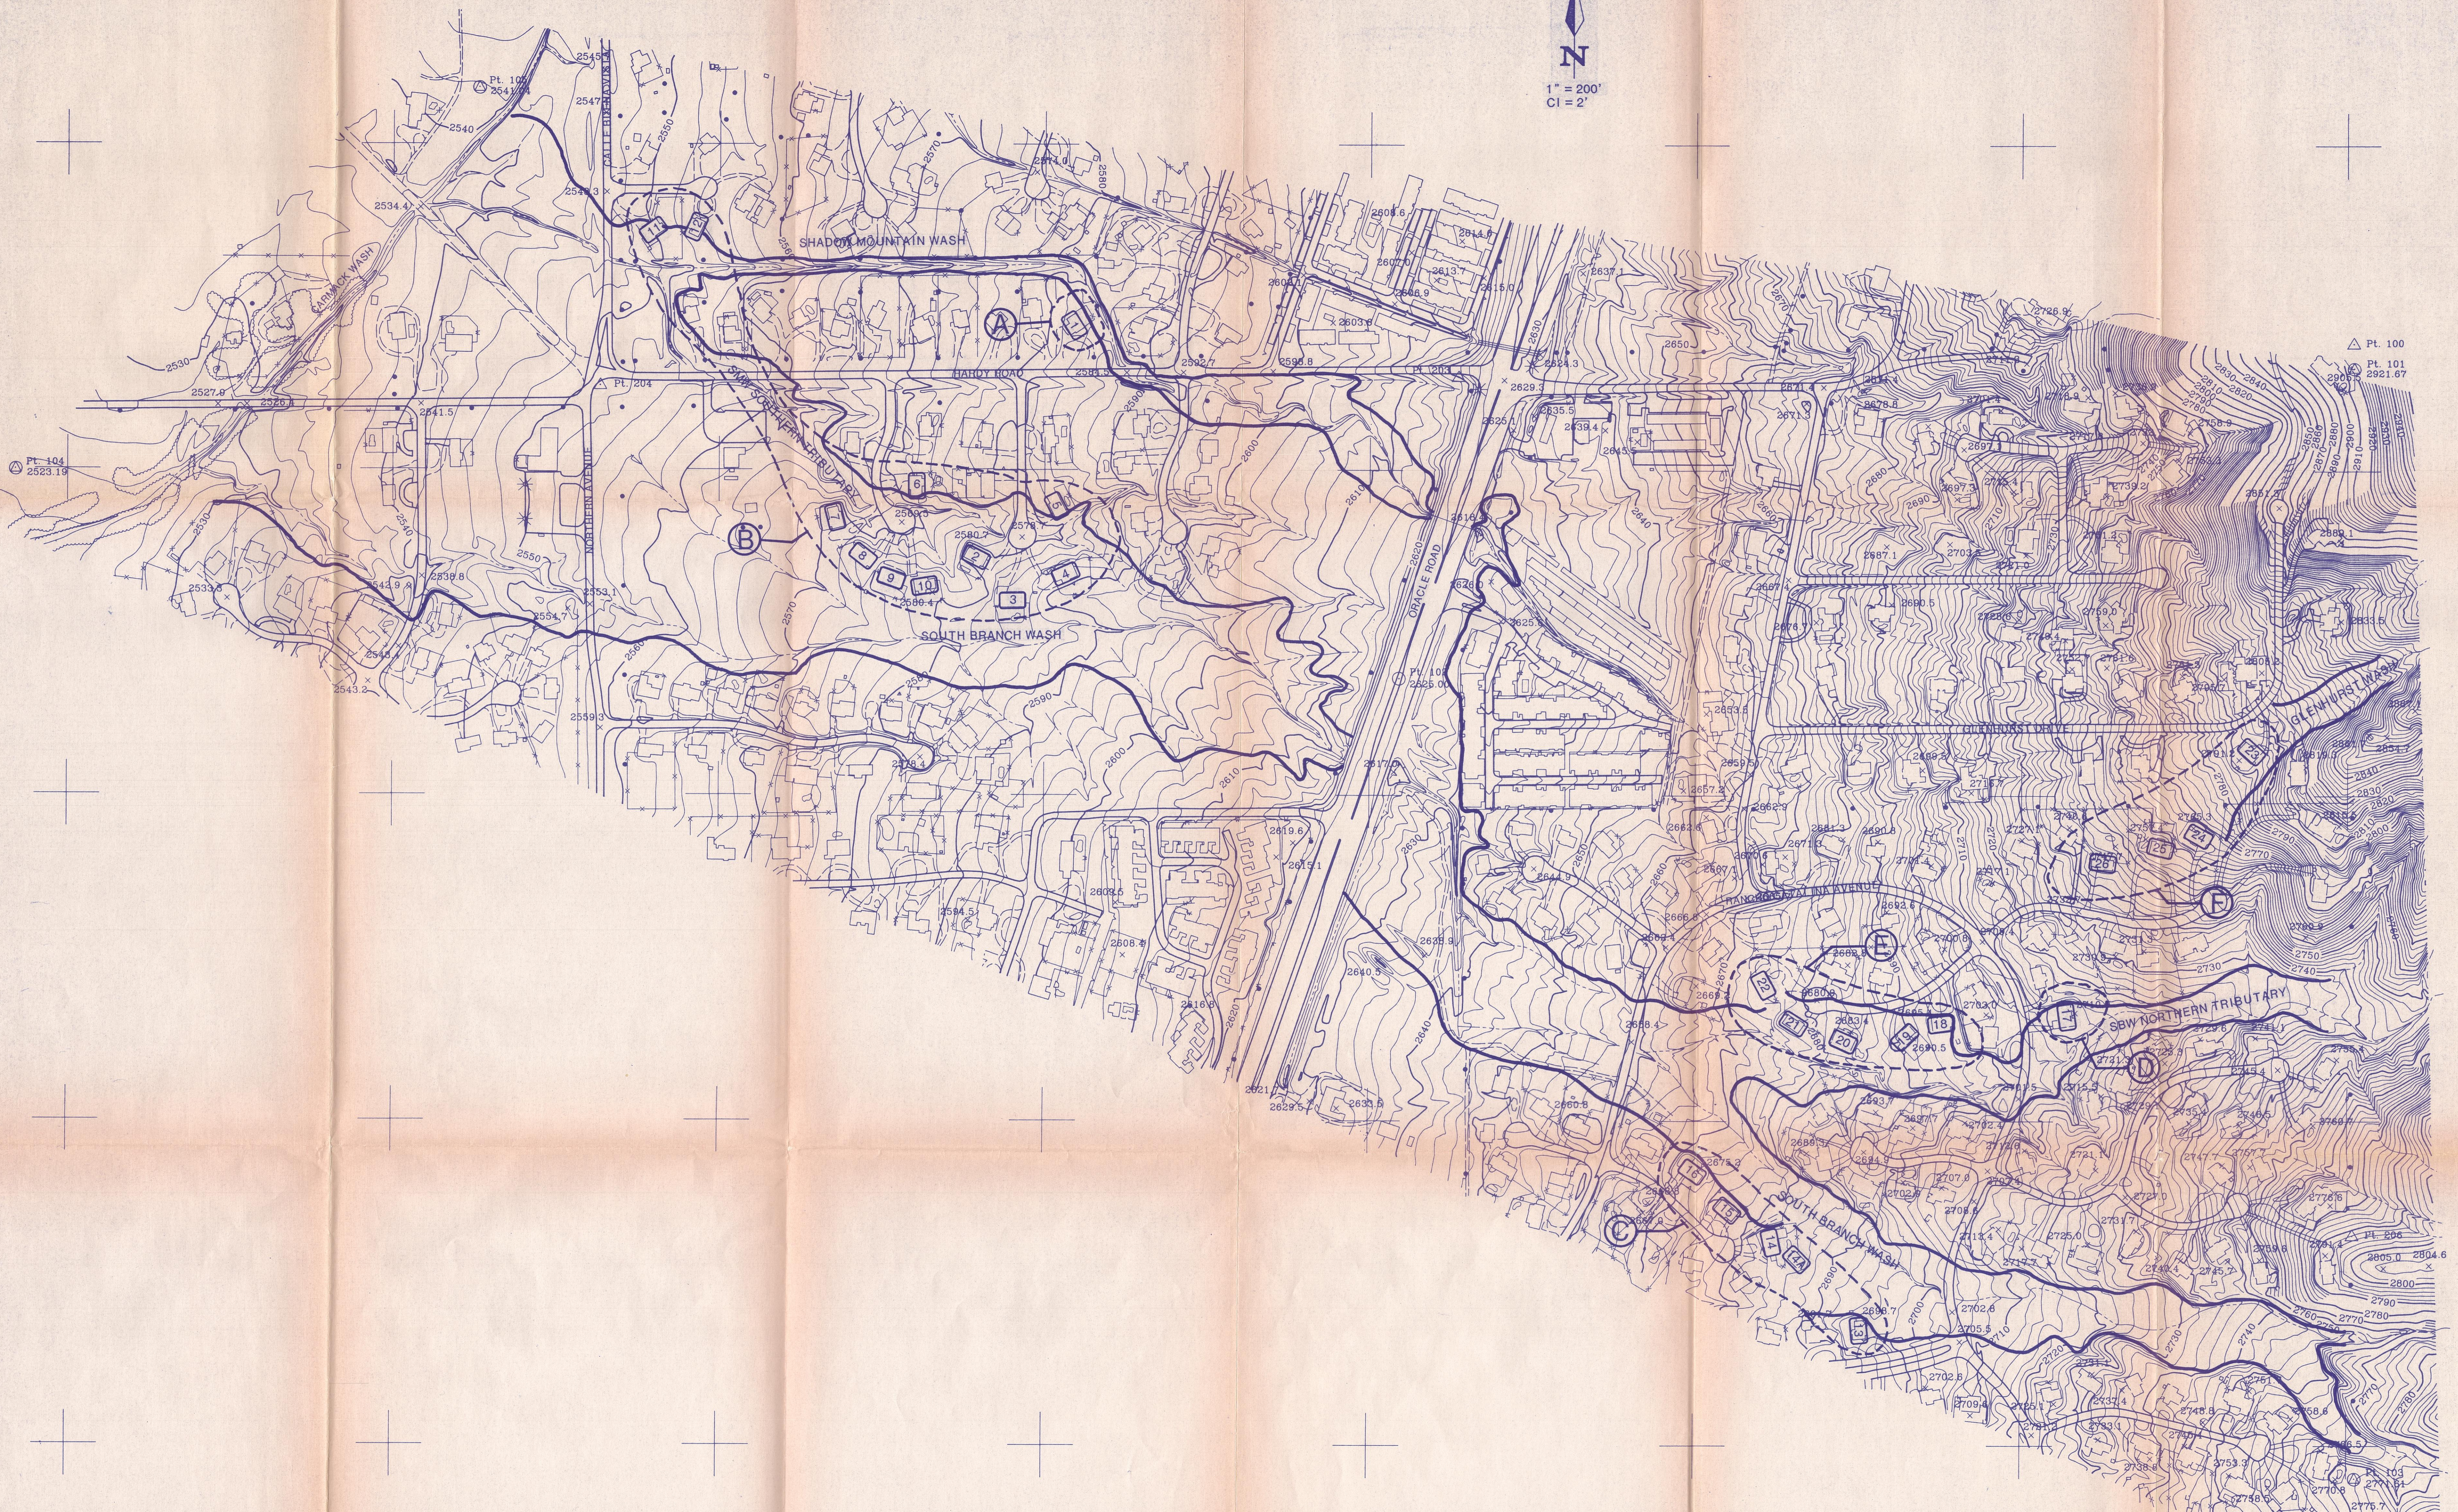
FIGURE 8 (PHASE I) FIGURE 9 (PHASE II)
 CROSS SECTION LOCATION & 100-YR FLOOD PLAIN MAP

Figures 7 and 8 represent two cross sections of the Shadow Mountain Drainageway within Problem Area A. These cross sections, which were taken from HEC-2 model 101-120.DAT, as presented in the Phase I report, are identified as Sections 113 and 114 (see Figure 9). Section 113 is located immediately downstream of the only home located in this problem area (i.e., home #1). Section 114 is located immediately upstream of the home. These figures also show the geometry of the improved channel section that could be provided within the existing drainage easement in an attempt to reduce the water surface elevation along this portion of the drainageway.

Figure 15 shows the proposed alignment of the floodwall for this problem area. Although the floodprone limit shown on Figure 9 extends to the north of most of the homes in this problem area, the proposed location of the wall will only constitute a very minor encroachment since most of this floodprone area is located in an ineffective flow-conveyance area. Consequently, this area was not included in the existing-conditions floodplain analysis (SBW-US2.DAT) as an effective conveyance area. The revised floodplain analysis that models the existence of the wall is the same one used for Problem Area D (i.e., SBWDUS2.DAT as contained in Appendix E).
